3.0 Understanding the Place—Built Elements & Archaeology

3.2 Physical Description of Blundells Cottage

To the west of the cottage a number of small huts were used for storage and a variety of home farm purposes, including an apiary for bees, while to the east another shed (described as old in 1923) was associated with the smaller paddocks used for stacking wheat and hay. Historic photographs and maps indicate that boundary fences were post and rail with slip rails in lieu of gates.⁷⁵

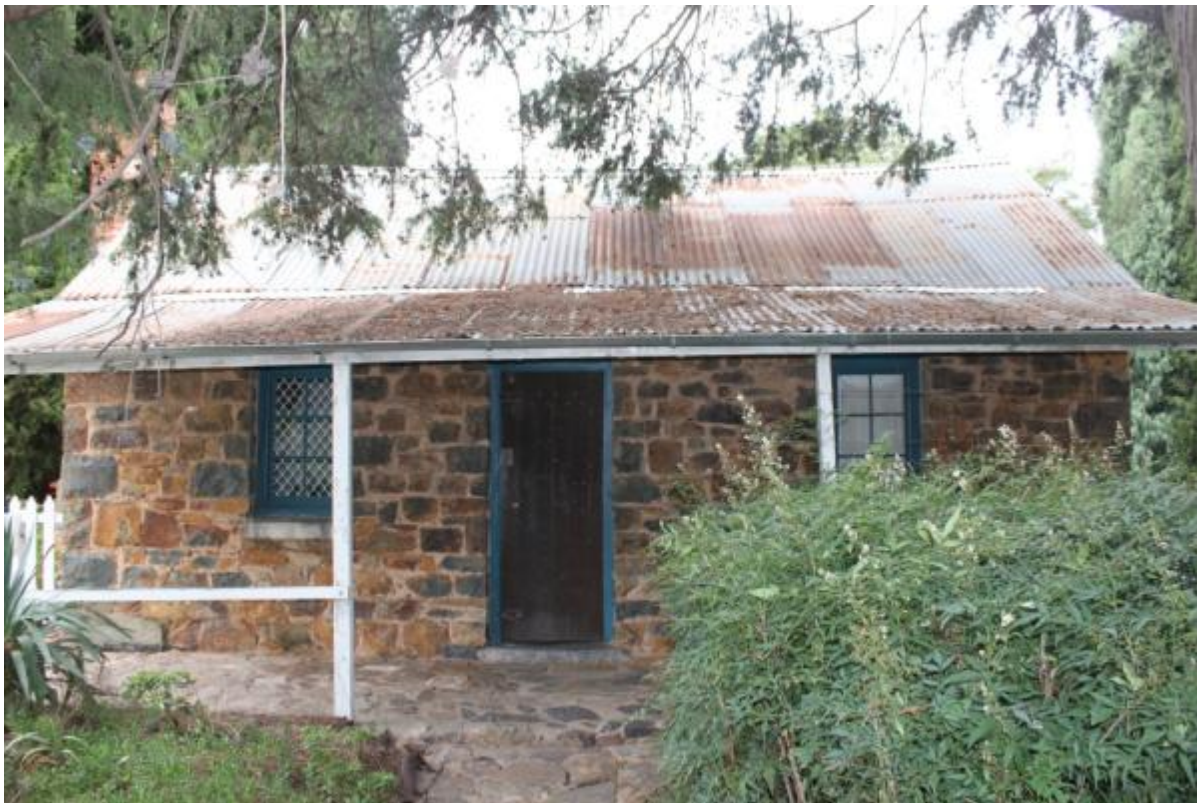
Figure 3.6 Northern elevation Blundells Cottage. (Source: GML 2013)

Condition	Importance of Fabric	Tolerance for Change
There is no evidence of rising damp or fretting mortar and all stones remain well bonded within their matrix. Condition of the wall is excellent other than for the previously mentioned weathering of mortar. Integrity is also very high as there does not appear to have been any significant modification other than the removal of the former limewash.	The walls are structurally and historically fundamental to the cottage. They are a core part of the building's aesthetic value and are likely to have a high degree of social value. This latter value is evidenced by Herman's initial instruction to clean off the former paint ⁷⁸ , and a subsequent reluctance by managers to reapply lime wash over the walls.	Repointing of mortar would be appropriate on an 'as needs' basis, but should be done 'here and there' rather than as a blanket treatment so that the overall patina of the wall is not compromised. Structural modifications would be unacceptable.

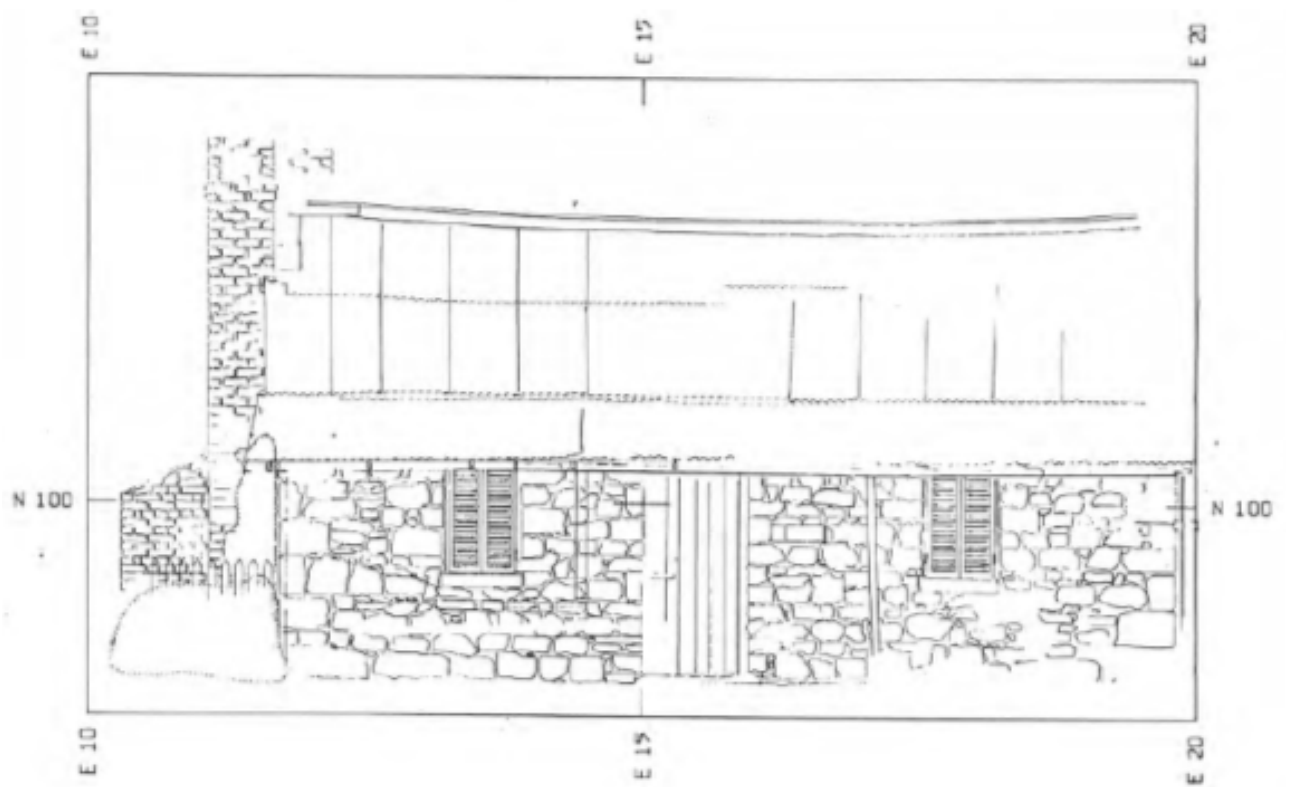
The roof form over the 1859 part of the house is a gable roof, unlike the rear addition, which is hipped. The ridge line has a distinct dip in its centre (apparent in the photogrammetric drawings (Figure 3.9). A prop was inserted under the ridge in 1991 to prevent any further subsidence.

Figure 3.9 North elevation drawing showing dip in ridge line. (Source: Australian Survey Office 1984)

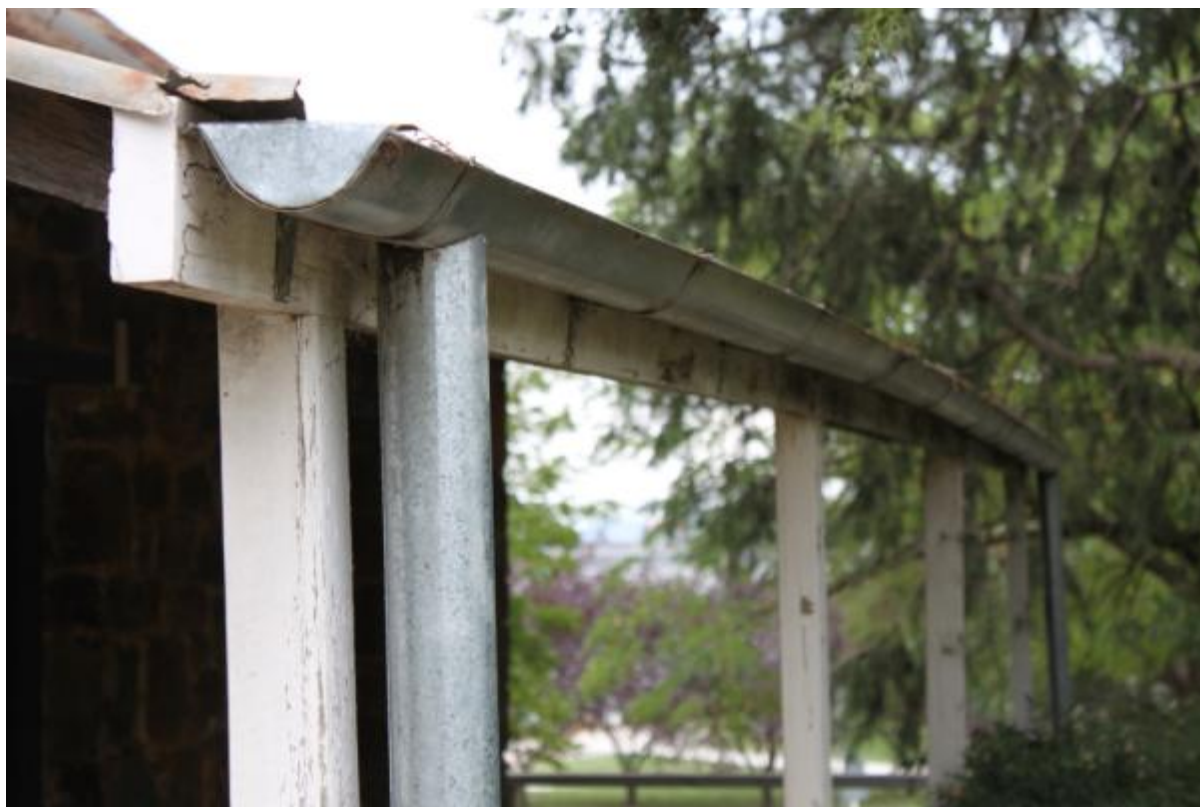
Figure 3.10 Half round gutter at front verandah. (Source: GML 2013)

Condition	Significance of Elements	Tolerance for change
Both the gutter and downpipe appear to be in good condition, with no rust evident on the outside. The gutters were clogged with debris at time of inspection and may be inadequate for the roof area to be drained.	The gutters and downpipes are sympathetic in style and material, but are relatively recent—Low.	As the gutters are not individually significant they could be changed for an alternative sympathetic profile—High.

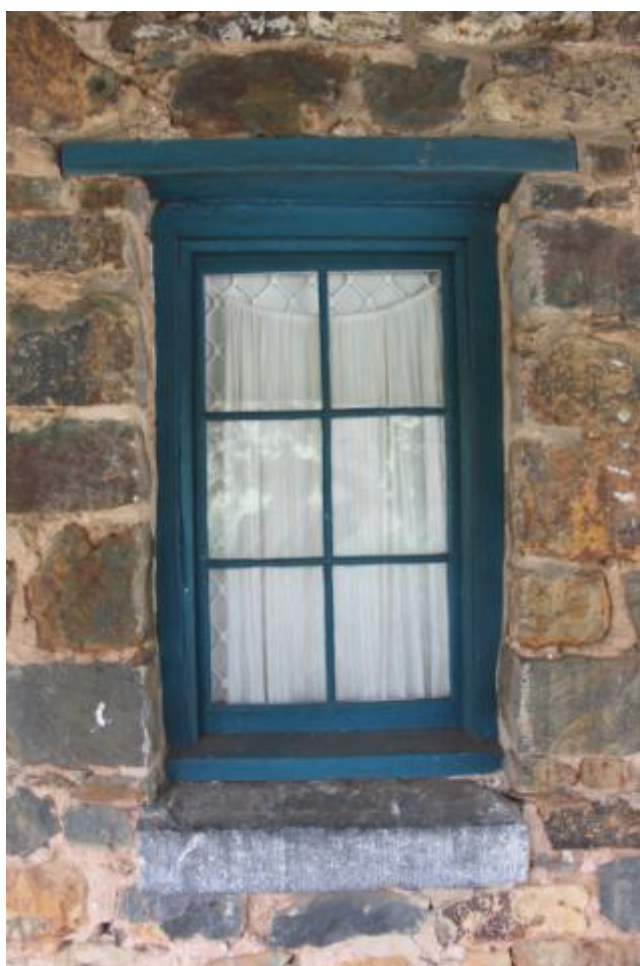
Figure 3.11. Front verandah window with timber lintel, hardwood frame, six-pane sash and shaped stone sill.
(Source: GML: 2013)

Condition	Significance of Elements	Tolerance for change
Condition of windows is very good	Both window frames are highly significant as original fabric—High. The eastern sash is also assumed to be 1858—High. The western sash is significant in terms of form but not in fabric—Moderate.	Frames—Low. East sash—Low. West sash—Moderate.

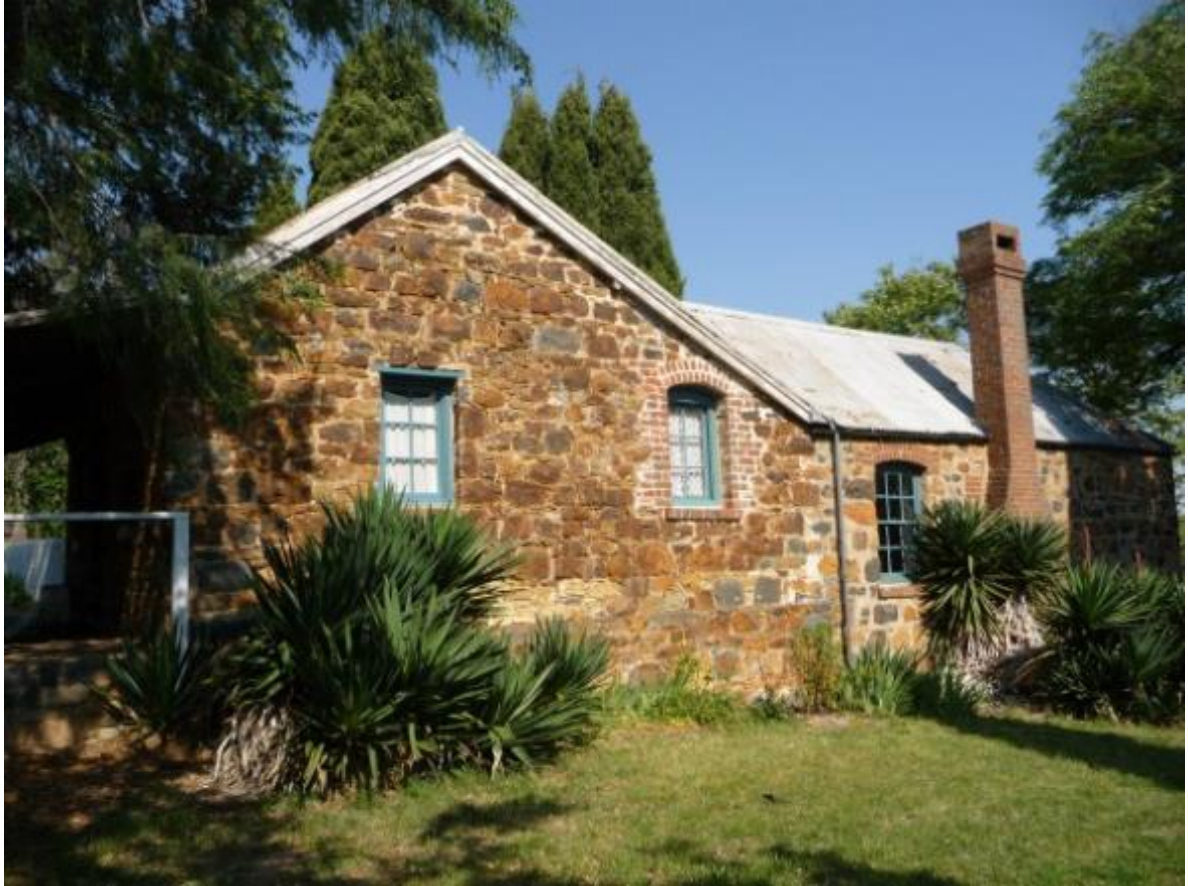
Figure 3.12. West elevation of Blundells Cottage. (Source: GML 2012)

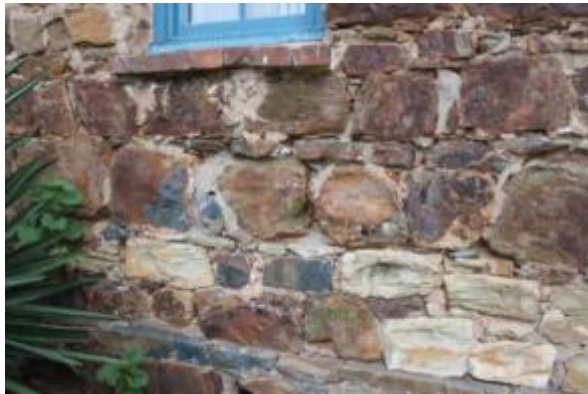
Condition	Significance of Elements	Tolerance for Change
Fundamentally the overall wall is sound, however, the extent of erosion on joints in the 1859 wall is considerable and warrants attention (Figure 3.12). The 1888 wall had subsided at its southwest corner and was underpinned in 1963. Herman's drawings Nos 4 and 5 (1961) include the instruction to 'underpin wall'. A crack is evident in the wall extending from the ground to the top plate approximately 900mm from the southern corner (Figure 3.13).	The stone walls are highly significant, as is the surviving evidence of the mortar and pointing joints that were done at the time of construction—High.	Repointing is acceptable providing it follows best practice Burra Charter procedure. Refer to the scope of works for further details—Moderate.

Figure 3.13 Deeply eroded mortar in 1859 west wall.
(Source: GML 2013)

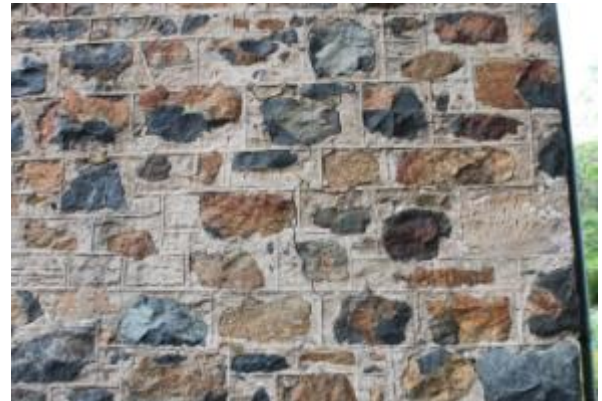
Figure 3.14 Raised pointing and structural crack in 1888 wall. (Source: GML 2013)

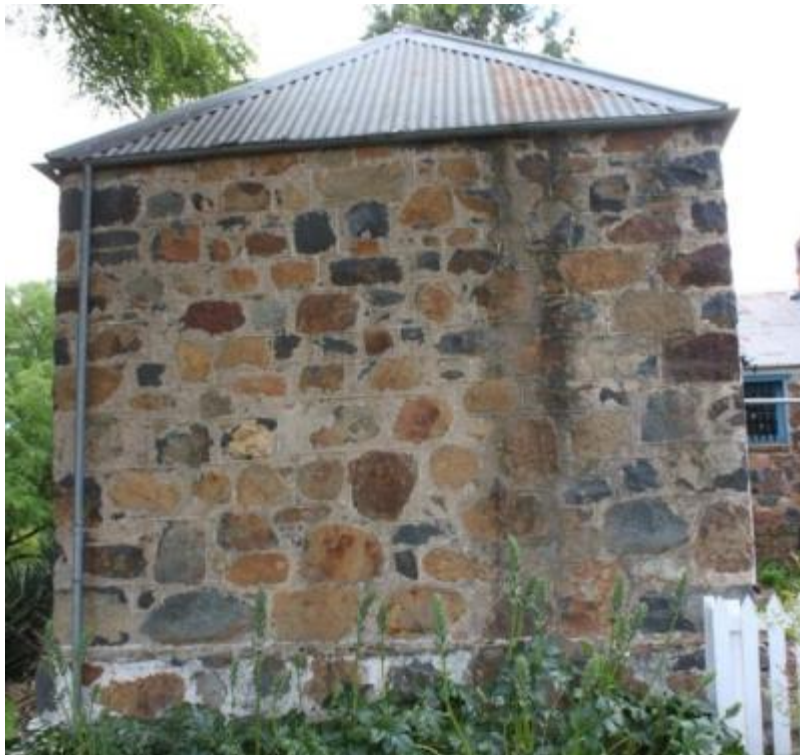
Figure 3.15 South elevation of 1888 extension showing hipped end to the roof. (Source: GML 2013)

The most significant change was the underpinning of the wall and repair of the crack about 900mm from the right hand edge during the restorations by the NCDC undertaken by Morton Herman. Herman commented that one of the main faults was 'somewhat severe settlement at the southwest corner'.⁸⁴ The underpinning repair work appears to have been very successful with no further opening of this crack. Otherwise the integrity appears high.

Condition	Significance of Elements	Tolerance for Change
Good	Original fabric—High.	The wall has very high integrity—Low.

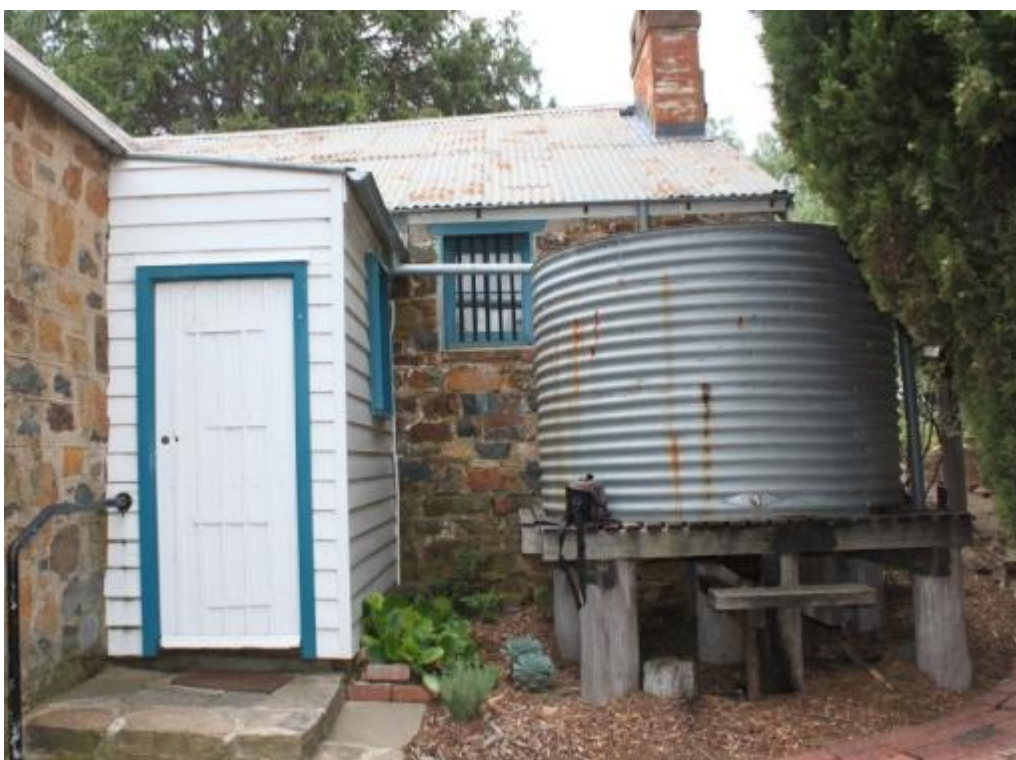
Figure 3.16. South elevation of 1859 section partly obscured by more recent porch and tank. (Source: GML 2013)

The tank-stand and tank were built in 1992 and replaced a former tank-stand and tank that dated from 1963 that had in turn replaced two smaller tanks, one square and one round (noted in Morton Herman's report). The 1992 galvanised iron tank is now leaking badly (Figure 3.16).

Condition	Significance of Elements	Tolerance for Change
Tank—poor condition. The iron has rusted through and the tank needs to be replaced in full.	From the period of occupation and may be the original tank from the north of the cottage relocated in the early 1960s.	Moderate. The fabric is decayed and must be replaced for the tank function to continue. The form and materials of the tank should be replicated for a replacement.

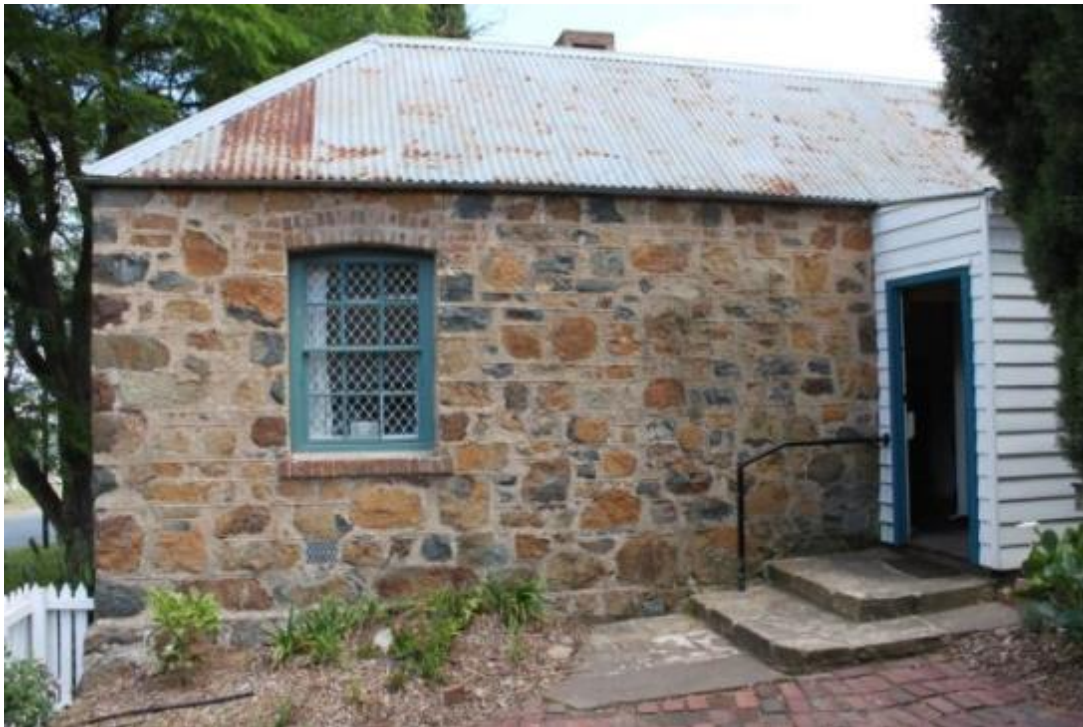
Figure 3.17 East elevation of 1888 extension. (Source: GML 2013)

Condition	Significance of Elements	Tolerance for Change
Corrugated iron—Moderate Some rusting.	1888 fabric—High.	Moderate. Avoid change unless roof iron and fixings are failing.
Guttering—Poor.	Introduced 1960s fabric.	High. Inadequate for function and
