8.0 Outline Conservation Works and Cyclical Maintenance Schedules

8.3 Schedule of Works for Blundells Cottage

Table 8.1 Identified issues and recommended works for the different components or elements of Blundells Cottage.

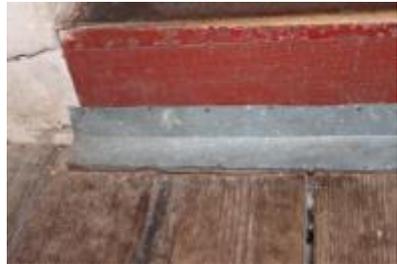
Element	Condition	Identified Issue/s	Recommended Works	Priority	Timing	Image
COTTAGE INTERIOR						
Back porch Cover strip between steps and floor	Fair	The cover strip is starting to come loose. This could become a trip hazard or worse if it catches on someone's shoe.	Carefully re-secure the metal strip to the floor following existing evidence.	High	2013

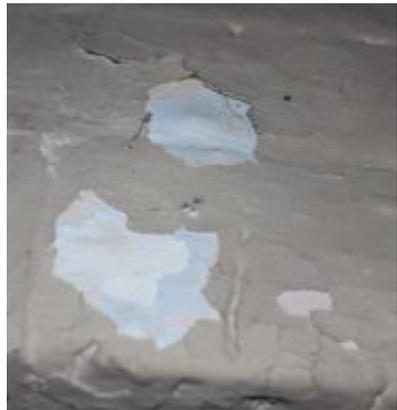
Back porch Upper west wall paint	Fair	Paint is flaking off the wall.	The porch walls are important as the only walls not covered in post-1965 limewash. Seek professional advice on how to stabilise flaking paint and retain the porch wall as it is to indicate the range of colour finishes used during the life of the cottage and use this for interpretation. Refer to Gillian Mitchell Blundells Cottage Paint Analysis 2012 (and Appendix D) for conservation and protection of painted finishes.	Medium	2013

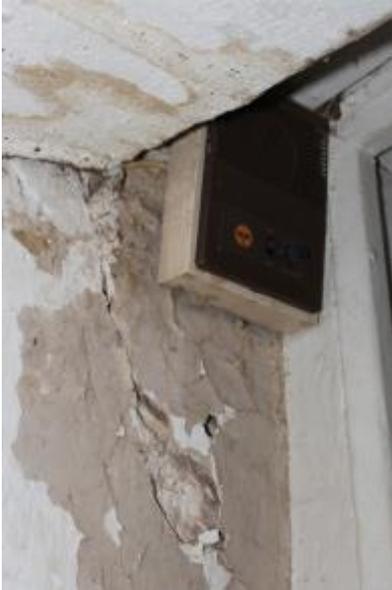
Element	Condition	Identified Issue/s	Recommended Works	Priority	Timing	Image
Back porch Upper wall	Poor	Intercom	If the Intercom system is redundant it should be removed.	Removal should occur before wall is stabilised.	2013

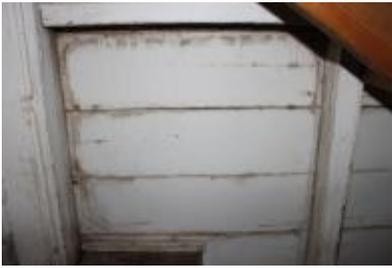
Roof leaks	Check if leaks have been repaired; monitor for leaks during rain.	High	2013	
		Ceiling stains	Research appropriate distemper/limewash products both in terms of content and colour, prepare and apply new.	It will identify if roof still leaking – High.	2013	
		Loose paint and plaster	Consolidate if possible, otherwise repair/replace damaged render as it is part of occupancy phase and therefore significant.	Medium	2015	
Back porch East wall	Stained	Evidence of former water entry. The stains mask whether there is on-going water entry. Gutters and valley on roof may be clogged.	Check gutters and valley on roof to prevent water penetration. Clean, and /or repaint.	Medium	2013 2015

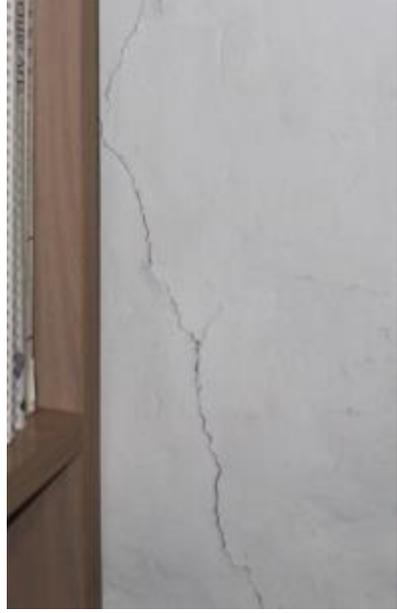
Element	Condition	Identified Issue/s	Recommended Works	Priority	Timing	Image
Room 1 West wall	Good	Hairline cracks are evident on the west wall and above the window in the eastern wall.	No immediate works at this stage as the walls appear relatively stable. The cracks should be monitored for movement, shrinkage and cracks, possibly through the attachment of 'Telltales'. This could reinforce use of Blundells as a conservation teaching site. Buy 'Telltales' and use in accordance with the instructions. Try < www.hmgroup.com.au >.	Medium	2013

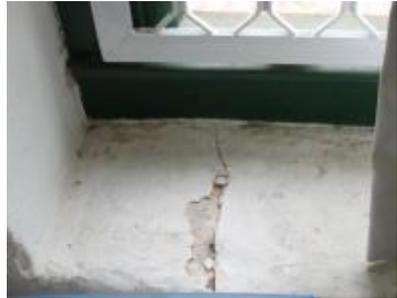
Decayed mortar by window sill	Prior to the room being lime washed the crack should be cleared to remove loose material to the substrate and then filled with lime mortar to patch.	High	2013

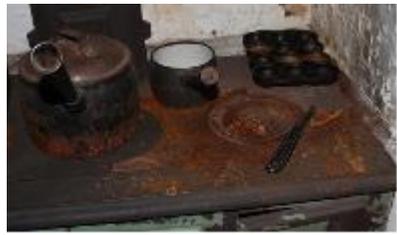
Room 2 Stove top	Poor	Water is entering through the chimney and rusting the stove top plate.	Cap the flue within the chimney opening at top of the chimney but allow vent to permit ventilation. Also check that recently introduced flashing at the junction of the roof and chimney is not causing problems. Note that recent cuts in	High	Early 2013

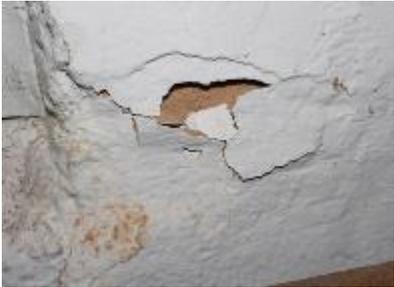
Element	Condition	Identified Issue/s	Recommended Works	Priority	Timing	Image
			brickwork to fit flashing are not consistent with sound Burra Charter practice. Contractors may need to be instructed in relation to traditional practices.			
Room 2 West wall	Poor	Render is actively spalling in a localised area to the lower right of the stove. This may be on-going, or exacerbated by the water falling on the stove. Salt activity may be involved.	Ensure there is no cement under the present surface and remove if necessary. Removed decayed material, apply poultice, dry wall and apply new lime based render once possible salt action has been stabilised. Monitor and check for other damp sources.	High	Mid 2013

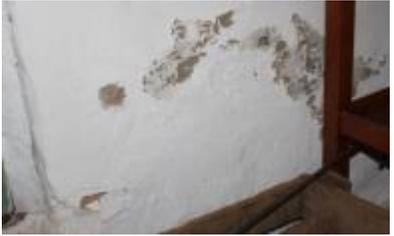
Room 2 West wall Rising damp	Poor	An arc of rising damp is evident up to about 700 mm to the left of the stove. The origin of the moisture needs to be located and resolved.	Check there is no cement under the current surface and remove if necessary. Remove built up soil and plants from the exterior to be consistent with local external ground level and well below the 50mm plinth. Review the recent flashing around the chimney and rectify. Ensure that roof and ground water is drained well clear of the wall. Make good interior render only after damp problems have been resolved.	Very high	Early 2013

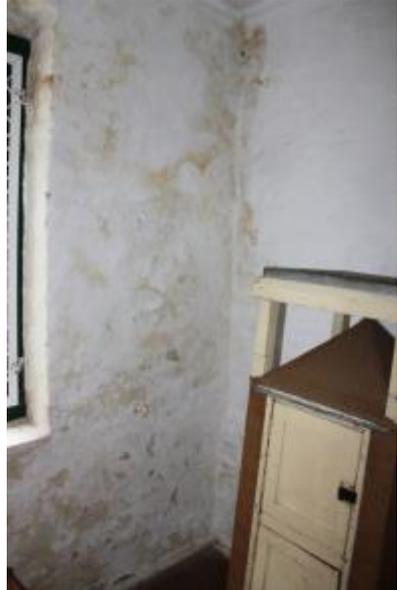
Element	Condition	Identified Issue/s	Recommended Works	Priority	Timing	Image
Room 2 West wall Falling and penetrating damp	Very poor	Damp is penetrating the wall from the ceiling all the way down to the floor.	<p>There is a roof valley that directs water to this location. The roof gutter also flows to this point. However the down pipe is completely clogged and causing water to run down the wall during rain.</p> <p>Roof water needs to be discharged well clear of the building and a comprehensive review of roof drainage should be undertaken to ensure that all roof water is collected and evacuated. In the short term the down pipe needs to be flushed clear or replaced. Gutters also need to be cleaned on a monthly basis. The internal surface can be repaired only after the external damp has been controlled.</p>	Critical	Immediate

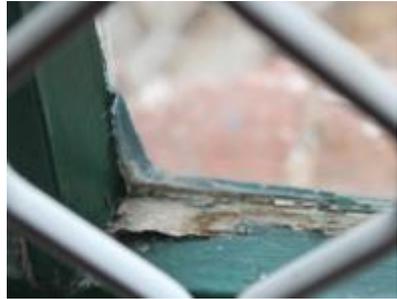
Room 2 West window	Poor	Paint on the interior of the windows is breaking down. Timbers in the sash will start to decay if this is not repaired. The problem is exacerbated by condensation on the inside of glass in winter.	<p>Sand back to sound wood, prime and paint.</p> <p>Use antifungal additive in paint or primer.</p> <p>De-humidify the room in winter to actively remove condensation.</p>	High	2013

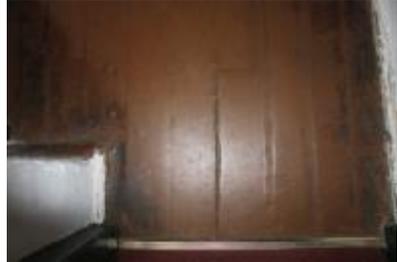
Room 2 Linoleum floor	Fair	The linoleum is distorting due to the uneven butt-jointed subfloor. This will exacerbate decay of the lino. The lino was added by the CDHS in 1963 and renewed in 1970. It is not individually significant but the use of recycled lino by the CDHS is typical of their conservation	Reinforce the underside of the lino. If the linoleum is lifted, investigate options for achieving a more level subfloor. Careful preparation will be needed to ensure linoleum is not damaged during lifting.	High	2013

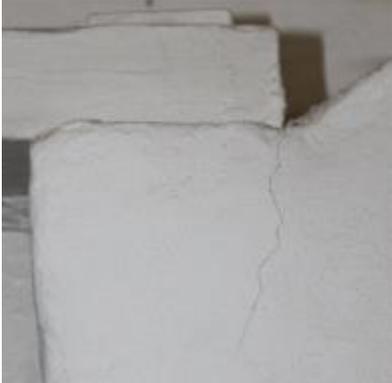
Room 3 Hairline crack east wall	Fair	The hairline crack is immediately below a point on which the door head beam rests, although as the beam carries no weight, it is difficult to see what caused the crack. One possibility is that the beam was used as a scaffold support during previous work.	Monitor this crack to ensure that the corner of brickwork does not break away completely. Apply limewash to fill the crack and note if it reappears—which would suggest the crack is growing, in which case structural pinning may be necessary. Do not apply heavy weights to the beam (eg scaffolding), or allow children to swing on it.	Medium	2015

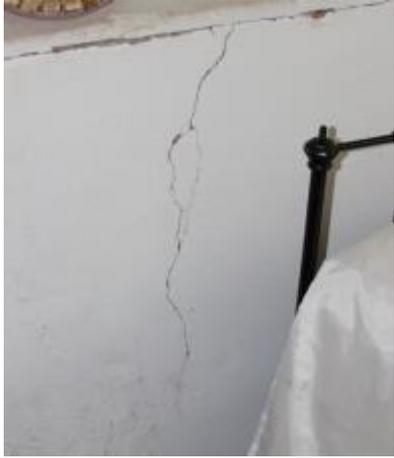
Element	Condition	Identified Issue/s	Recommended Works	Priority	Timing	Image
Room 3 South wall crack	Fair	A crack extends from the former window sill to the floor. The crack matches cracks on the other side of the wall and indicates some settling in the building or a stress crack from overloading. It is not weakening the structure and appears benign.	Rake the crack to firm the substrate and fill it with lime mortar and repaint with lime wash.	Low	2015

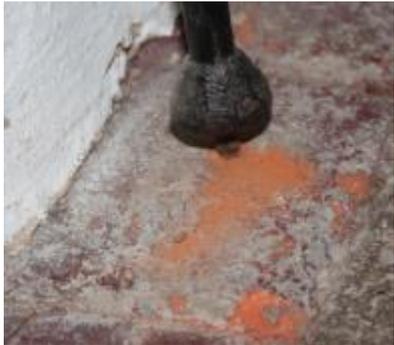
Room 3 Brickwork by door	Poor	The base of the bed leg has a sharp point protruding where a castor may have once been located. The point is scratching into the brickwork and causing erosion.	Fix a small but broad pad to the base of the cot leg.	High	Urgent

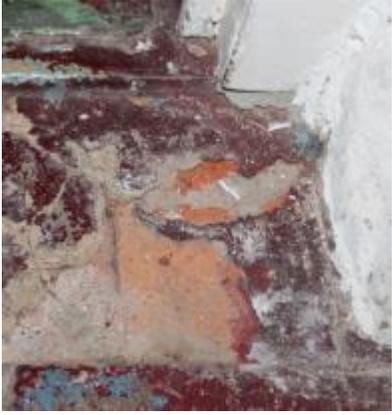
Element	Condition	Identified Issue/s	Recommended Works	Priority	Timing	Image
Room 3 Floor by door	Slowly deteriorating	The mortar capping over this part of the floor is drummy and slowly deteriorating. The mortar is important because it contains several layers of surface treatment.	Monitor the mortar and consider consolidation, possibly by injecting adhesive between the layers although this risks exfoliation. Seek further advice from a materials /conservation specialist.	Medium	2014

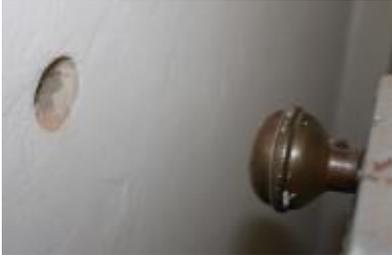
Room 3 Door knob impact on wall	Poor	The door knob has worn a large hole in the render from impact when the door is opened. The age of the wear is not established, but it is bad for both the knob and the wall.	Fill the hole with render and patch and paint. A small door stop at floor level is needed to prevent the problem re-occurring.	Medium	2014

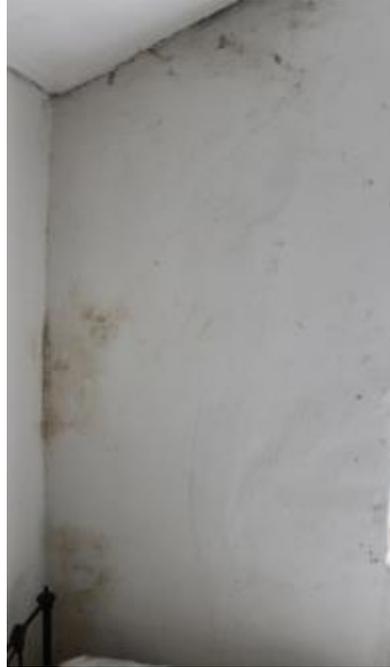
Element	Condition	Identified Issue/s	Recommended Works	Priority	Timing	Image
Room 3 Southwest corner damp	Poor	This is a continuation of the damp that is causing problems on the NW corner of Room 2. The problem is due to clogged gutters and downpipes externally, plus some deterioration of external mortar.	<p>Check and clear/repair the roof and down pipe as necessary.</p> <p>Roof water needs to be discharged well clear of the building and a comprehensive review of roof drainage should be undertaken. In the short term the down pipe needs to be flushed clear or replaced. Gutters also need to be cleaned on a monthly basis. The internal surface can be repaired only after the external damp has been controlled.</p> <p>Check ground drainage is directed away from building.</p> <p>Renew mortar with lime based mortar after clearing out all loose material.</p> <p>Allow to dry, scrape off stained material. Apply algaecide if moulds or algae present.</p> <p>Apply new limewash/distemper after researching suitable products.</p>	Very high	2013

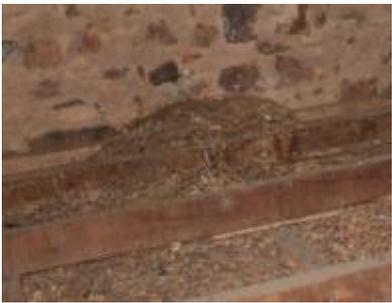
Room 4 Interior		No obvious issues				
Room 4 Ceiling space	Stable	Presence of asbestos cement sheeting and evidence of former lath and plaster ceiling. The stability of the asbestos cement sheet should be confirmed—the material around the manhole could easily be friable and therefore a risk. There is clear evidence of a	<p>Investigate the presence of asbestos by Hazardous Material in Buildings Review and undertake stabilisation.</p> <p>Subject to the recommendations of the Hazardous Material In Buildings Review, it is recommended that within a few years the asbestos sheet</p>	Urgent	Immediate

Element	Condition	Identified Issue/s	Recommended Works	Priority	Timing	Image
		former lath and plaster ceiling which could be reinstated or replaced with lath and plaster or fibrous plaster sheet. The lining boards are post-1963 and not significant to this site.	be removed and replaced with fibre cement sheet. The introduced lining boards can be reinstated. The fibre cement sheet will keep dust out of the room and the boards represent CDHS input. They will also provide a degree of texture that would have been present with a lath and plaster ceiling, but is lacking in modern plasterboard sheets.			
Room 4 Ceiling space	Dangerous	A large amount of debris has built up on the west wall in the ceiling, most probably due to former starlings or rats. The matter is highly flammable. It may also include asbestos.	Investigation of asbestos presence and remediation. Engage a specialist to investigate for asbestos presence and recommend appropriate clearing.	Urgent	Immediate

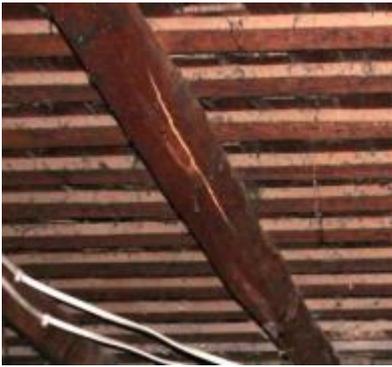
Room 4 Ceiling space	Unclear	Possible termite activity	Inspect regularly and treat if active. Install termite baits. Get an assessment for any carpentry repairs or strengthening.	Urgent	Immediate

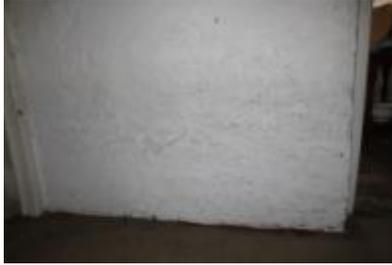
Element	Condition	Identified Issue/s	Recommended Works	Priority	Timing	Image
Room 5	Scuff marks	Heavy visitor use has resulted in a fair amount of scuffing along this wall.	At an appropriate time the wall could be cleaned and possibly re-limewashed/distempered in accordance with the interpretative presentation of the cottage.	Low	When other walls are being limewashed/distempered

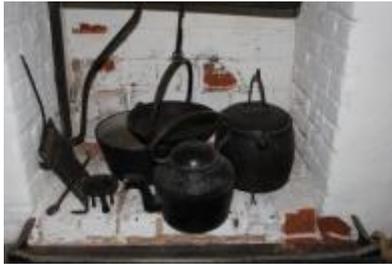
Room 5	Fair	Fretting bricks	Investigate to determine the cause—damp or drying? Apply a poultice to extract salts and then apply a sacrificial lime mortar, after salts have been removed/stabilised limewash can be applied. Monitor.	Medium	At the same time as similar repairs elsewhere in the building

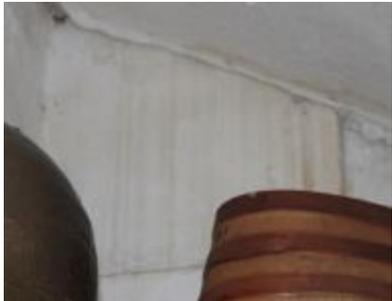
Room 5 Stains above chimney	Fair	Stains above the chimney suggest that there has been leaking at the chimney roof junction. It is not obvious if this is old or recent.	Check the roof flashing above the chimney and rectify if necessary to prevent further water entry. Clean stains in the short term, and apply limewash/distemper when the rest of the room is being limewashed, in accordance with 'Blundells Cottage Paint Analysis 2012' and consistent with the interpretative presentation of the cottage.	Very high	Check for leaking in the flashing in 2013. Remaining works when convenient.

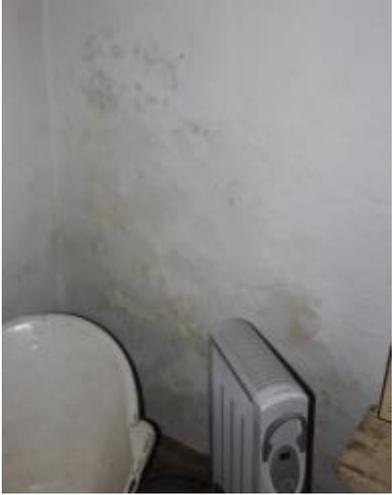
Element	Condition	Identified Issue/s	Recommended Works	Priority	Timing	Image
Room 5 South wall	Poor	Damp is entering the wall and is evident from floor level through to mid wall height. The source of damp is not entirely clear and it is likely that a range of measures will be necessary.	<p>Clear any soil build-up against the outside of the wall. Ensure south wall gutters and drains are effective and that water from leaking water tank is not causing problems.</p> <p>Repoint eroded sections of external wall to assist it to shed water.</p> <p>Apply poultice to interior wall, allow wall to dry then apply fresh limewash in accordance with 'Blundells Cottage Paint Analysis 2012' and consistent with the interpretative presentation of the cottage.</p>	High	2013

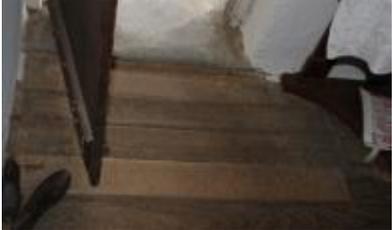
Room 6 Loose boards by front door	Fair	Some of the flooring boards by the front door are loose. These boards may provide access to the subfloor.	Screw the boards to the floor using slot head screws. Ensure boards can be easily removed for subfloor inspection.	Low	2015

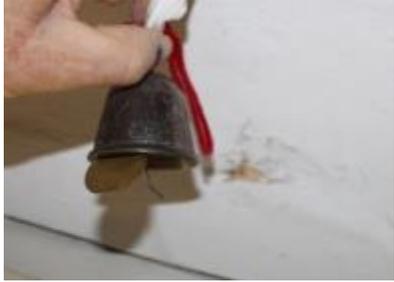
Element	Condition	Identified Issue/s	Recommended Works	Priority	Timing	Image
Room 6 Door bell	Eroding	Every time the door is opened or closed, the doorbell swings up and hits the underside of the head beam. This is damaging the paint and substrate.	Replace the doorbell with a fixed bell that does not swing.	High	2013

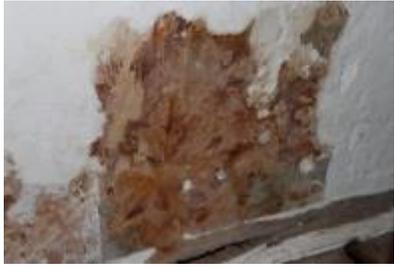
Room 6 Original wall paper	Good	A small sample of original wall paper has been left exposed. This is significant fabric that provides an opportunity for reinterpreting the room's décor.	Ensure the sample is not inadvertently damaged. Investigate protection with something like a Perspex cover. Consult specialist materials conservator for conservation options which allow interpretation.	Low	2015

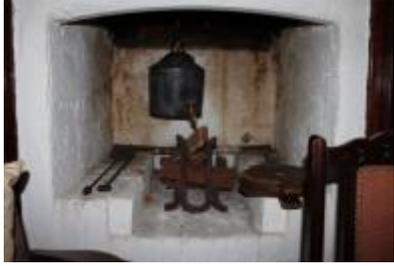
Room 6 Fireplace	Fair	There are stains in the back of the fireplace which themselves are not a problem, however they may indicate occasional leaking down the chimney. Evidence suggests the fireplace was previously limewashed.	Monitor the fireplace during rain to observe if water is entering the chimney. Check chimney flashing and repair/replace as needed. Re-apply limewash.	High	2013

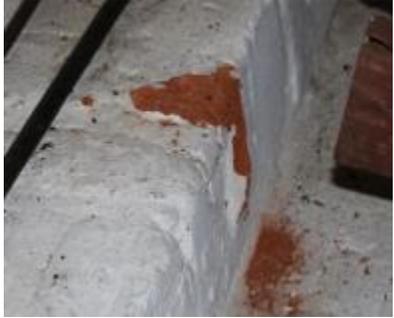
Room 6 Fretting brick in fireplace	Poor	The brick is decaying, probably due to salts, low brick firing and water penetration.	Investigate and remove the source of the water. Apply poultice to remove salts and when stable re-limewash.	High	2013

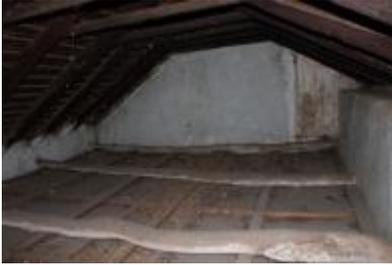
Element	Condition	Identified Issue/s	Recommended Works	Priority	Timing	Image
Room 6 Ceiling space	Stable	There is clear evidence of a former ceiling and shingle roof.	Consider additional interpretation of this space to visitors. Consider lighting to assist viewing.	Low	2015

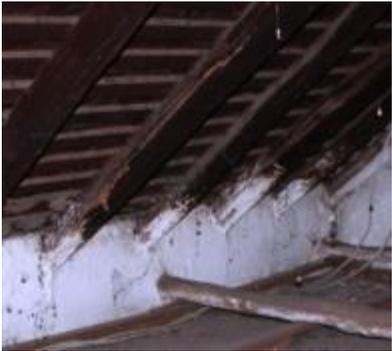
Room 6 Ceiling space	Unclear	There appears to be mud tunnel on the edge of a ceiling joist that is consistent with termite activity.	Confirm if this is a termite tunnel and treat it. Install termite bait and monitor. Assess and repair any timberwork damage.	Urgent	Immediate

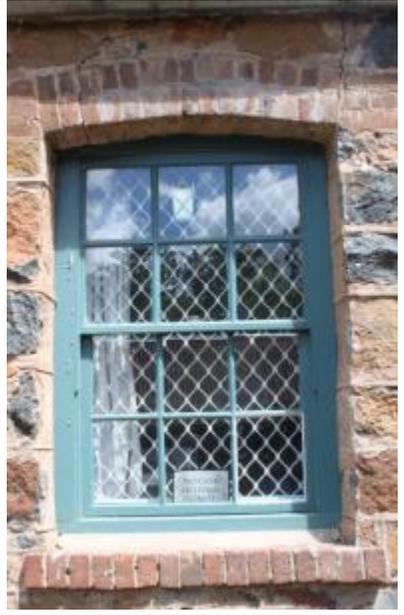
Element	Condition	Identified Issue/s	Recommended Works	Priority	Timing	Image
COTTAGE EXTERIOR						
East wall Window	Fair	Peeling paint on sash and casement.	Prepare carefully and repaint. Ensure painting will not result in sticking window or prevent window from opening. Paint colours to be in accordance with 'Blundells Cottage Paint Analysis 2012' and consistent with the interpretative presentation of the cottage.	Medium	2014

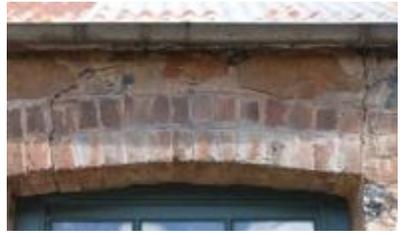
East wall Window arch	Cracked	Subsidence cracks in stone and mortar. Similar cracks are evident elsewhere in the wall and could also be treated.	Check lintel is safe. Engage a heritage engineer or experienced heritage bricklayer to provide detailed assessment and long-term strategy for this problem. It may be appropriate to lift the arch and retrofit an arch bar to support the brickwork prior to repointing.	Medium	2014

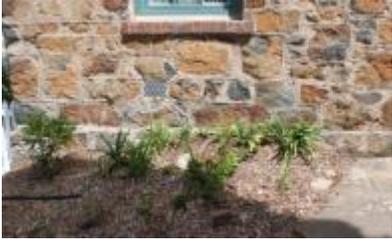
Element	Condition	Identified Issue/s	Recommended Works	Priority	Timing	Image
East wall Soil build up	Fair	Soil is building up in the garden bed.	All soil levels next to the building should be kept low and below internal floor level to prevent water entering the stonework. Ensure all surface ground water flows away from the building.	Low	2015

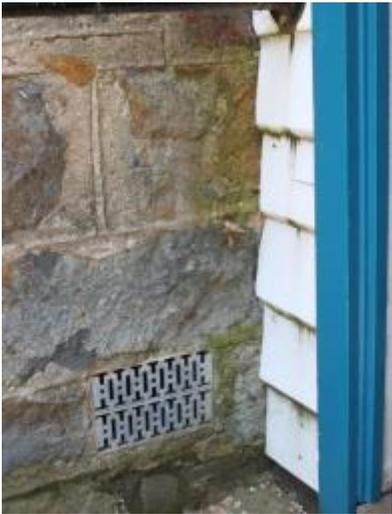
East wall Damp	Poor	Damp is accumulating in the corner and supporting the growth of algae and mould.	Ensure all gutters and drain pipes are working. Remove algae with an appropriate algaecide only once source of damp is identified and rectified.	High	2013

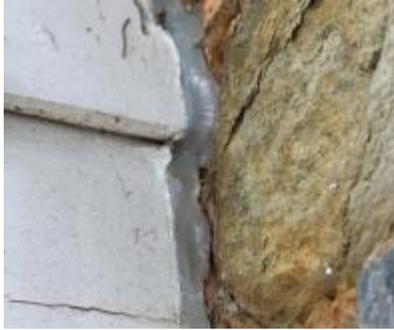
Element	Condition	Identified Issue/s	Recommended Works	Priority	Timing	Image
Porch Corner	Poor	The use of silicon here is an unsympathetic material.	Remove the silicon and replace if necessary with a more traditional solution, eg a mortar joint with a small timber cover strip.	Low	2015

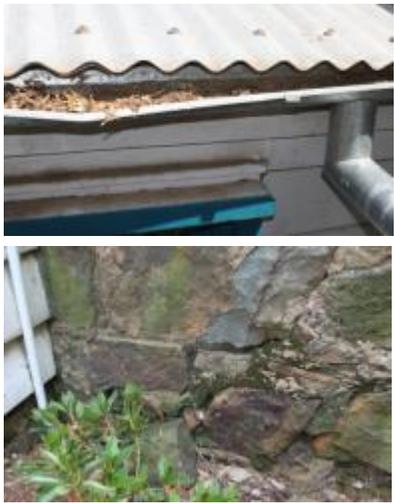
South wall Gutter behind tank	Poor	The gutter is clogged, distorted and overflowing onto the wall of the building and ground below promoting growth of algae and moss.	Clear the gutter, straighten and ensure all water flows well clear of the building. Check behind valley flashing as well. Monitor regularly.	High	2013

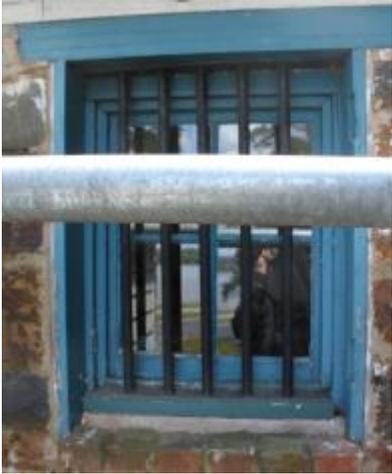
Element	Condition	Identified Issue/s	Recommended Works	Priority	Timing	Image
Window behind tank	Fair	<p>Paint is peeling.</p> <p>A down pipe runs in front of the window.</p> <p>Intrusive security bars.</p>	<p>Carefully prepare and repaint window.</p> <p>Investigate alternatives to the location of the downpipe guttering.</p> <p>Remove security bars and make good. Investigate alternative security of crimsafe mesh as necessary.</p>	Medium	2014

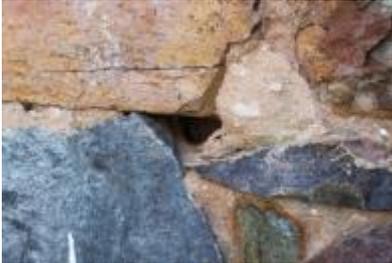
Wall behind tank	Fair	<p>Mortar has eroded in places to leave deep holes. This occurs in multiple locations around the building and will be allowing water penetration.</p>	<p>Remove any hard cement.</p> <p>Implement lime based mortar repairs to all locations where mortar has eroded. Allow up to 10% of joints for repointing.</p> <p>Carefully maintain existing masonry character. Match colour and style. Prepare samples first and match when dry. An appropriate mix is 1 lime putty: 3 selected sharp sand. A mix of 1 cement: 2 lime: 9 sharp sand may also be used, especially if it enables a more sympathetic colour match to be achieved.</p>	High	2013

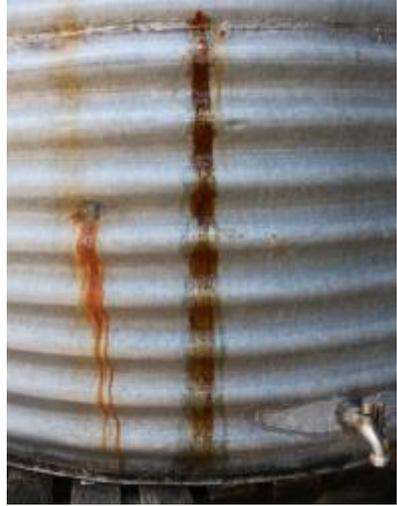
Element	Condition	Identified Issue/s	Recommended Works	Priority	Timing	Image
Water tank	Poor	The tank is leaking and needs to be replaced as water leaks onto the ground and is also decaying the timber in the tankstand. The tank was installed in the mid-to-late 1990s and is not individually significant.	Replace tank with new galvanised iron tank (not colorbond or zincallume).	Urgent	2013

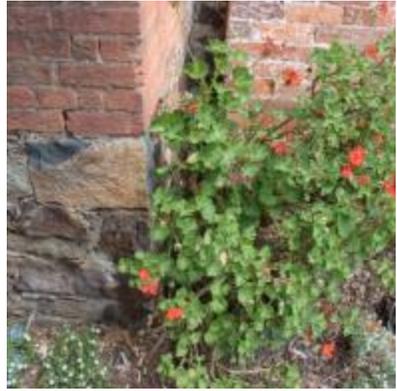
East wall Soil and plant material between chimneys	Poor	Soil and garden bed has built up between the chimneys. Mortar decay.	Remove soil and re-grade the ground so water drains away from the building. Remove plant material. Repoint only open mortar joints.	Urgent	2013

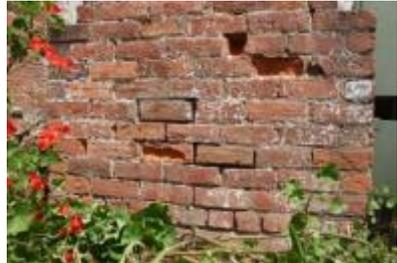
East wall Chimney	Poor	Spalling bricks and eroding mortar.	Resolve the damp which is eroding the pointing—remove built up soil from garden bed and do not water plants next to walls. Apply poultice to withdraw salts. Replace eroded bricks with closely matching	Very High	2013

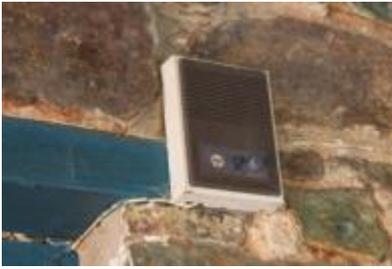
Element	Condition	Identified Issue/s	Recommended Works	Priority	Timing	Image
			replacements. Remove loose material and repoint joints, holes with lime mortar.			
Intercom by front door	Poor	The intercom is not consistent with Blundells heritage values.	Remove the intercom if it is redundant or arrange alternative.	Low	2015

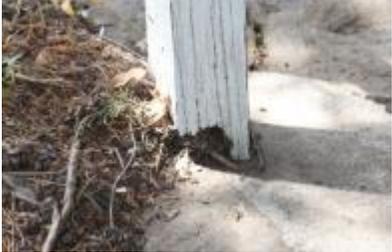
Front Verandah post	Poor	The base of the post has decayed.	Scarf in the timber at the base, or replace the whole post. The post dates from 1963 and is not significant fabric. Any replacement should be like for like; that is, 100 x 100 rough sawn hardwood, sanded and then painted in accordance with 'Blundells Cottage Paint Analysis 2012' and consistent with the interpretative presentation of the cottage. Seal the base of the post and secure to pavement with a concealed pin.	High	2013

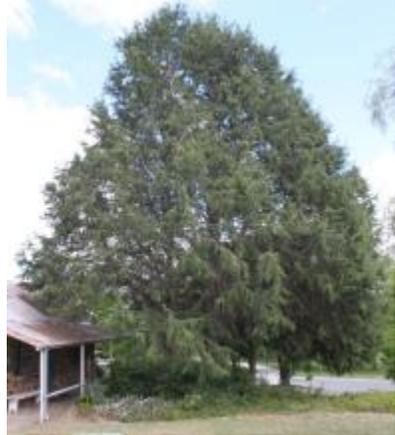
Element	Condition	Identified Issue/s	Recommended Works	Priority	Timing	Image
North Trees	Problematic	This is a cluster of trees, one of which is growing over and dwarfing the building. The trees drop large quantities of needles onto the roof which accelerates decay of roof iron by holding moisture onto the roof, allowing water to penetrate between overlaps, clogs gutters and downpipes and which in turn is leading to water penetration into the building as water runs down the walls. The leaf litter on the ground is highly flammable.	Follow advice in SULE report on trees at the site. Trees at heritage sites have to be managed so that they do not damage buildings. Trees can be replanted to reinstate former landscapes.	Medium	2014

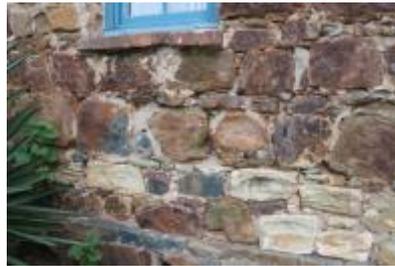
West wall Mortar loss	Poor	Mortar loss on the west wall is generally more pronounced than on the other walls, probably due to greater weather exposure and cyclical wetting and drying.	Repoint the worst affected areas with lime based mortar to ensure full joints and reduce water penetration to the building. Allow 50% of pointing to be redone with 1 lime putty: 3 sharp selected sand. Match dry samples for colour and style before repointing affected areas.	High	2014–2024

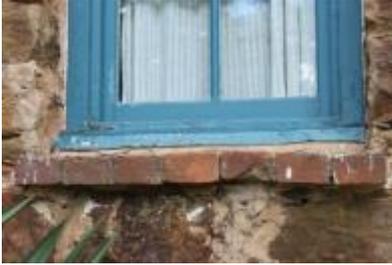
Element	Condition	Identified Issue/s	Recommended Works	Priority	Timing	Image
West wall Windows x 2	Poor	The existing paint is breaking down.	Carefully prepare and repaint both windows in accordance with 'Blundells Cottage Paint Analysis 2012' and consistent with the interpretative presentation of the cottage.	High	2013

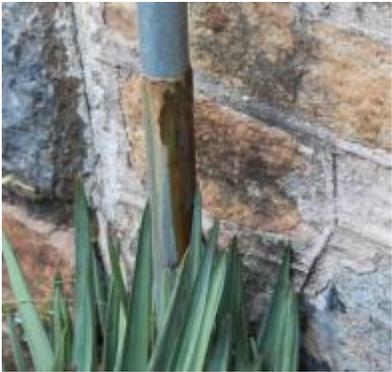
West wall Downpipe	Clogged	Water can't get down the downpipe and so spills over the wall.	In the immediate instance clear the downpipe. Then replace with larger diameter (75mm) gal downpipe as per the above note. The downpipe needs to be larger and able to discharge more successfully at ground level. Install underground stormwater in preference to perforated agricultural drainage. Plastic pipe above ground to be covered with stone and not be visible.	Very high	Immediate

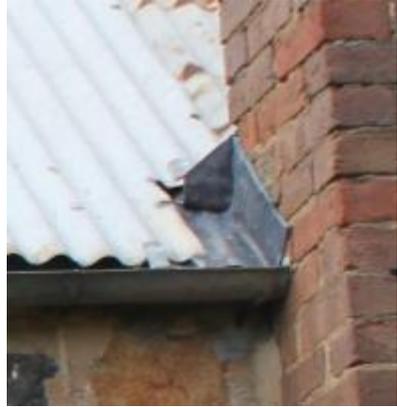
Element	Condition	Identified Issue/s	Recommended Works	Priority	Timing	Image
West wall Chimney flashing	New	<p>This has been done poorly and not consistently with traditional methods. The flashing has been cut into the brickwork instead of stepped into the mortar course. The cross flashing appears to direct water under the roof iron.</p> <p>It is not known if this work has led to the leaking onto the stove below.</p>	Flashing should be removed and replaced by a tradesman who is appropriately trained. In future, such work should be only undertaken by people with appropriate expertise.	Urgent	2013

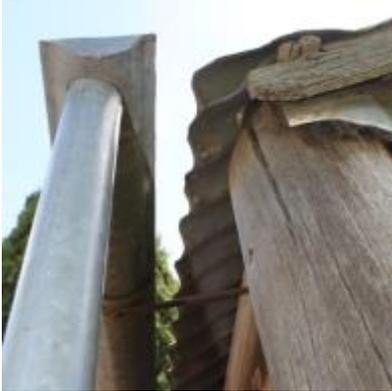
Element	Condition	Identified Issue/s	Recommended Works	Priority	Timing	Image
SLAB SHED						
Slab shed Gutter	Loose	The gutter has drifted away from the roof and is not functional.	Reinstate and monitor effective operation.	High	2013

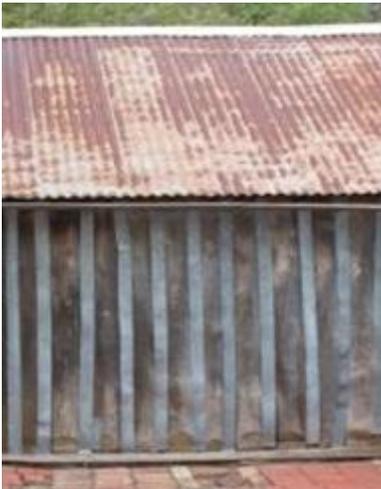
Slab shed Galvanised cover strips	Good	Do not seal the building completely. Fabric introduced by CDHS.	Investigate if clay caulking was originally used. Only replace galvanised cover strips if there is conclusive evidence of prior clay sealing of the slabs and exact nature of clay caulking used. Do not proceed on the basis of past general custom or conjecture.	As necessary	As necessary

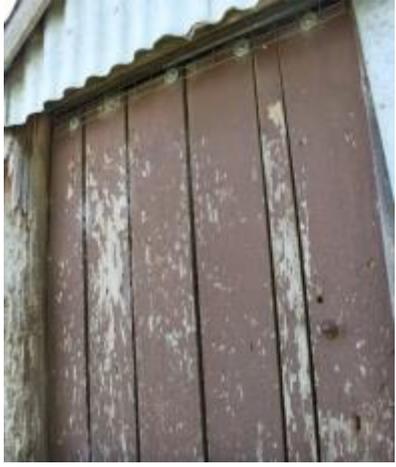
Element	Condition	Identified Issue/s	Recommended Works	Priority	Timing	Image
Slab shed South door	Poor	Peeling paint	Prepare carefully and apply new paint or umber stain to the door in accordance with 'Blundells Cottage Paint Analysis 2012' and consistent with the interpretative presentation of the cottage.	Medium	2014

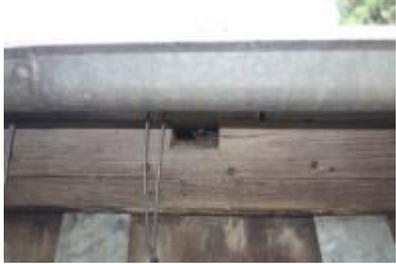
Slab shed East wall Top plate	Good	The top plate provides evidence that this shed is the one that has been on the site from early days.	Retain all evidence embedded in the shed's fabric such as this rebate that supported the buggy lean-to roof.	High	Ongoing

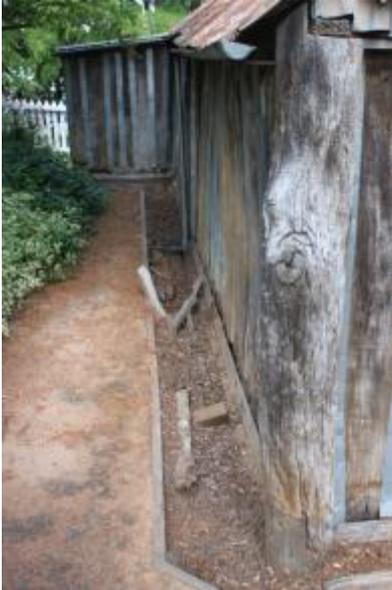
Element	Condition	Identified Issue/s	Recommended Works	Priority	Timing	Image
Slab shed East wall	Fair	Gutter does not seem to be aligned. There is leaf litter at ground level.	Keep the gutter and ground clean and ensure water is draining away from building. A full plumber assessment is recommended.	Medium	2013

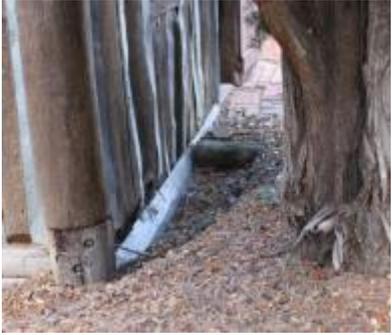
Slab shed West wall ground conditions	Poor	Leaf litter is building up at ground level.	Leaf litter must be regularly removed from building up against and near to the building as it will again lead to decay of base plates and slabs A tree management strategy is recommended.	High	2013

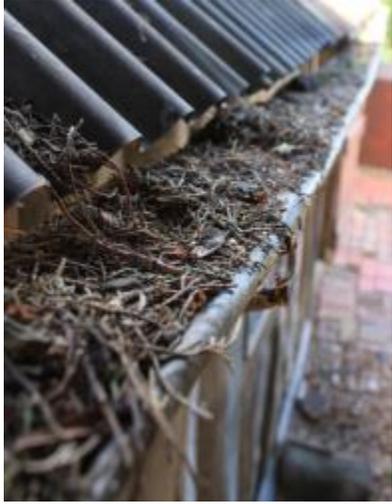
Element	Condition	Identified Issue/s	Recommended Works	Priority	Timing	Image
Slab shed West wall gutter	Poor	Gutters fill with leaf litter from the nearby trees.	Clean gutters regularly, at least on a monthly basis.	High	Immediate

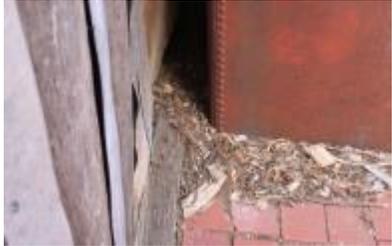
Slab shed West wall	Poor	There is leaf litter between the tank and the slab wall that is likely to lead to decay of timbers.	Clean the leaf litter out. Move the tank away from wall a sufficient distance to allow regular access for cleaning.	High	2013

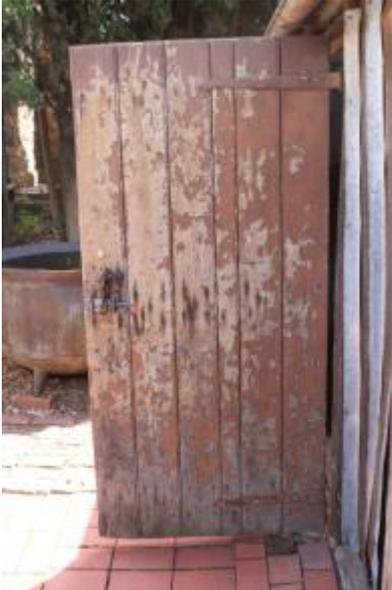
Element	Condition	Identified Issue/s	Recommended Works	Priority	Timing	Image
Slab shed Shed door	Poor	There is peeling paint and timbers are starting to decay.	Check the security of hinges and their hanging. Fix as necessary. Carefully prepare and repaint to match existing colour scheme in accordance with 'Blundells Cottage Paint Analysis 2012' and consistent with the interpretative presentation of the cottage.	High	2013

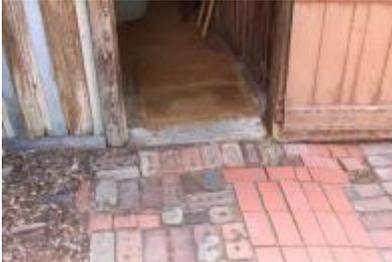
Slab shed Doorway	Mixed	Ensure that rain water doesn't enter the building.	Monitor and re-grade the bricks if required. The bricks are modern introductions to the landscaping and can be altered.	Low	Ongoing

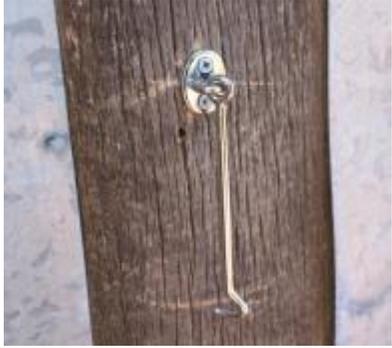
Element	Condition	Identified Issue/s	Recommended Works	Priority	Timing	Image
Slab shed Door catch	Modern	The use of bright chrome, stainless steel and Phillips-head screws are not suited to the historic presentation of Blundells cottage.	Replace with more appropriate functional hardware—a blacksmith may be necessary for manufacture.	Low	2015

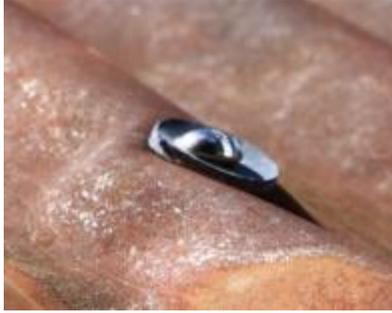
Slab shed New roofing screws throughout	Bright zinc finish	These bright steel screws won't patinate over time. Ideally galvanised screws will be used.	Obtain a supply of galvanised screws and lead washers for future repairs.	Low	2015
