**Blundells Cottage**  
**Heritage Management Plan**

Report prepared for the National Capital Authority

May 2014

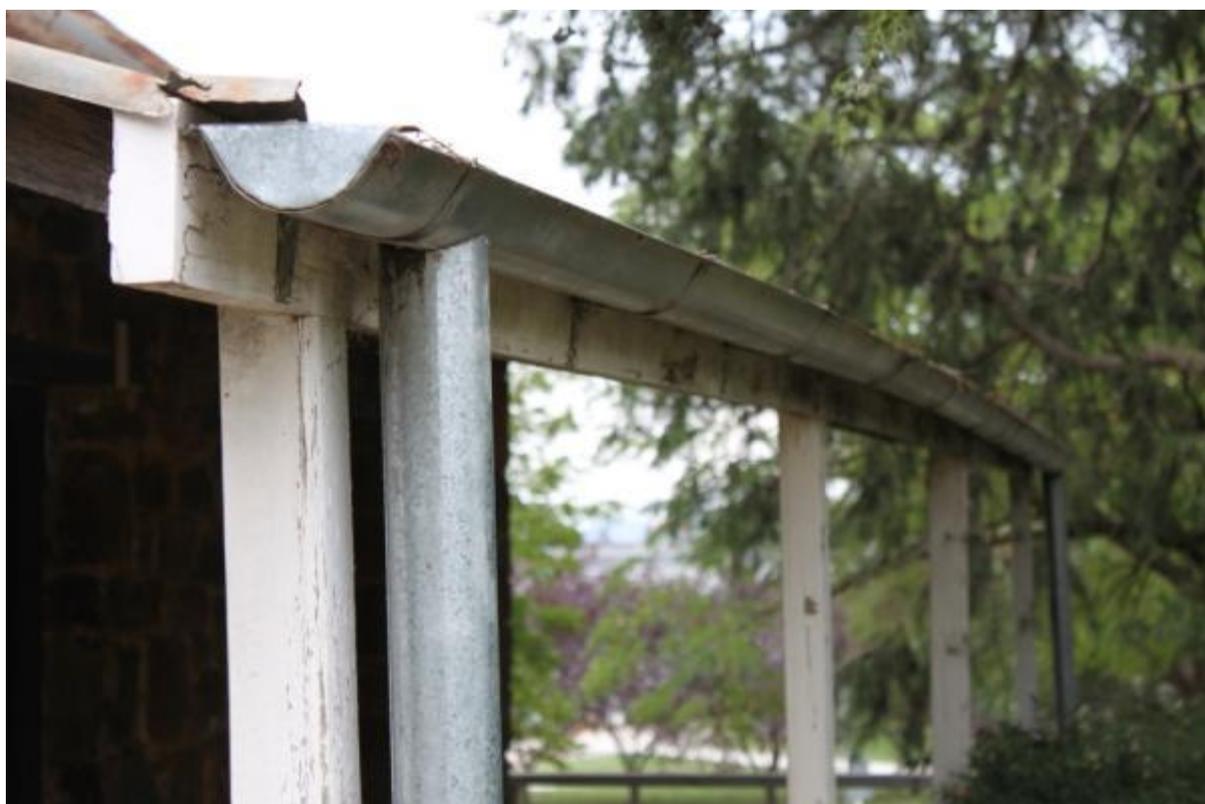
**Figure 3.10** Half round gutter at front verandah. (Source: GML 2013)

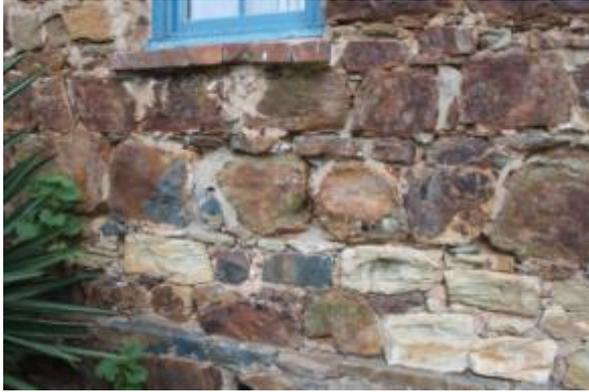
**Figure 3.13** Deeply eroded mortar in 1859 west wall. (Source: GML 2013)

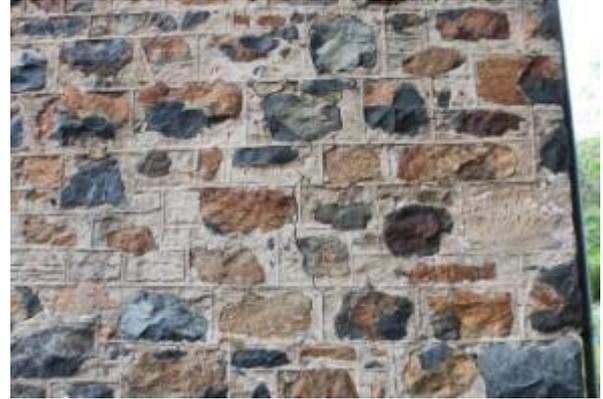
**Figure 3.14** Raised pointing and structural crack in 1888 wall. (Source: GML 2013)

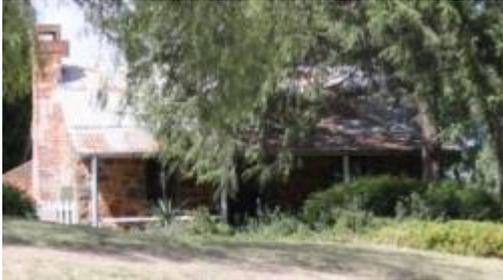
<p>2012</p>
<p><b>West wall</b></p>	<p>1994 CMP—the random rubble wall was in fairly good condition, although there was some breakdown of pointing between the stones, particularly on the older section of wall 'most of the pointing from the earlier work has weathered off'.</p> <p>2012—the window frames had been painted blue/grey, there had been an increase in the breakdown of mortar, and possibly even some of the stone, particularly around the downpipe. Note that the yuccas have grown considerably.</p>

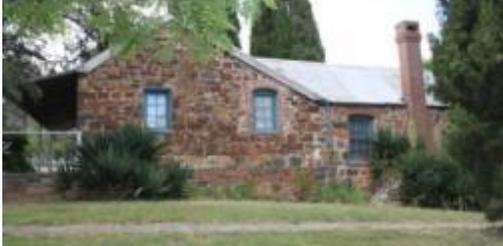
<p>2012</p>
<p><b>Guttering and flashing</b></p>	<p>1994 CMP—the CMP notes that the present guttering is believed to have been introduced and that gutter brackets were fabricated, but not to match earlier details. They were accorded a low level of importance.</p> <p>2012—new lead flashing has been added to chimneys.</p>

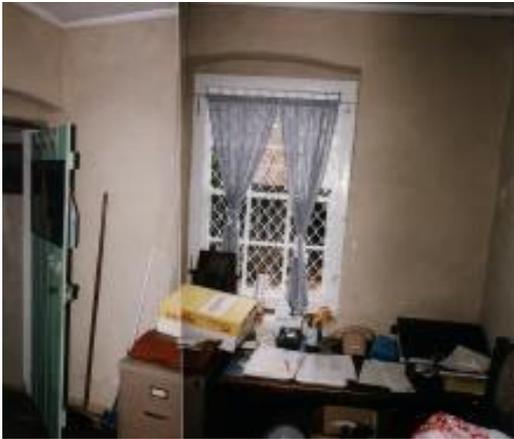
<p>1994</p>
<p><b>Room 2 Kitchen</b></p>	<p>1994 CMP—the CMP notes that there has been leaking above the fireplace and at the wall junction with the original four-roomed cottage structure but that both leaks had been repaired and only staining remained.</p> <p>2012—the leaking above the fireplace has stabilised, although damp continues to penetrate at the junction of the west wall with the original four-roomed cottage.</p> <p>1994—beige paint has been replaced with white limewash and internal sashes have been painted green.</p>

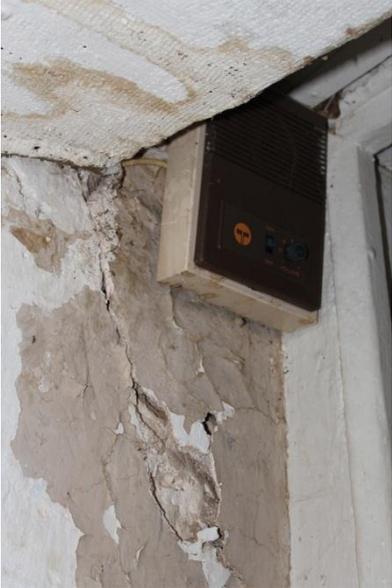
Roof leaks	Check if leaks have been repaired; monitor for leaks during rain.	High	2013	
		Ceiling stains	Research appropriate distemper/limewash products both in terms of content and colour, prepare and apply new.	It will identify if roof still leaking – High.	2013	
		Loose paint and plaster	Consolidate if possible, otherwise repair/replace damaged render as it is part of occupancy phase and therefore significant.	Medium	2015	
<b>Back porch East wall</b>	Stained	Evidence of former water entry. The stains mask whether there is on-going water entry. Gutters and valley on roof may be clogged.	Check gutters and valley on roof to prevent water penetration. Clean, and /or repaint.	Medium	2013 2015

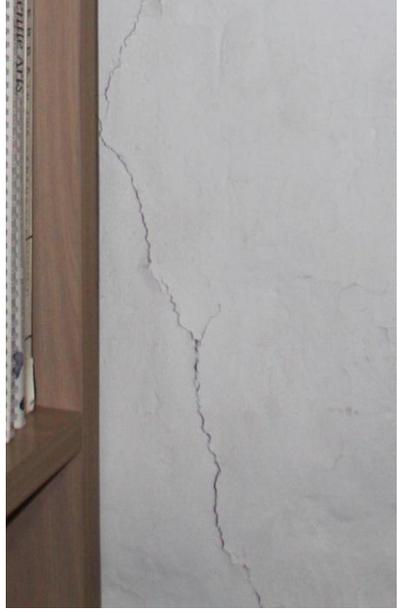
Decayed mortar by window sill	Prior to the room being lime washed the crack should be cleared to remove loose material to the substrate and then filled with lime mortar to patch.	High	2013

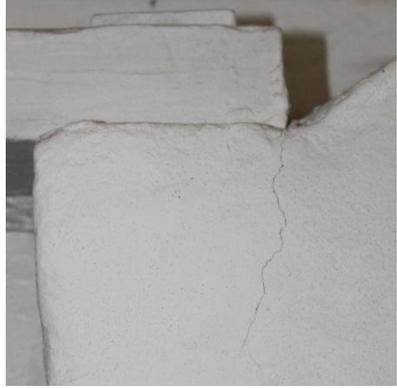
<b>Room 3 South wall crack</b>	Fair	A crack extends from the former window sill to the floor. The crack matches cracks on the other side of the wall and indicates some settling in the building or a stress crack from overloading. It is not weakening the structure and appears benign.	Rake the crack to firm the substrate and fill it with lime mortar and repaint with lime wash.	Low	2015

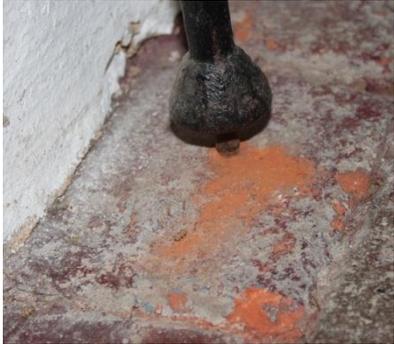
<b>Room 3 Floor by door</b>	Slowly deteriorating	The mortar capping over this part of the floor is drummy and slowly deteriorating. The mortar is important because it contains several layers of surface treatment.	Monitor the mortar and consider consolidation, possibly by injecting adhesive between the layers although this risks exfoliation. Seek further advice from a materials /conservation specialist.	Medium	2014

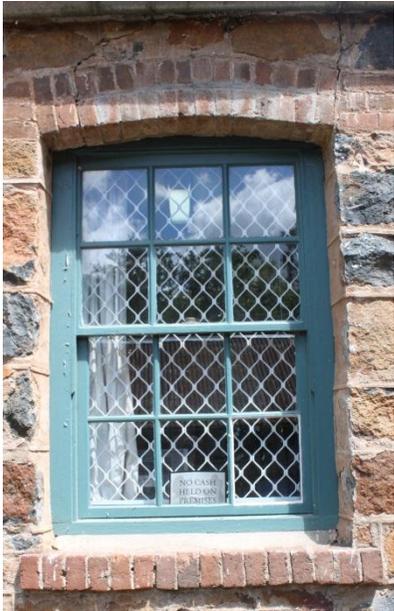
<b>East wall Window arch</b>	Cracked	Subsidence cracks in stone and mortar. Similar cracks are evident elsewhere in the wall and could also be treated.	Check lintel is safe. Engage a heritage engineer or experienced heritage bricklayer to provide detailed assessment and long-term strategy for this problem. It may be appropriate to lift the arch and retrofit an arch bar to support the brickwork prior to repointing.	Medium	2014

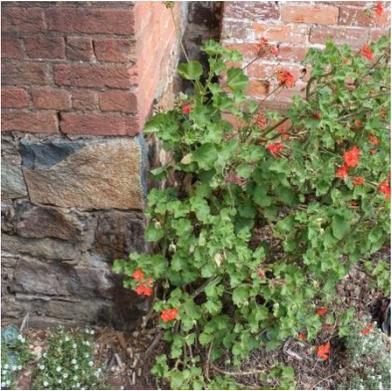
Element	Condition	Identified Issue/s	Recommended Works	Priority	Timing	Image
<b>East wall Chimney</b>	Poor	Spalling bricks and eroding mortar.	<p>Resolve the damp which is eroding the pointing—remove built up soil from garden bed and do not water plants next to walls.</p> <p>Apply poultice to withdraw salts.</p> <p>Replace eroded bricks with closely matching replacements.</p> <p>Remove loose material and repoint joints, holes with lime mortar.</p>	Very High	2013

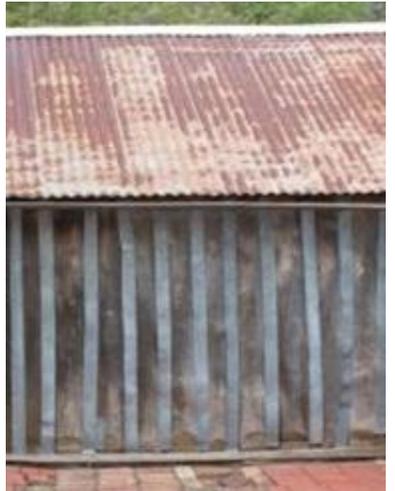
Element	Condition	Identified Issue/s	Recommended Works	Priority	Timing	Image
<b>Slab shed South door</b>	Poor	Peeling paint	Prepare carefully and apply new paint or umber stain to the door in accordance with 'Blundells Cottage Paint Analysis 2012' and consistent with the interpretative presentation of the cottage.	Medium	2014

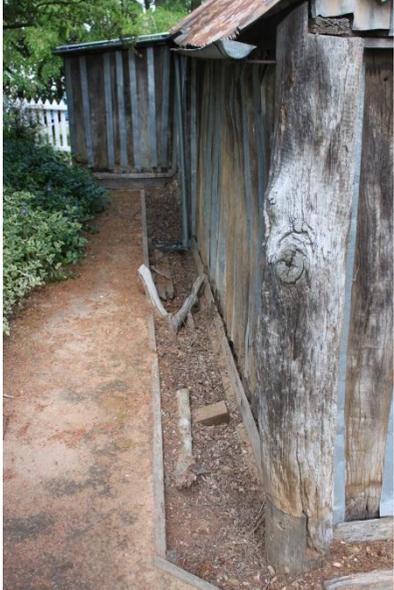
<b>Slab shed West wall ground conditions</b>	Poor	Leaf litter is building up at ground level.	Leaf litter must be regularly removed from building up against and near to the building as it will again lead to decay of base plates and slabs  A tree management strategy is recommended.	High	2013

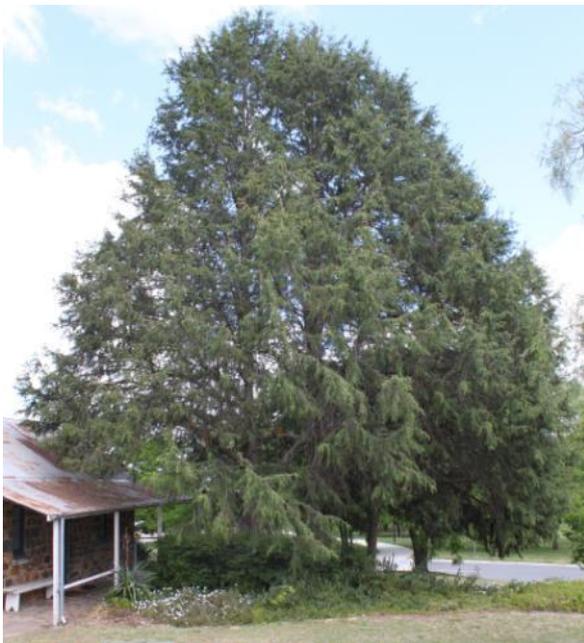
**Figure D.7** The Himalayan cypress 2012. The tree closest to the cottage hangs heavily over the building. (Source GML 2012)
