Project  
BLK 14 SEC 2 DP 709  
71 NATIONAL CIRCUIT, DEAKIN  
Client  
COGGAN FAMILY

Drawing Title VEGETATION ASSESSMENT		
Scale	Plot Date:	Sheet No.
Drg. No. 4218-G101 A		1

<b>Company</b>	Coggan Family	<b>Date</b>	17 May 2021
<b>Attention</b>	Melissa and Paul	<b>This Page +</b>	7
<b>From</b>	dsb Landscape Architects	<b>Project No.</b>	4218
<b>Project</b>	71 National Circuit DEAKIN Block 14 Section 2		
<b>Subject</b>	Vegetation Assessment Report

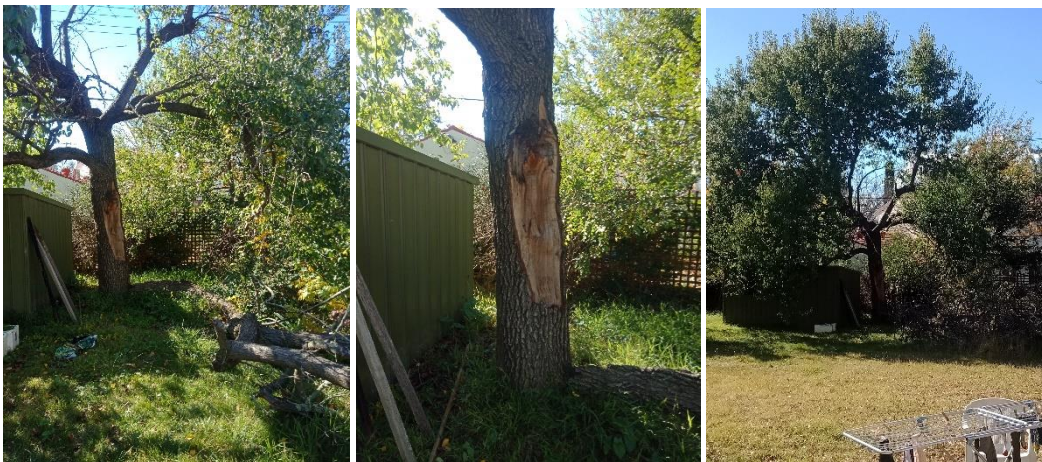
A large Pyrus sp. tree is located in the back yard under the power lines. It has recently lost a large limb with decay in the joint and trunk. Retention of this tree is not recommended.

Tree 7 is a poorly performed *Pyrus* sp. and should not be retained.
