Company	Tony Yang	Date	15 July 2022
Attention		This Page +	9
From	dsb Landscape Architects	Project No.	4550
Project	15 Talbot Street Forrest B2 S7		
Subject	Vegetation Assessment Report Issue 2

VEGETATION ASSESSMENT
15 Talbot Street, Forrest
Block 2 Section 7, Forrest

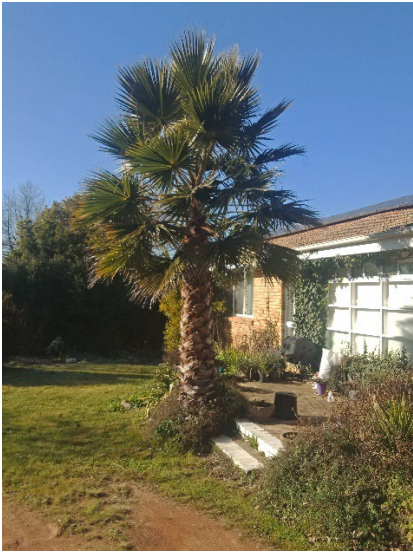
Tree 1 Washingtonia robusta

This palm tree is regulated due to trunk circumference. It is nominated as 'For Removal' as it is in close proximity to demolition works and new construction works.

This palm tree is readily transplanted and is detailed for transplanting into the pool side planting bed.

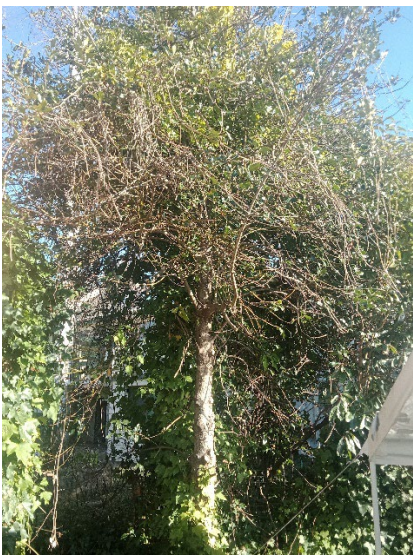
Tree 6 Ilex aquifolium

This is a shrub that has grown into a large form and is located on the lease boundary. Recommended for removal.

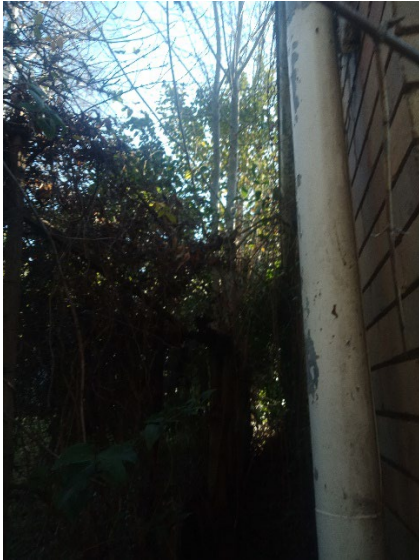
Tree 7 *Acer negundo* This is a multi trunk regrowth weed species tree located on the lease boundary adjacent to the existing garage. It is nominated as 'For Removal' as it is in close proximity to demolition works.

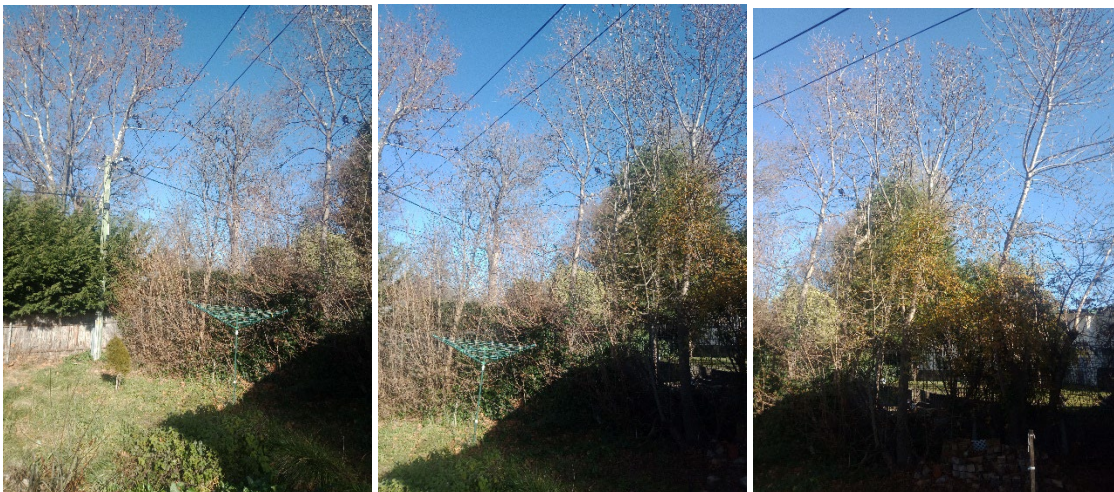
Trees 8-15 are *Acer negundo*, *Acer campestre* and *Fraxinus oxycarpa*. These trees are located along the lease boundary and are multi trunk regrowth and multiple trunks. These are poor form and are of little landscape value to the proposed works.
