Visual Tree Assessment and Tree Management Plan

**Australian Institute of Sport
26 Leverrier Street Bruce Belconnen ACT
Block 26 Section 8 Belconnen ACT**

**9 April 2026
Prepared by Duncan MacLennan**

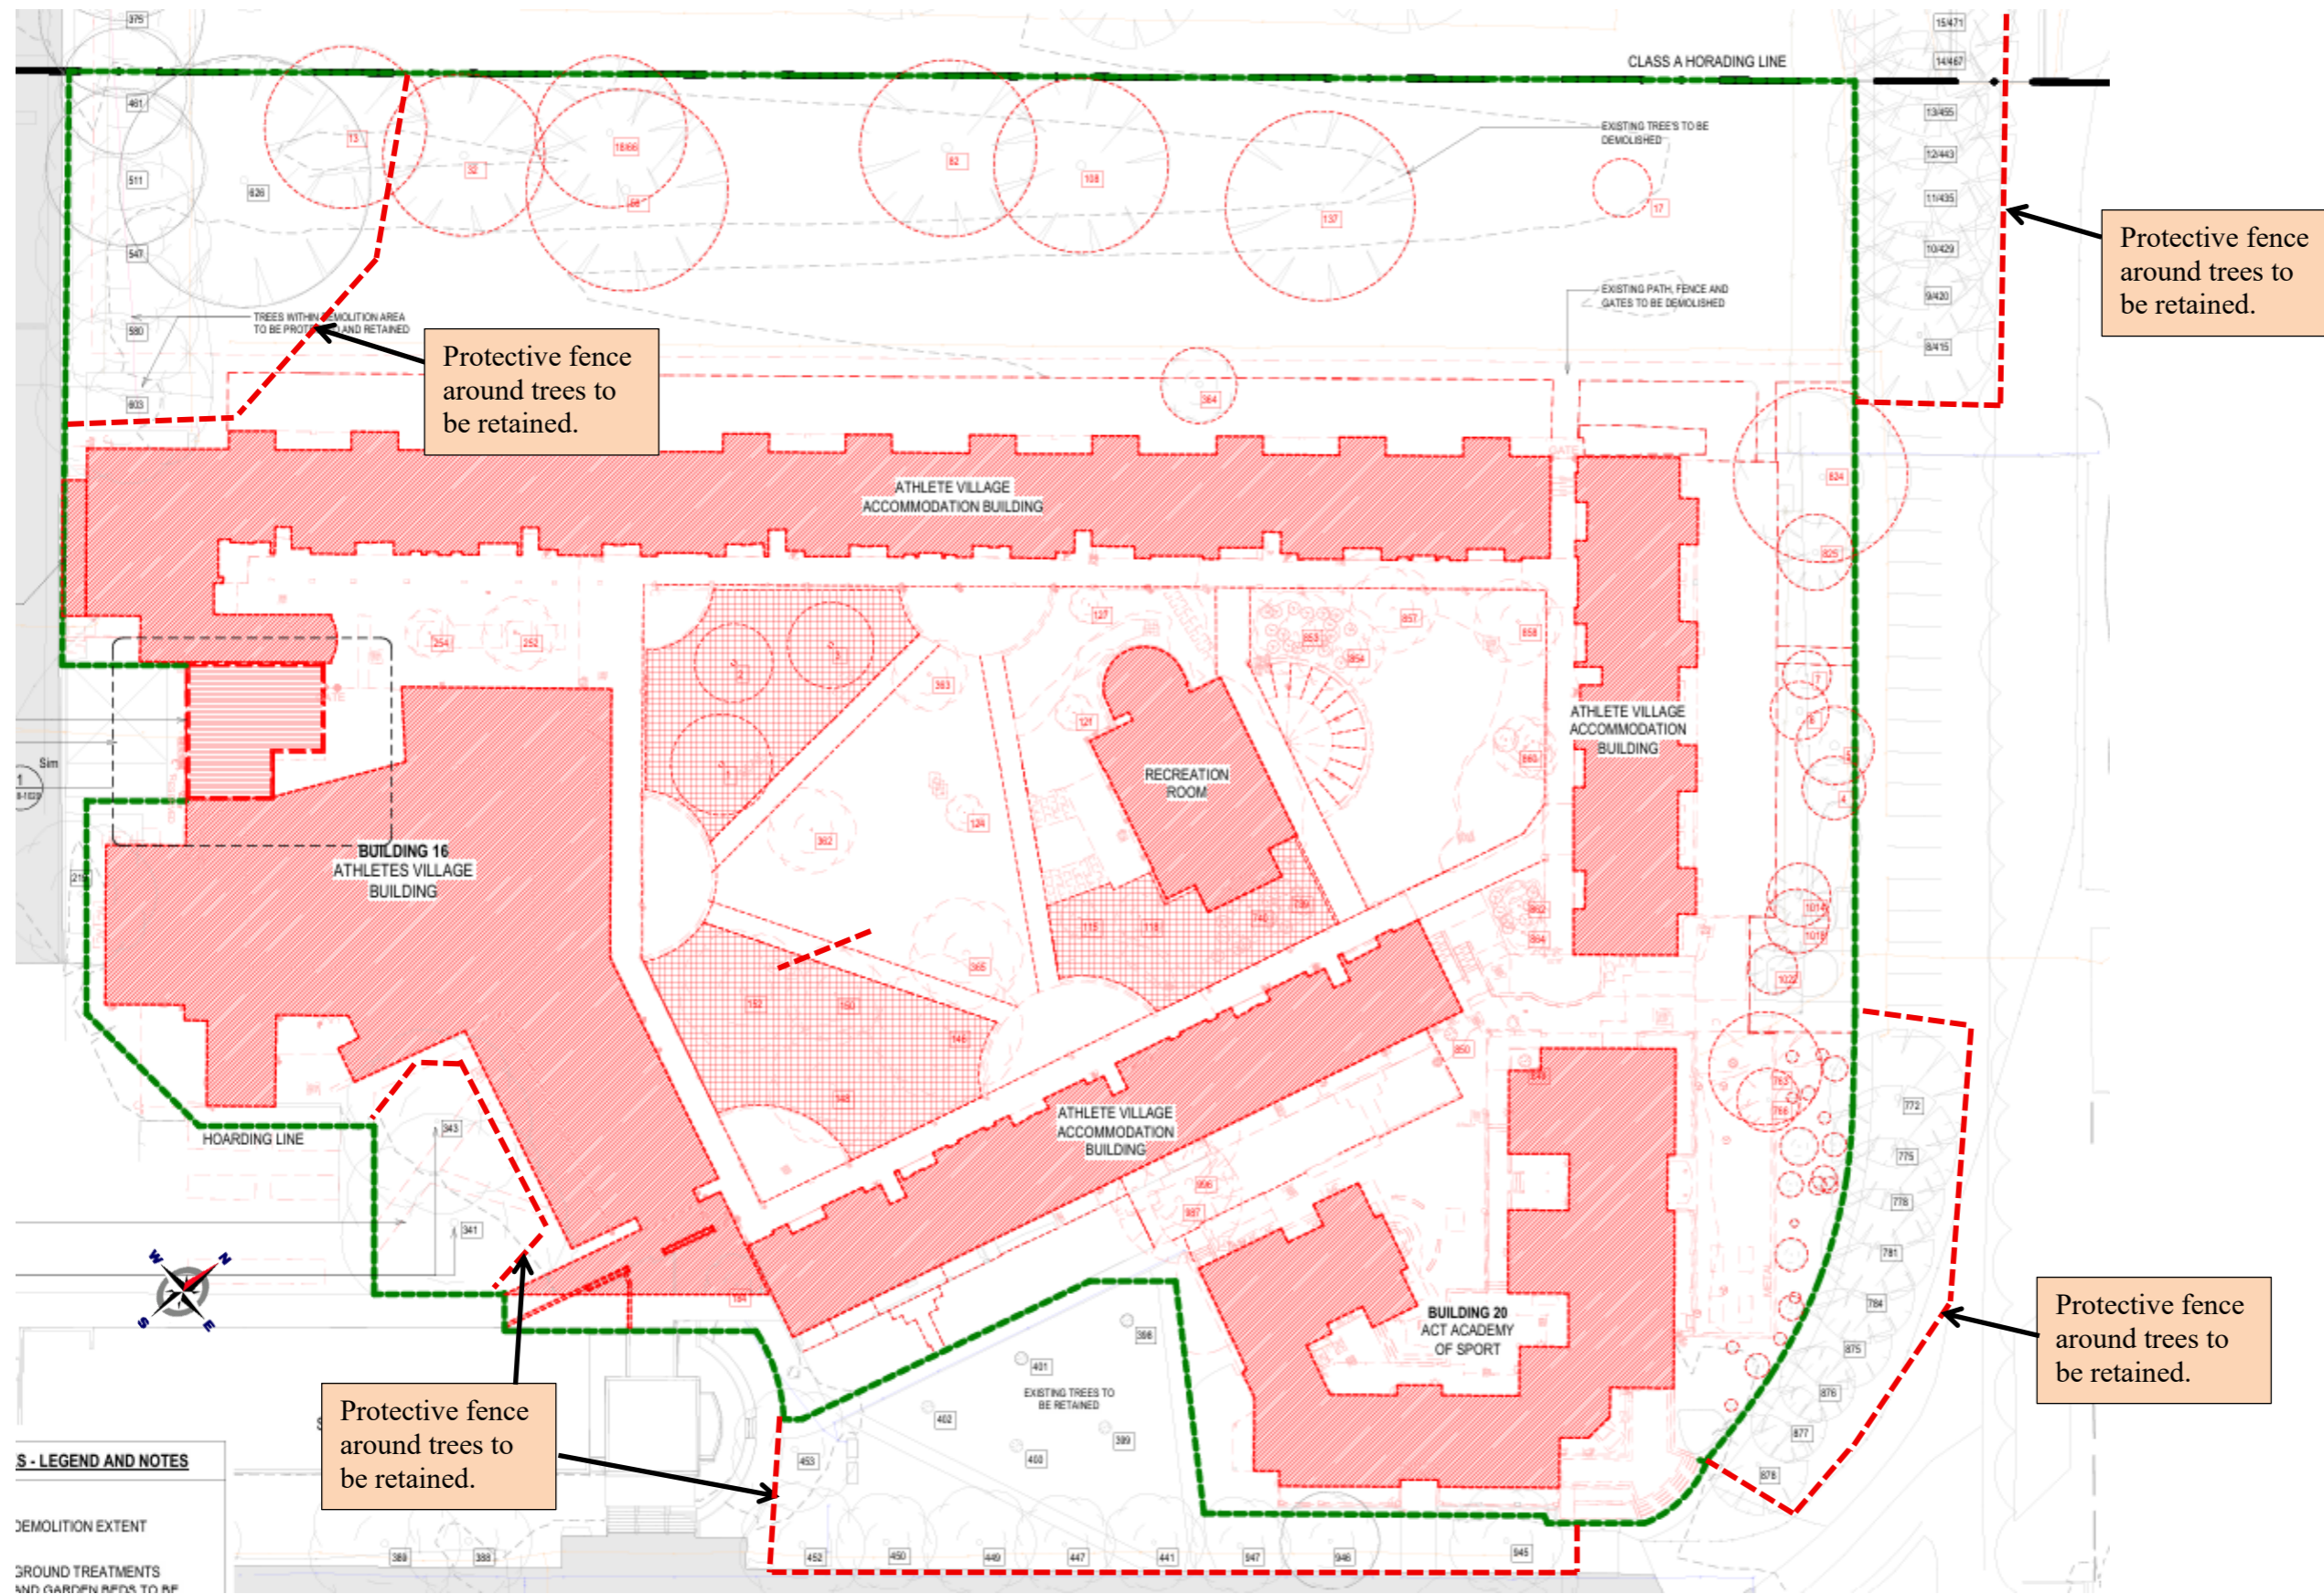
5.8 Plan 1 - Location of trees with protective fencing required during demolition

The trees marked red in Plan 1 at 5.8 below are all to be removed to enable the development. There are a total of 47 trees to be removed including trees 13, 32, 18/66, 50, 82, 108, 184, 364, 137, 17, 824, 825, 1, 2, 3, 4, 5, 6, 7, 1014, 1018, 1022, 763, 766, 252, 254, 362, 363, 365, 121, 127, 115, 118, 146, 148, 150, 152, 739, 740, 996, 853, 854, 857, 858, 864, 860, and 862.

The location of required protective fencing for the Pin Oaks (Tree Nos.461, 511, 547, 580, 603) and a young Yellow Box (Tree 626) is shown in Plan 1 at 5.8 below. The final placement of the fencing can only occur after Tree 13 is removed.

The plan below at 5.8 shows the entire site including the location and number of each tree. The plan includes details of where protective fencing should be placed to help ensure the trees to be retained are not damaged. The alignment of the protective fencing is shown as a red dotted line on each plan. Protective fencing must be 1.8m high continuous steel mesh secured into concrete bases. The tree protection fencing must be covered in shade cloth with signs "TREE PROTECTION ZONE – NO ACCESS" fixed at regular intervals. All tree protection fencing must be placed before site establishment and retained until the completion of all works.

Trees 441, 447, 449, 450, 452, 945, 946 and 947 are English Elms on the eastern side of the site that are to be retained. These trees' roots extend up to the foundations of the building that is to be demolished. The protective fencing should be placed as close to the building as possible and therefore over as much of the trees' tree protection zone (TPZ) as possible. Demolition machinery must not travel over the trees TPZ.
