## Updated Tree Report and Protection Measures

Site address: 20 Talbot Street Forrest, ACT 2603

Completed for: Turco and Associates

Date of report: Monday 3<sup>rd</sup> August 2026

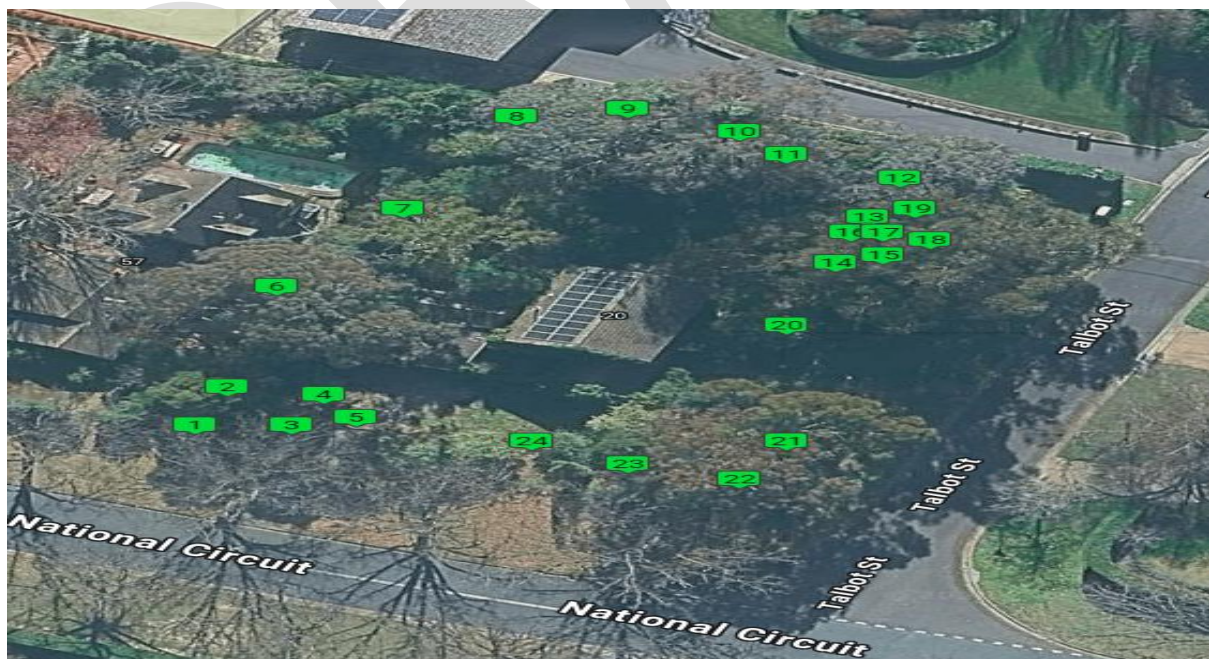
Minor encroachment (under 12%) will occur into the tree protection zones of two *Eucalypt* species on the corners of National Circuit and Talbot Street. A *Eucalyptus Mannifera* and a *Eucalyptus sideroxylon*. Tree numbers twenty-one and twenty-two on the image below.

Figure 1 Aerial view of trees assessed in September 2025 – PLEASE NOTE SEVERAL TREES HAVE SINCE BEEN REMOVED
