Hazardous Material Survey & Management Plan

**Building 83 and 83C
Australian National University
Acton ACT, 2601**

May 2013

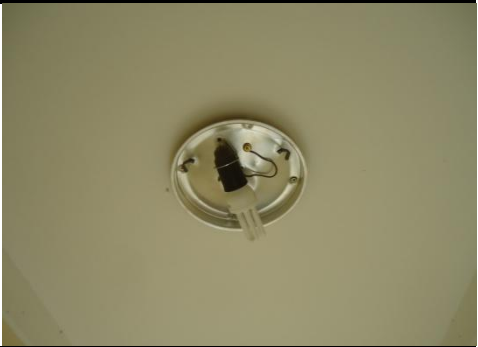
ASBESTOS			
ITEM NO	ACM DESCRIPTION	ACM LOCATIONS	PHOTOGRAPH
1	Insulation	To light fittings in female toilet and corridor

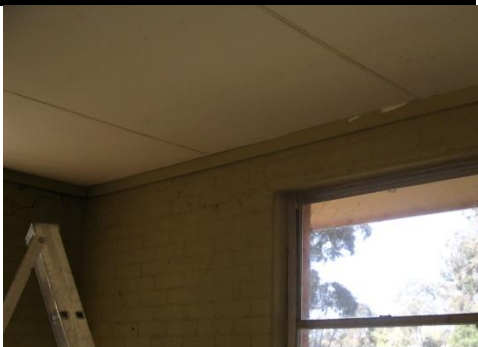
2	Sheet	Store room Ceiling sheet – Eastern wing – Off -White fibrous sheeting

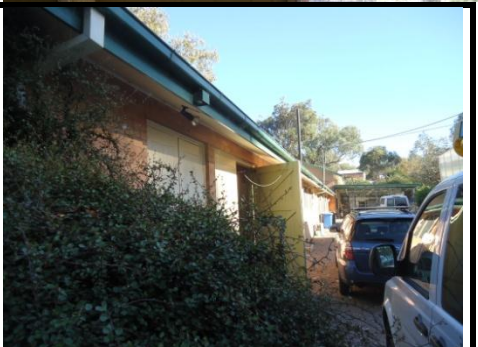
3	Sheet	Eave Sheet – Off -White fibrous sheeting, painted yellow

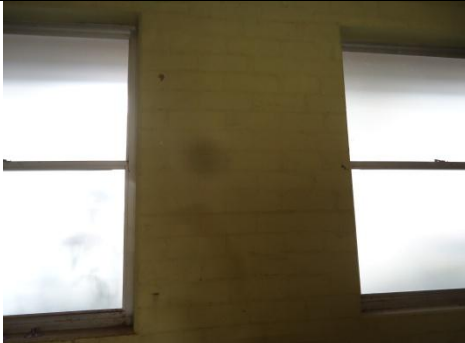
ASBESTOS			
ITEM NO	ACM DESCRIPTION	ACM LOCATIONS	PHOTOGRAPH
5	Caulking	Store room windows

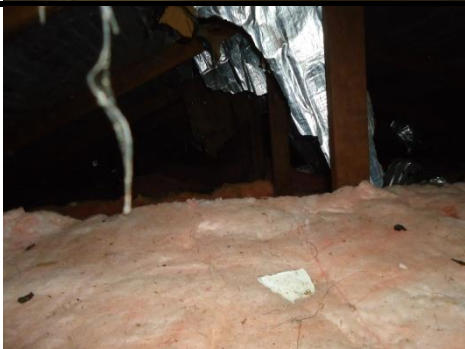
6	Sheet	Sheet debris in ceiling space

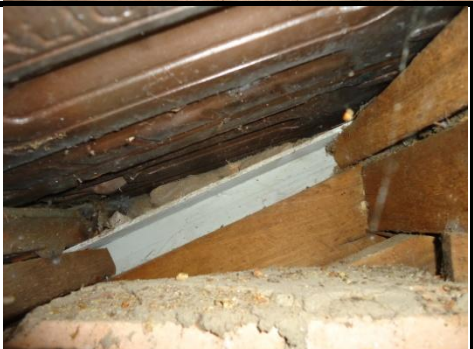
7	Sheet	Verge under cloaking

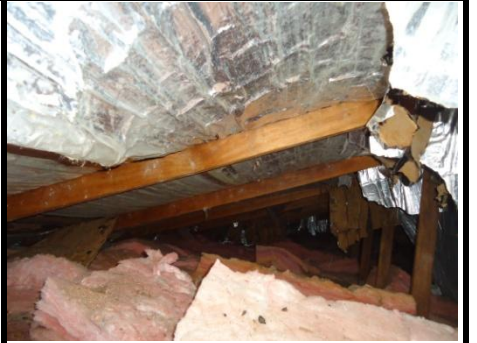
SYNTHETIC MINERAL FIBRE			
ITEM NO	MATERIAL	LOCATIONS	PHOTOGRAPH
SMF1	Pink Batts	Ceiling Space

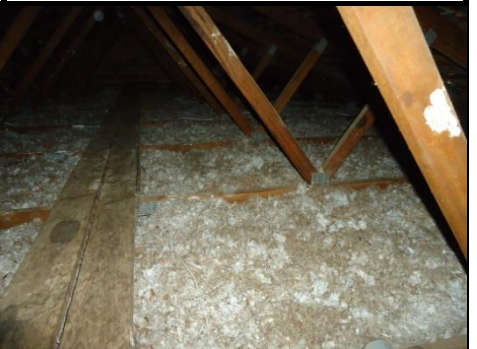
SMF2	Rockwool	Ceiling Space

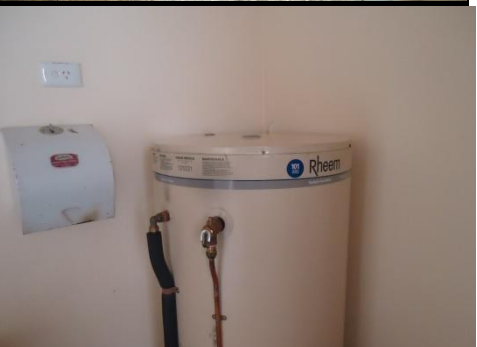
AMF3	Internal Insulation	Hot Water Service
