RECONSTRUCTION
CHANGI CHAPEL

NATIONAL
POW MEMORIAL
RMC DUNTROON

Reconstruction of Changi Chapel
As A National POW Memorial
RMC Duntroon, Canberra

Report March 1990

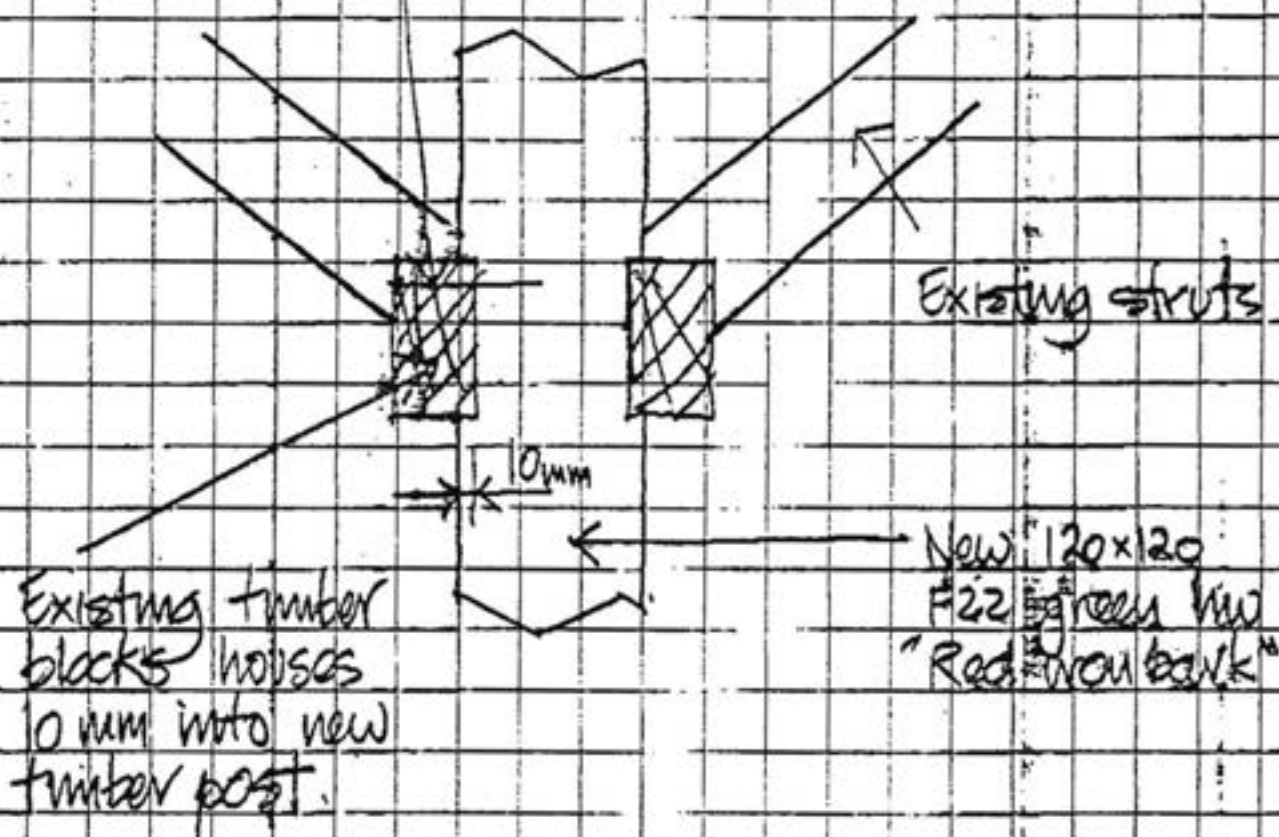
Considerable outwards deflection was evident in the two front posts that support the timber roof structure. This distortion has been caused by the horizontal thrust imposed on the posts by the diagonal struts intersecting the beam from two directions.

The front two posts are not structurally adequate and will need to be replaced with 120x120 F22 green hard wood. Red ironbark should be available in this stress grade. Refer SK1 for our recommendations.

DETAIL FOR NEW 120x120
TIMBER POSTS

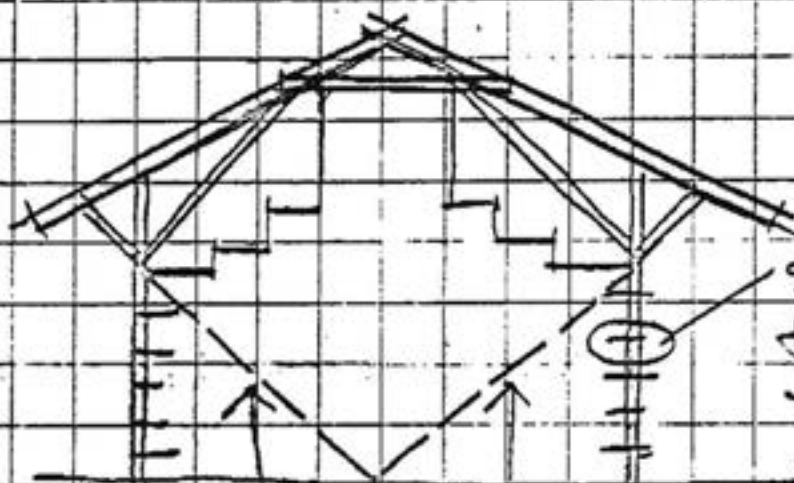
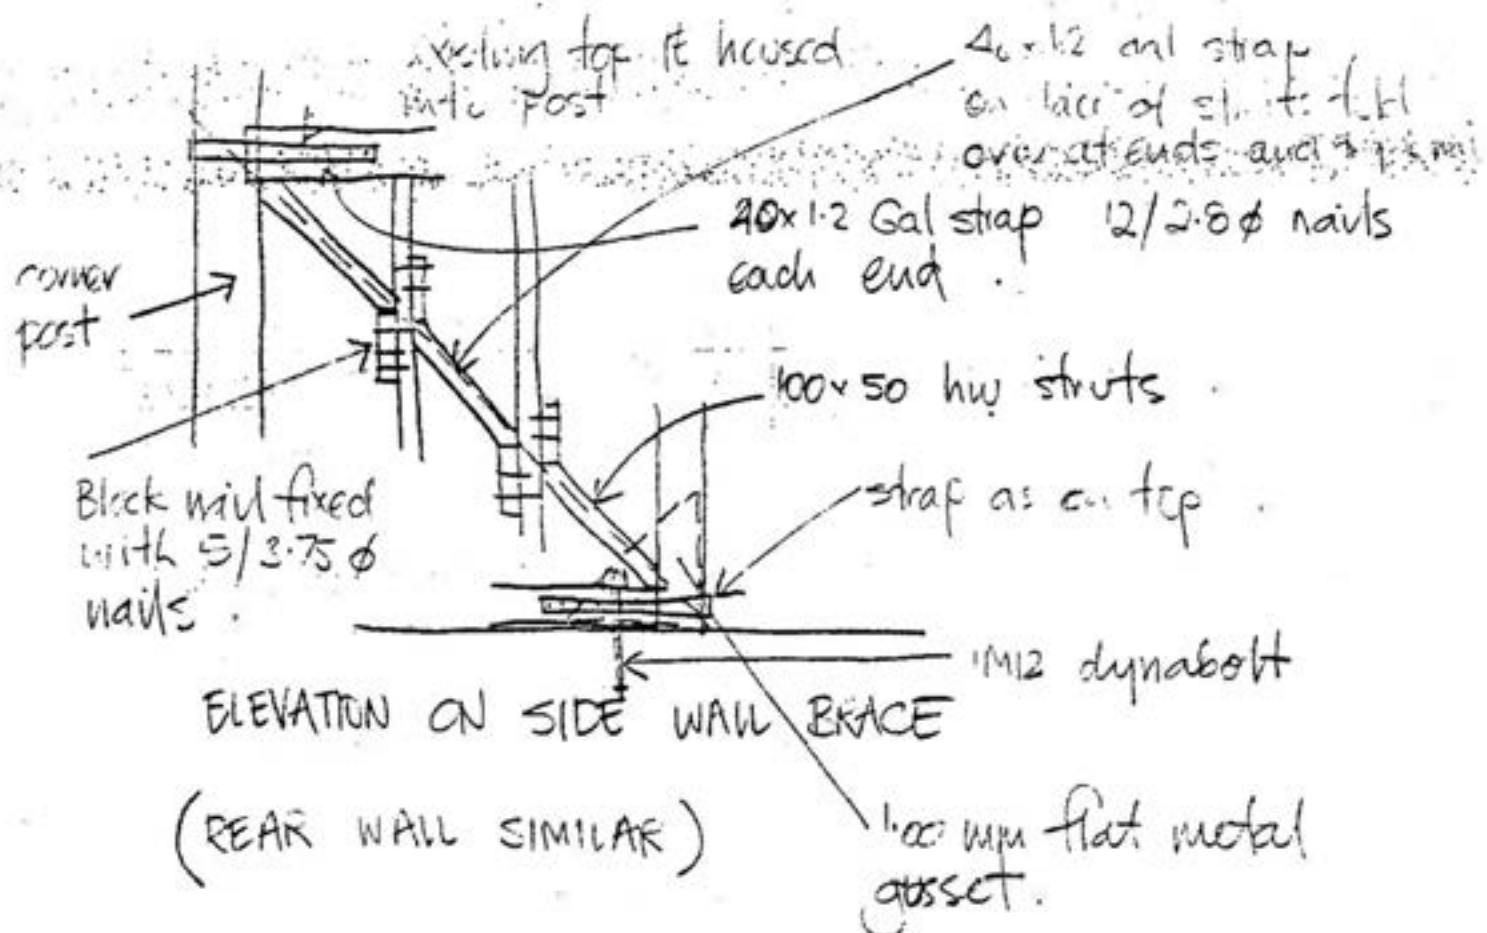
SK 2

Observations on site indicate that the structure is very flexible. The reason for this could be that the existing stud wall and roof bracing is not rigid enough. Adherence to the details on SK2 will improve the rigidity of the stud walls. The roof bracing appears adequate, however we recommend that the tiles be selectively lifted to allow the installation of supplementary screw fixing of the existing timber braces to the top of all intersecting rafters.

secure screw
fix lost stud
to existing
post

New 90x45 timber
struts fitted tightly
and blocked in
position between
existing studs
