Tree Management Report – 69 National Circuit, Deakin

Client: Arkitex Design Solutions Client's Contact: Alessandro D'Ambrosio

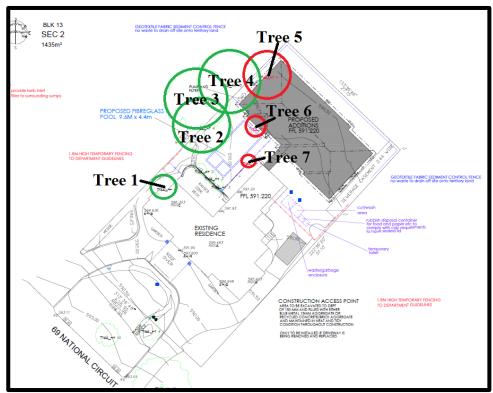
Figure 1. Shows the site and trees to be retained (in green) and trees to be removed (in red) at 69 National Circuit, Deakin.

Given the footprint of the development proposal has been placed over Trees 5 and 6, these trees will require removal for the development to proceed.
