Prepared by Duncan Marshall, Phil Creaser & Douglas Partners for the National Capital Authority

EXECUTIVE SUMMARY

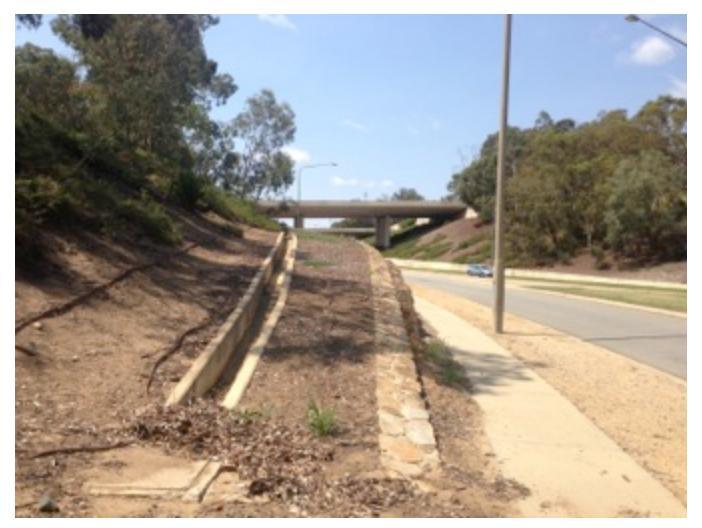
The top of the cutting has a bench area with a random (unworked) stone capping set in mortar close to the cutting face, and a concrete drain behind (see Figure 11). The landscaped battered slope extends above the bench. Many of the ground cover plants have failed, leaving the ground and irrigation pipes exposed (see Figure 6).

Figure 6. Western end of the Cutting with stone capping and concrete drain

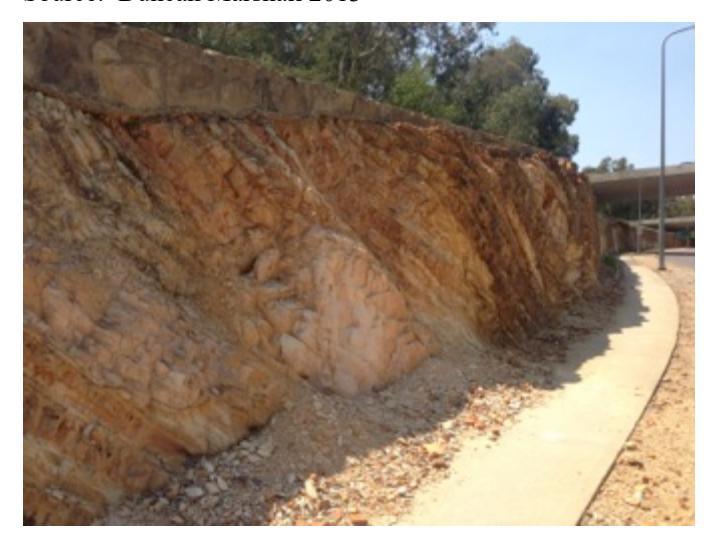
The concrete drain is also overgrown by some ground cover plants, there is debris partly blocking the drain, and the connection to the stormwater system at the western end is blocked. The gutter at the toe of the cutting is also partly blocked by debris. Mounds of erosion debris has also accumulated at the toe of the cutting in places (see Figure 7). There is one loose stone in the stone capping.

Figure 7. Section of Cutting at western end showing some erosion Source: Duncan Marshall 2013

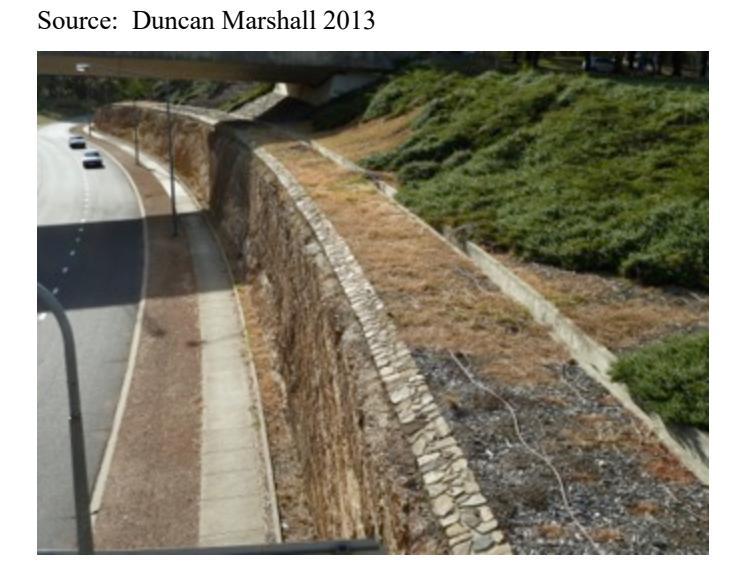
Figure 11. View of the Cutting and bench above

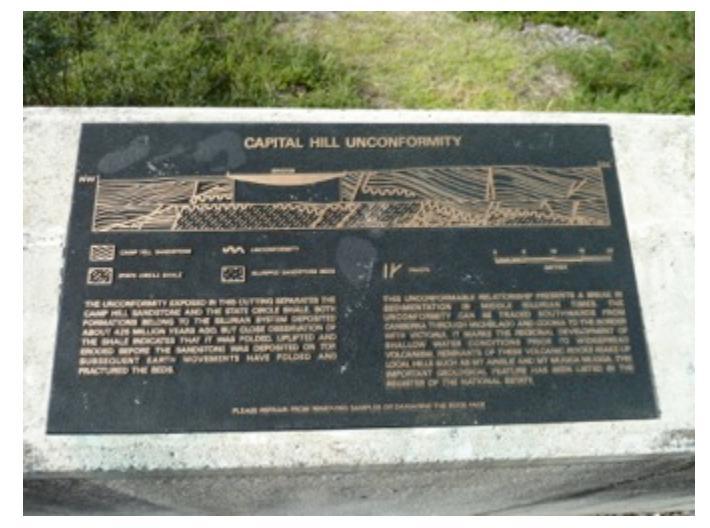
Figure 13. Bronze interpretation plaque in viewing platform

at the viewing platform on the south side of State Circle, overlooking the cutting. The plaque is somewhat out of date, as it shows the upper face of the cutting prior to its removal and replacement by a landscaped battered slope. This platform is also somewhat hidden and unless visitors know about it, they are not likely to find it.

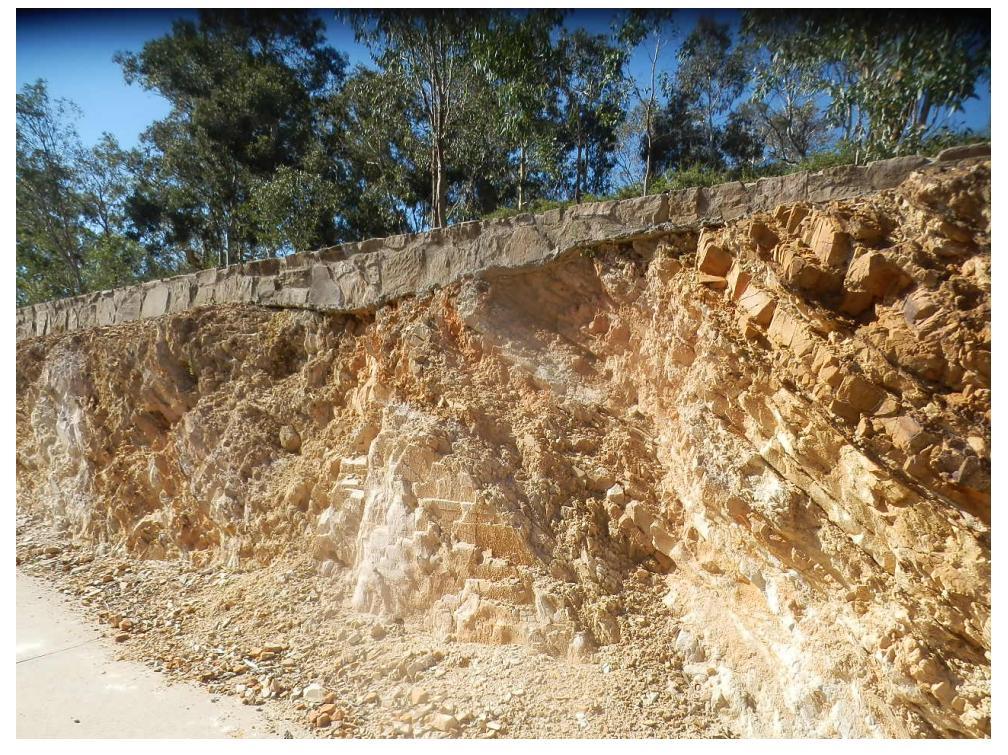
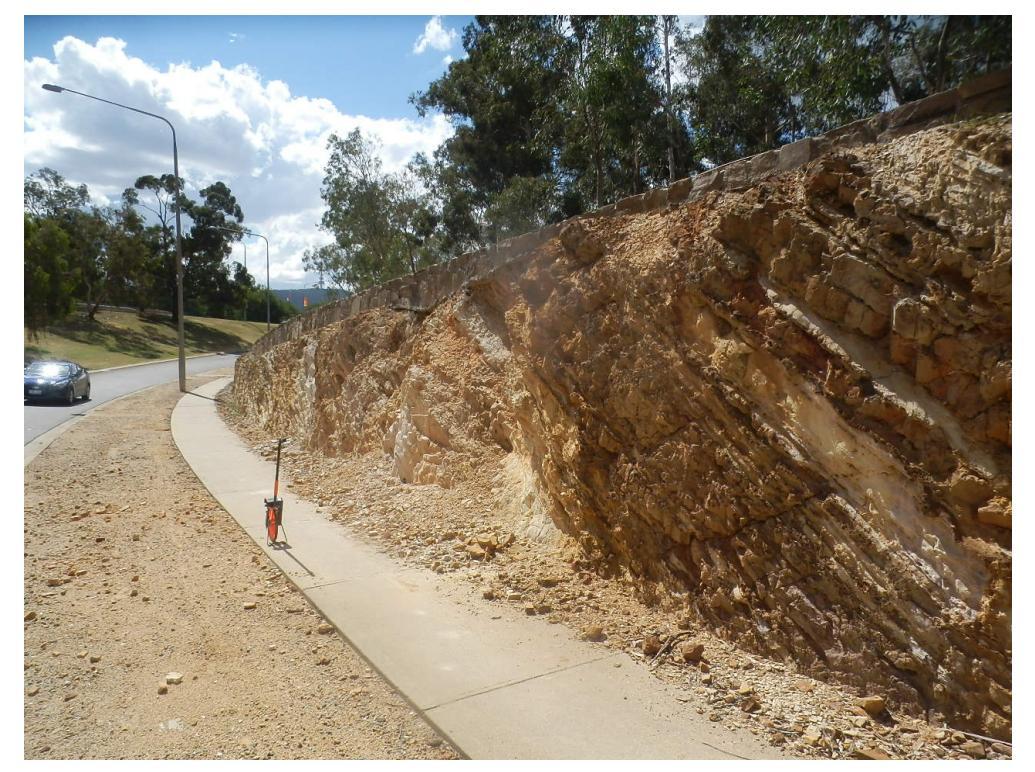
Plate 3 - Erosion and unravelling of batter face between CH 35m and CH 46m

Plate 4 - Erosion and unravelling of batter face between CH 35m and CH 46m

Remedial options for this section of the face could include minor scaling works of the loose blocks and 'dental' work to protect the friable layers and underpin the stone capping layer where necessary.

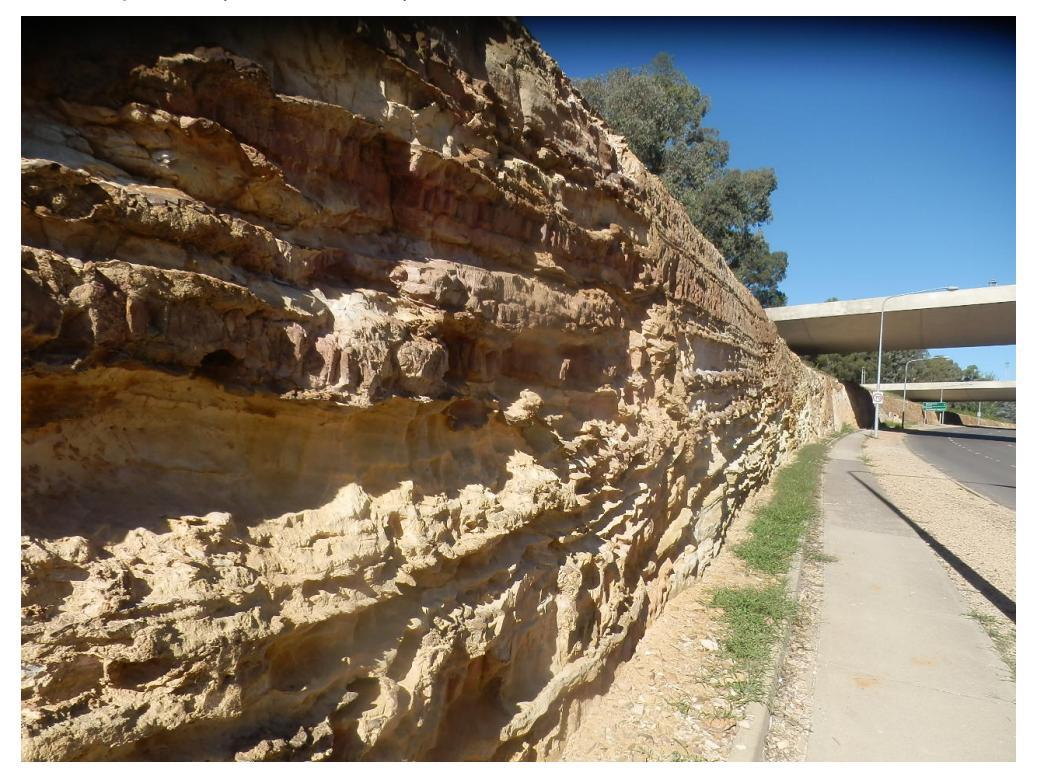
This section of the lower batter reaches a maximum height of approximately 5 m. There has been some differential weathering and regression of the batter face leading to the more resistant ironstone beds being undercut by up to 100 mm to 200 mm. However, most of the resistant bedding appears intact at present (refer to Plate 5).

Plate 5 - Typical differential weathering and regression of the batter face between CH 46m and CH 106m

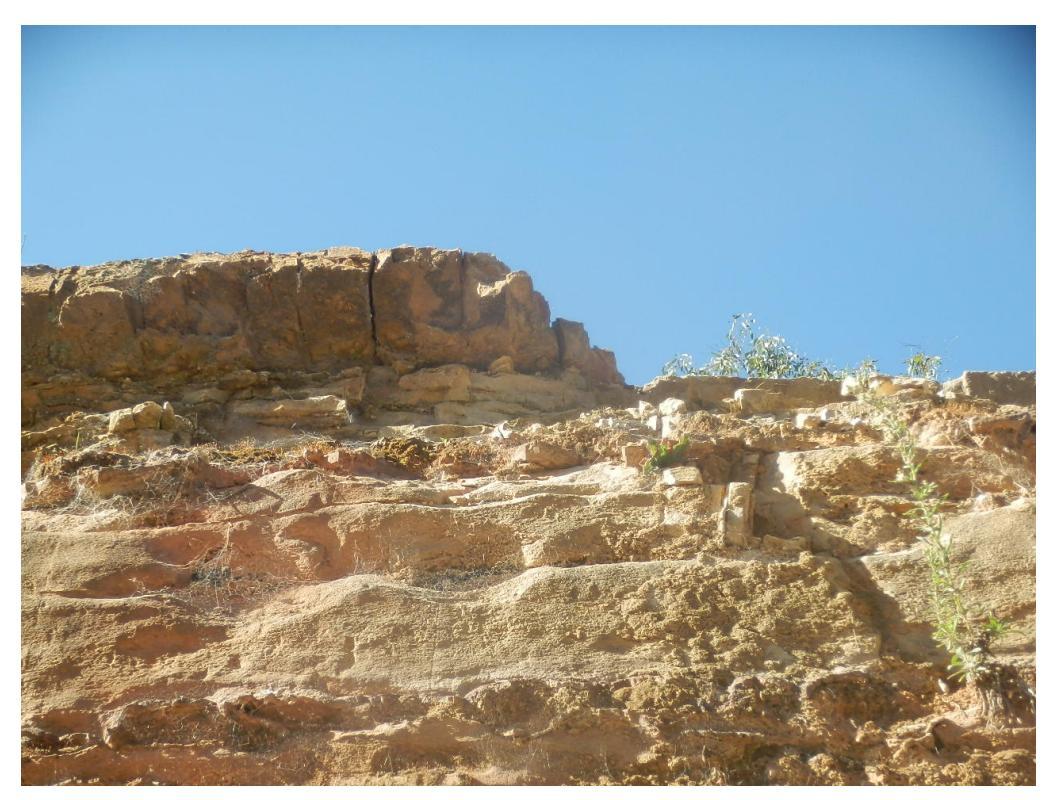
There are also some partially detached ironstone joint blocks to 200 mm diameter along the crest of the batter, particularly near CH 88m (refer to Plate 6). A loose stone in the cemented capping layer was noted at CH 78m.

Plate 6 - Loose, 200 mm diameter ironstone joint block at batter crest at CH 88m

Remedial works on this section of the batter could be limited to the scaling of the ironstone joint blocks depicted in Plate 6 and the re-cementing of the loose capping layer stone at CH 78m.

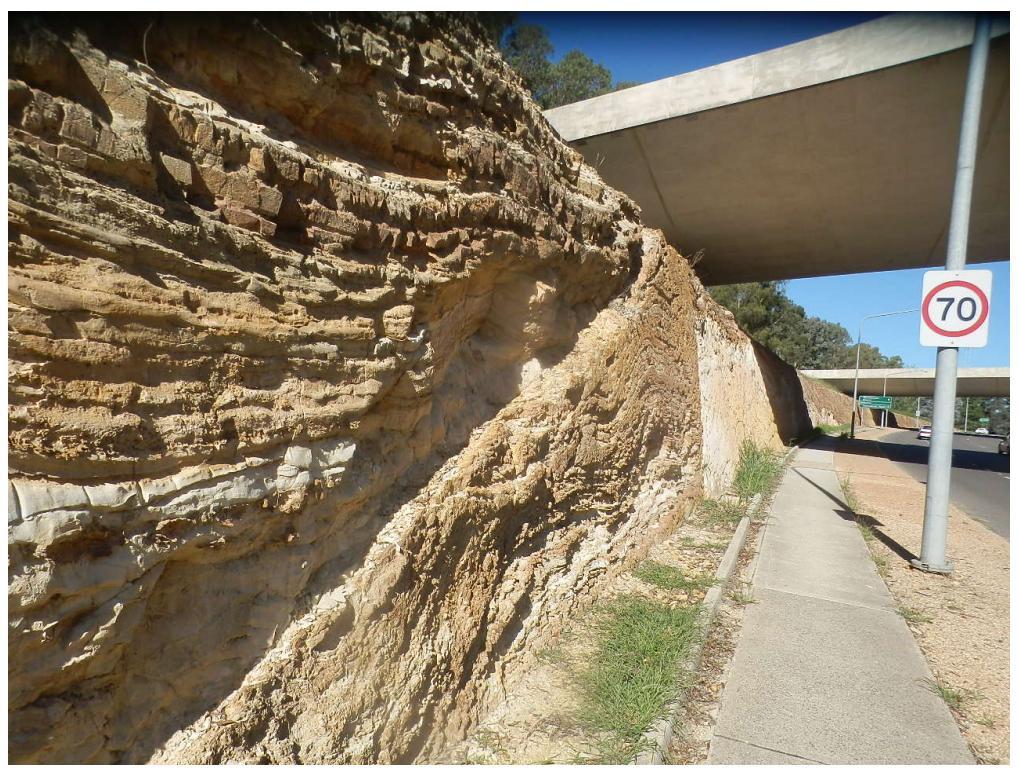
Plate 7 - Preferential erosion of a friable layer (which dips to the west across the face) between CH 106m and CH 120m

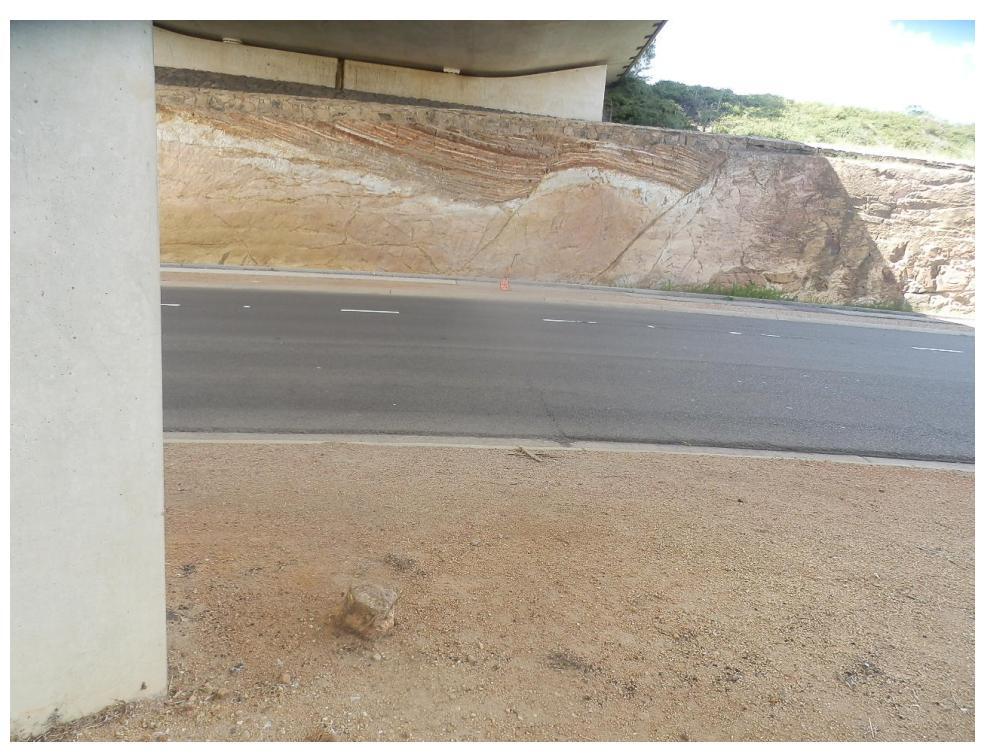
Plate 8 - General view of geological unconformity below western over-bridge. Note the 150 mm diameter joint block lying on central road median in the foreground.

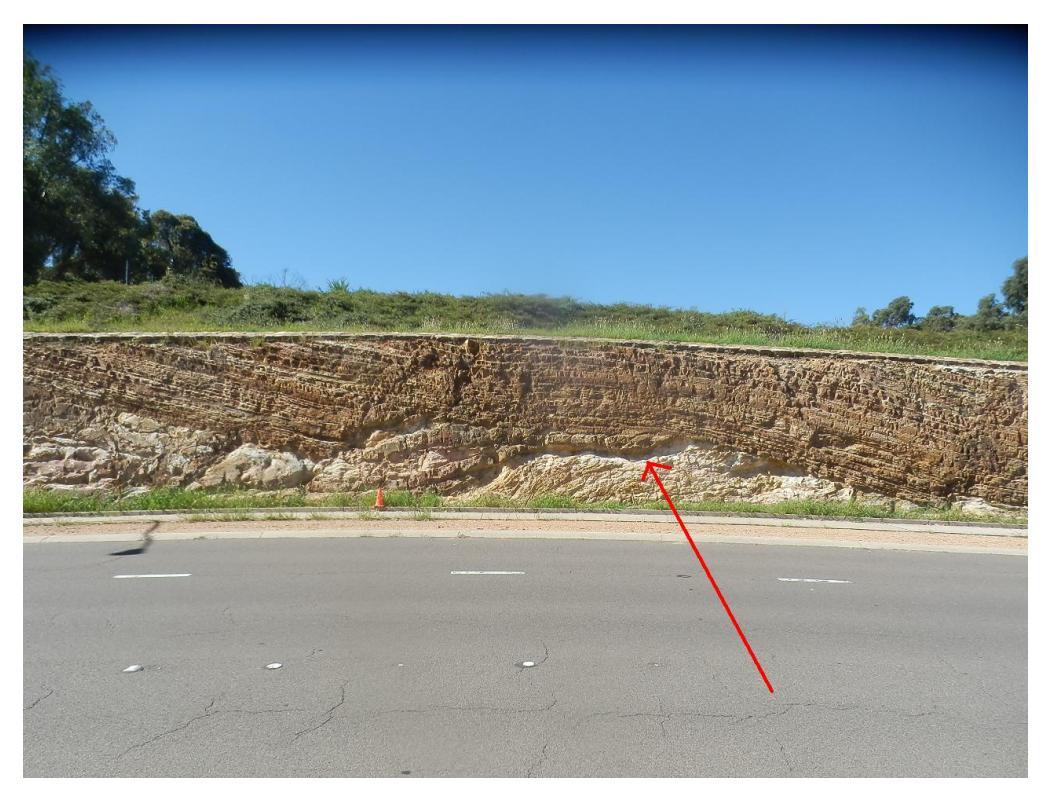
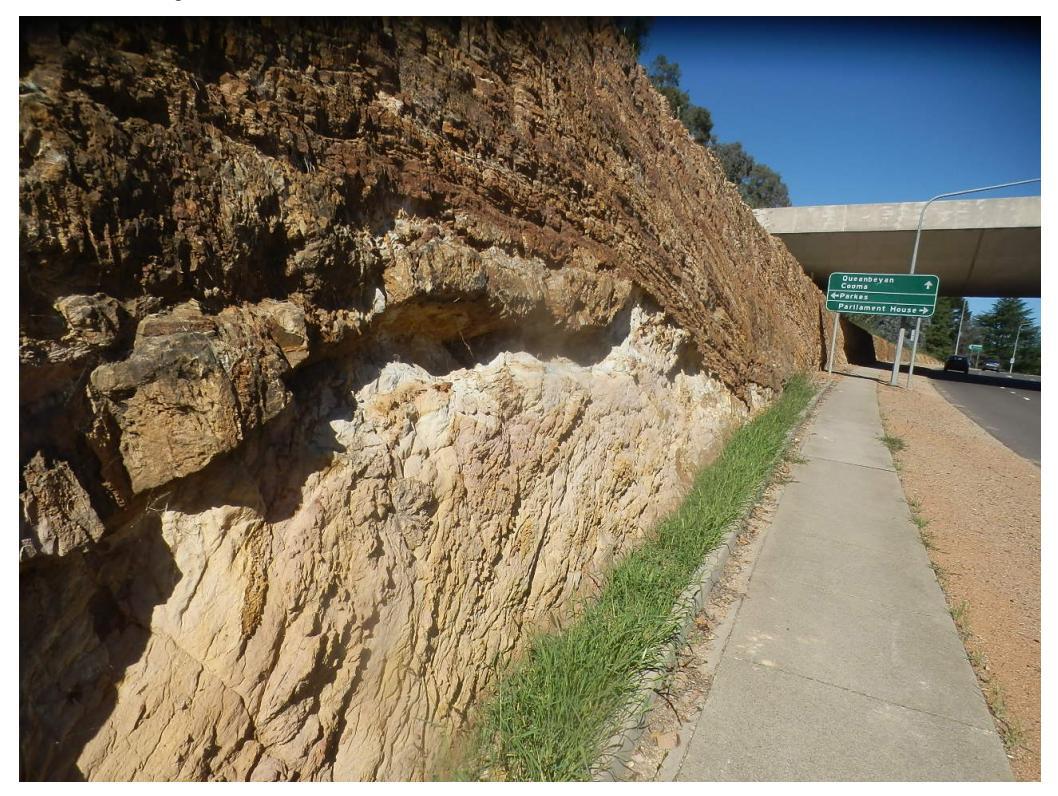
Plate 9 - General view of batter around CH 180m showing undercutting at geological unconformity.

Plate 10 - Detail of undercutting shown in Plate 8.

Some 'dental' work with the eroded layers or cementing of the undercut joint blocks immediately above the unconformity and minor scaling works of the ironstone joint blocks along the crest would reduce the frequency of future block failures.

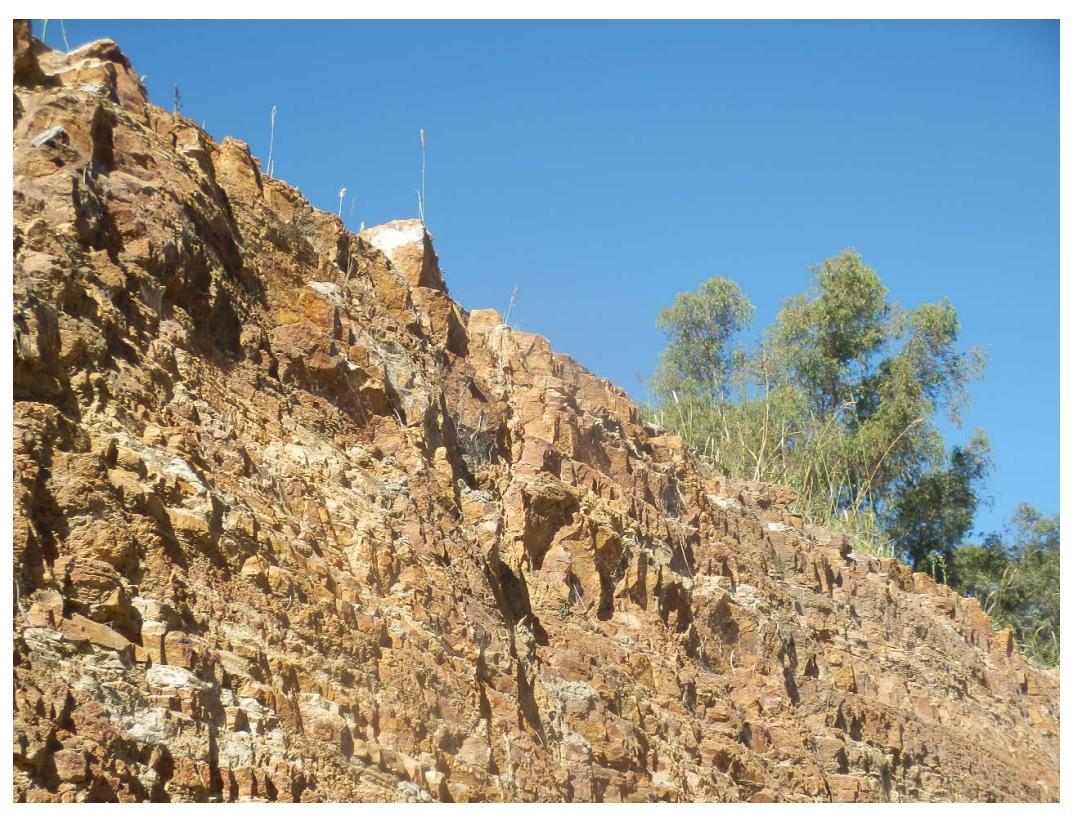
Plate 11 - Detail of ironstone joint blocks along batter crest at CH 177m

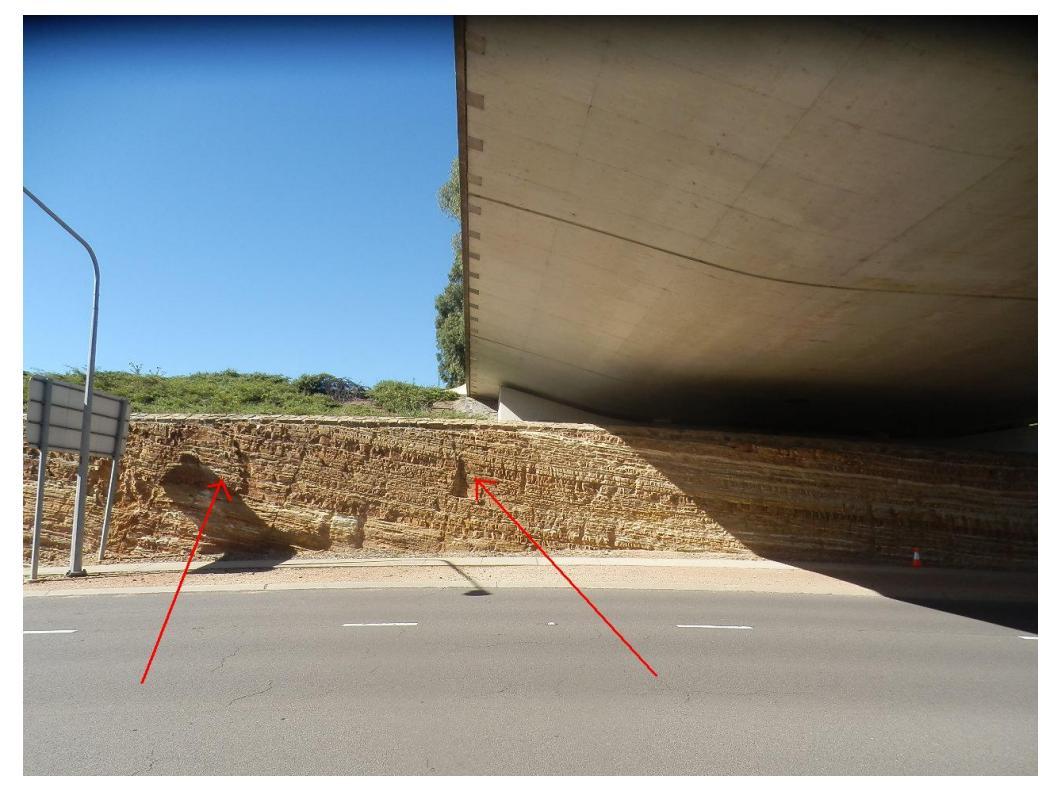
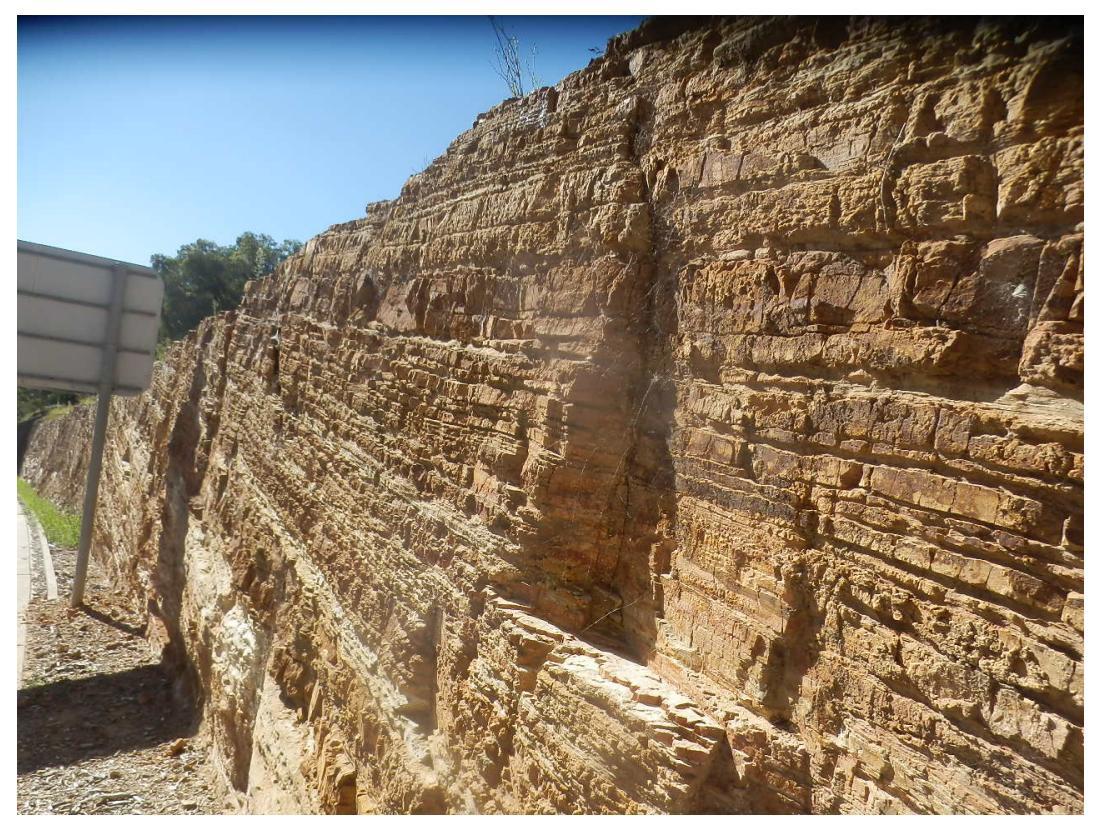
Plate 12 - Over-view of joints daylighting from batter face between CH 200m and CH 215m

Plate 13 - Detailed view of joints depicted in Plate 12
