# **Commencement Column Monument**

## Heritage Management Plan

Volume 2—Conservation Works, Treatment Recommendations

Report prepared for the National Capital Authority

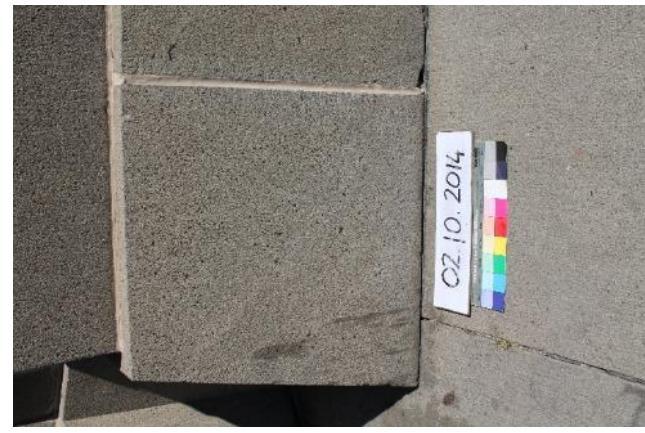
Figure 5.2 Detail stain on north face skirting

Most of the stains are temporary and food based. Natural weathering will reduce their visual impact. Regular washing as part of the maintenance program will also help alleviate this problem.

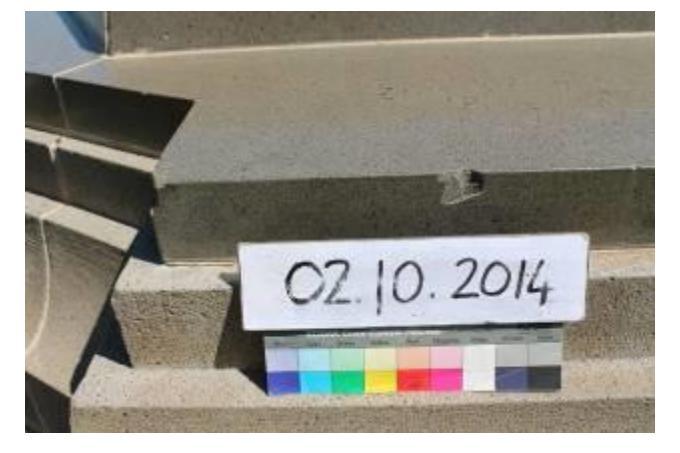
Figure 5.3 Details chips on north face horizontal capping

While visually displeasing the chips, losses and fills are stable. They could be replaced with a polyester resin fill tinted to match the surrounding stone if desired.

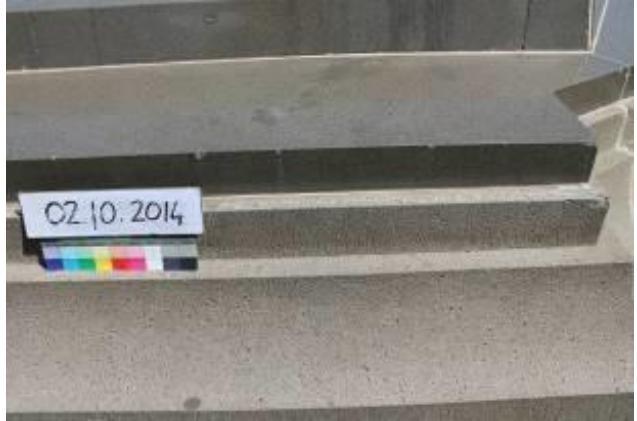
Figure 5.4 Detail chips and stains on north face horizontal capping

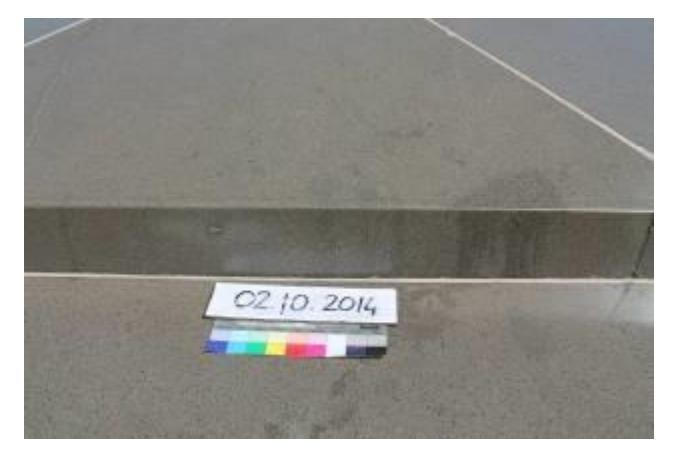
Figure 5.5 Detail stains on north face sloping capping

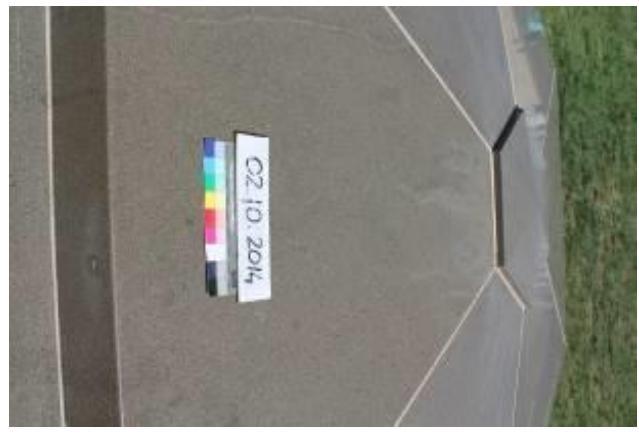
The sealant has chalked slightly and has caused light cream runoff stains that are especially noticeable on the sloping capping.

Figure 5.6 Detail of run stains from sealant on north face sloping capping

While the sealant is functional it is visually displeasing. As funding allows the current colour should be replaced with a darker colour and the work should be carried out by a stone mason experienced in getting a high quality finish. Sikaflex polyurethane sealant is an appropriate product. While the Sikaflex is not what would have been used originally there is now such a history of different joint materials that adhesion of traditional jointing compounds is likely to be highly compromised due to migration of oils into the surface of the stone. Consequently continuing with the same system, which is performing its function well, is the only sensible option.

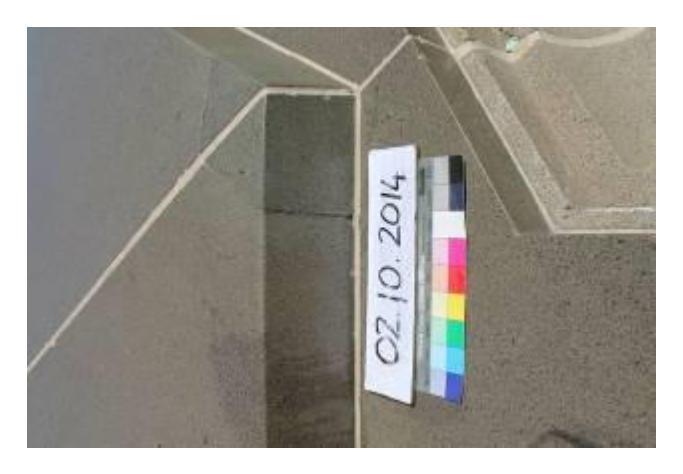
The top edges of two foundation stones have been cut down, presumably to remove significant chips. There is also a corner repair to the top sloping capping stone on the northwestern side. Examples of these repairs can be found in Figure 5.7 and 5.13 in Section 5.2—Detailed Condition Findings.

Figure 5.7 Detail stain and replacement corner on north face sloping capping

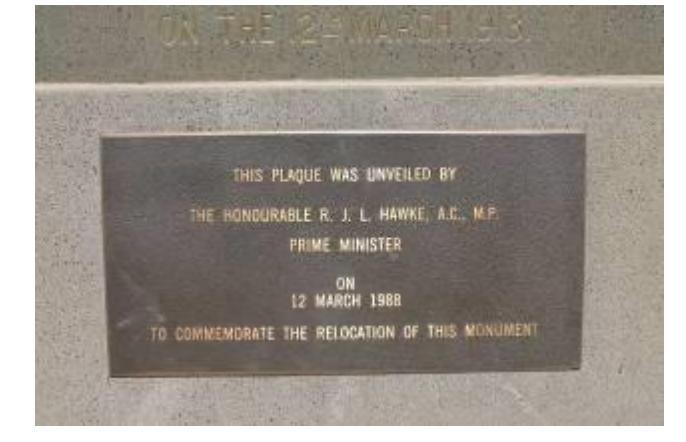
The bronze elements are in good condition. The faint white marks on the surface of the panels is old maintenance wax wearing off. The seal between the panels and the stone walls has split slightly in some locations.

**Figure 5.9** Detail bronze plaque, NW face. Plaque has a sprayed epoxy finish on it. The slight white discolouration is blanching of a maintenance wax coat that has been applied on top of the epoxy.

The old blanched wax should be cleaned off with white spirits and a new coat of microcrystalline wax be applied to the panels. The wax will slow any tarnishing of the letters but also act as an anti-graffiti coating.

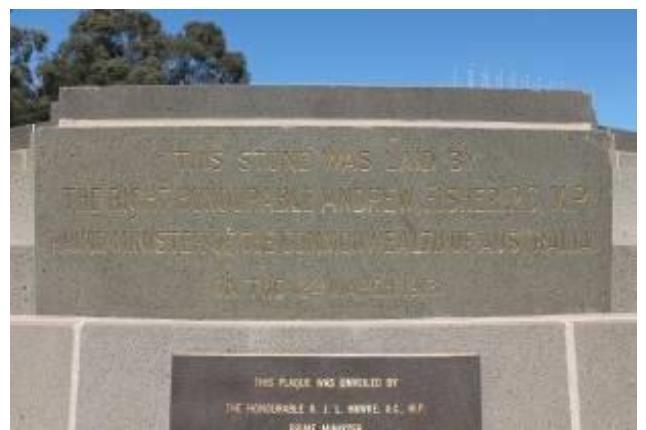
There are extensive losses and some discolouration to the gold detailing of the incised lettering on the foundation stones. The metallic pigment paint that has been used at some point in the past has tarnished. The losses and tarnishing has resulted in a dull mottled appearance to the letters.

**Figure 5.10** Detail incised foundation stone (Fisher) on NW face. Loss and tarnishing of gold detail is evident.

Any loose existing gold detailing should be removed with blades and ultra-fine scourer pads. The lettering should be re-gilt in 23 carat gold leaf, applied with an oil size.

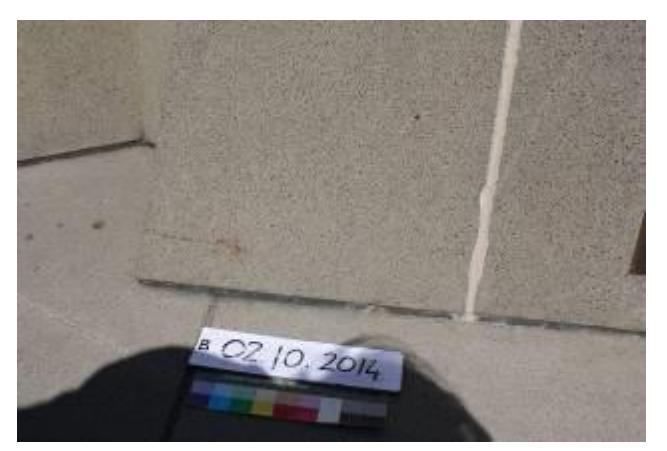
The scratches on the skirting stones that have become more obvious due to iron staining have been caused by lawnmower decks dragging against the stone when the lawn is being cut.

Figure 5.11 Iron stain on the skirting stone from contact with a lawn mower (NW face).

The lawn mower damage could perhaps be reduced by offering a briefing to the maintenance staff about the significance and history of the monument. This may encourage greater care while mowing.

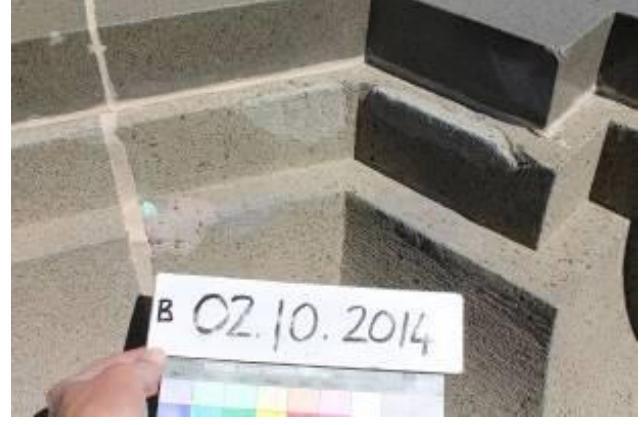
Similarly, there are a range of mortar based fills that do not match the surrounding stone very well. Examples of these can be seen in Figure 5.12 and 5.32 in Section 5.2—Detailed Condition Findings.

Many stones have suffered chips and losses. Some of these have been filled with a range of cement-based mortar fills that do not match the surrounding stone very well. In some instances the fills are more unattractive than the damage they are supposed to be repairing. Aesthetics aside the fills, chips and losses are stable.

**Figure 5.12** Detail of three fills all completed in poorly matching stone replacements. The green dot is chewing gum (NW face).

The surface accretions including some grey/silver paint, chewing gum and melted candle wax should be removed by a conservator using a combination of solvent and mechanical removal.

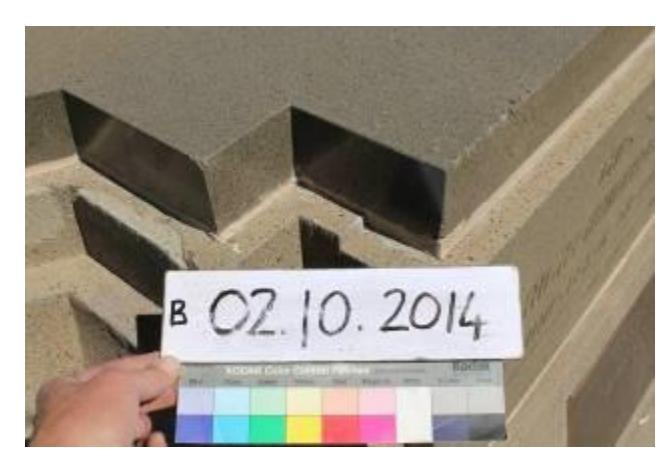
**Figure 5.13** Note small step in the top surface of the decorative moulding, it has been deliberately cut lower as a means of repairing some past damage (NW face).

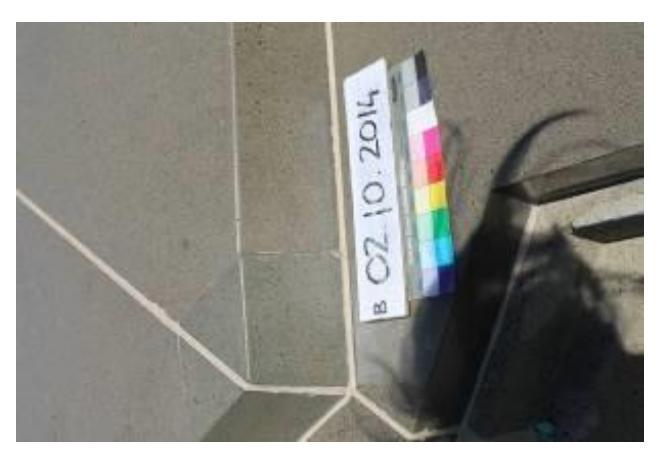
Figure 5.14 Corner repair on sloping cap (NW face).

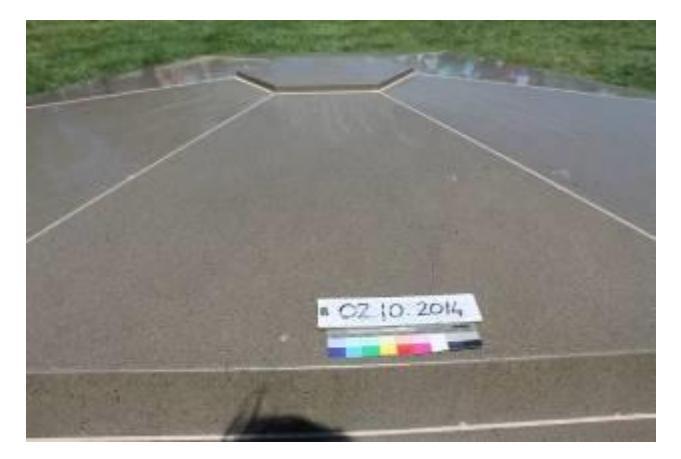
Figure 5.15 Chalky run marks from the sealant on the sloping capping (NW face).

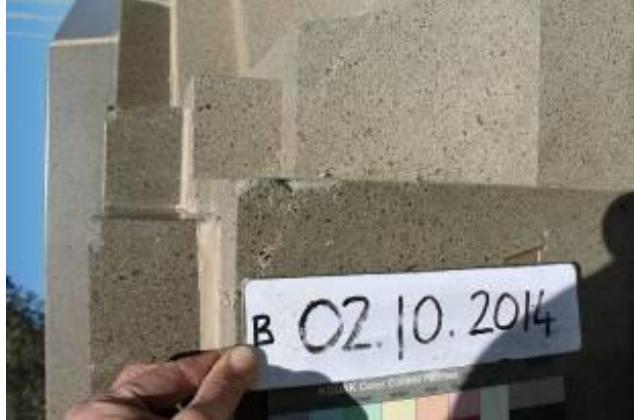
**Figure 5.16 S**mall step in the top surface of the decorative moulding, it has been deliberately cut lower. The height of the foundation stone has been reduced right across the front (NW face).

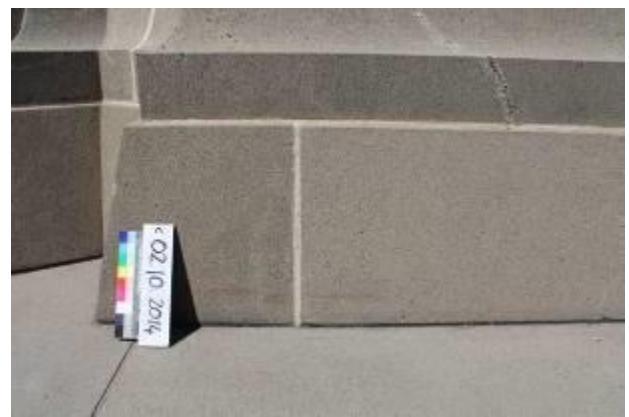
Figure 5.18 Detail of iron staining from lawn mower damage (SW face).

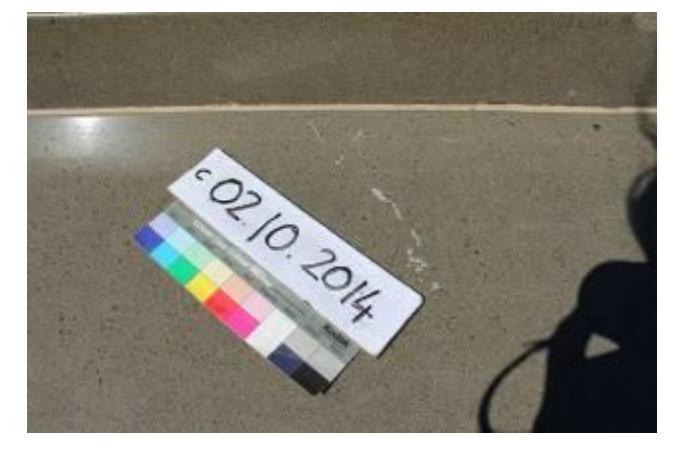
There are a range of surface accretions including some grey/silver paint and chewing gum and melted candle wax.

Figure 5.21 Detail of paint like accretion on the horizontal capping (SW face).

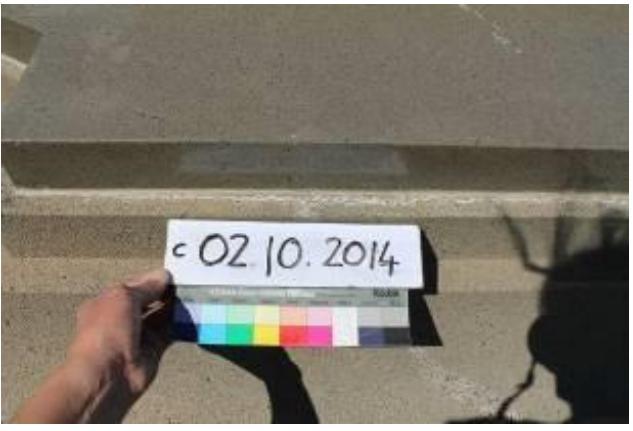
There is a small amount of calcium staining on the southeastern horizontal surfaces. This area will be the slowest to dry after rain or sprinklers and has resulted in a small amount of calcium or salt deposition. This small area of calcium deposits is the only indication that there may still be some dampness and or drainage issues as was highlighted in the 1996 condition report (Maxwell and Durr).

Figure 5.20 Detail of calcium deposits on the horizontal surface of the decorative moulding (SW face).

The small amount of calcium deposition could be removed with an EDTA poultice and mechanical action. This is an aesthetic treatment only.

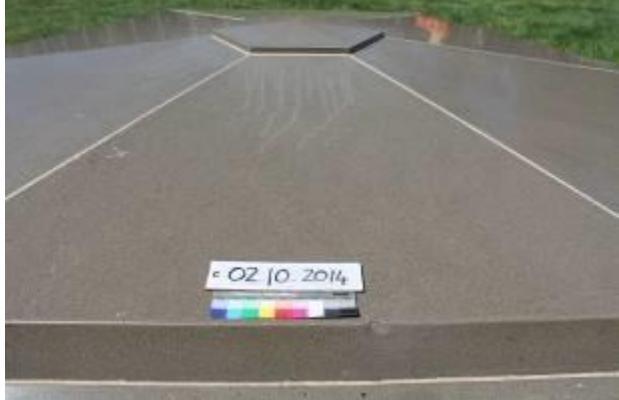
Figure 5.22 Detail of sealant run marks (SW face).

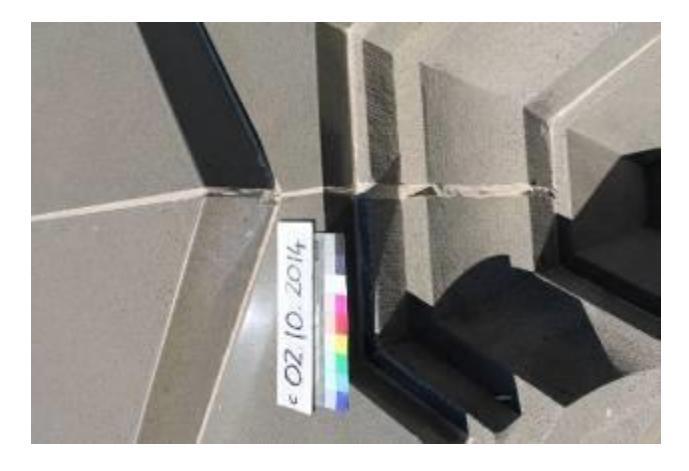
The colour of the sealant used is quite stark and the workmanship is slightly lacking with some of the sealant runs appearing quite messy.

**Figure 5.23** Detail of vertical sealant joints – note poor colour match, the light colour stands out more than necessary (SW face).

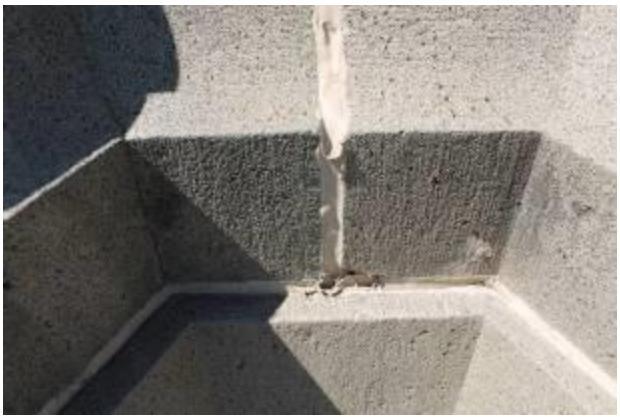
**Figure 5.24** Detail of sealant joints – note poor workmanship (SW face).

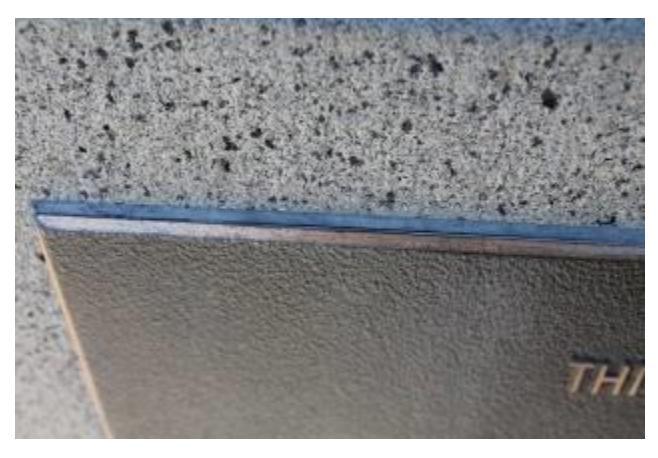
**Figure 5.29** Detail black flexible sealant joining bronze plaques to stone wall (S face). There is minor failure of the sealant against the metal plaque.

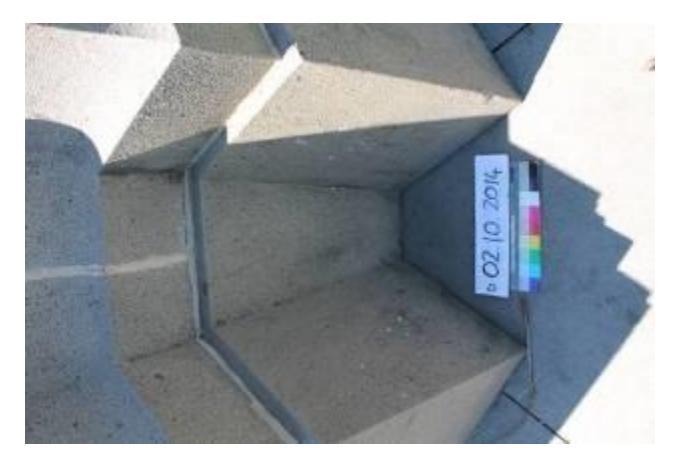
There are numerous stains of different origins on many stones. The black staining on the southern and southeastern faces is algae. There are many other oily and sticky stains which are most likely food and drink related. On the day of inspection it was clear that a group of people had used the monument as a picnic table for their lunch as it was covered in sticky drink spills and food crumbs.

Figure 5.33 Detail algae staining (S face).

The small amount of biological growth can be treated by a single application of the biocide Wet and Forget. It need only be applied to the skirting and decorative moulding stone on the south and east sides.

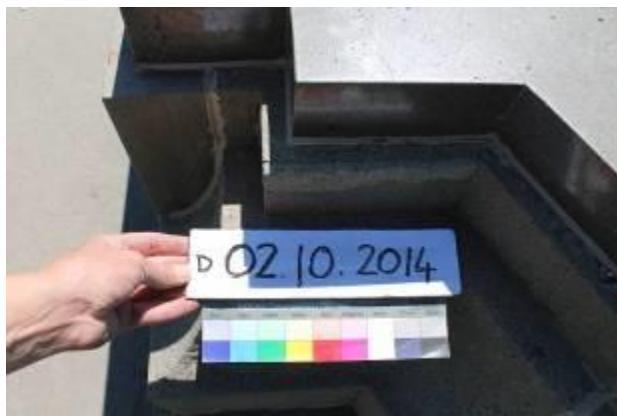
Figure 5.32 Detail poorly matched stone fill decorative moulding (S face).

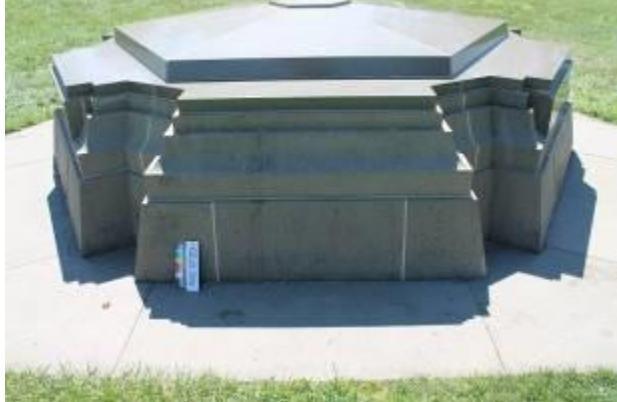
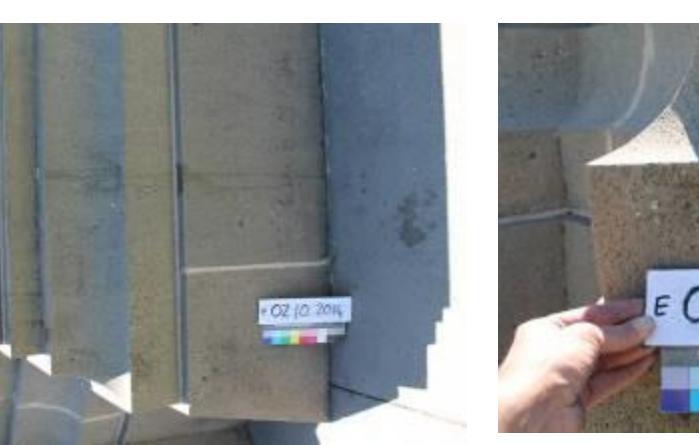
Figure 5.35 Detail algae and other staining (SE face).

Figure 5.34 Overall and detail algae and other biological staining (SE face).

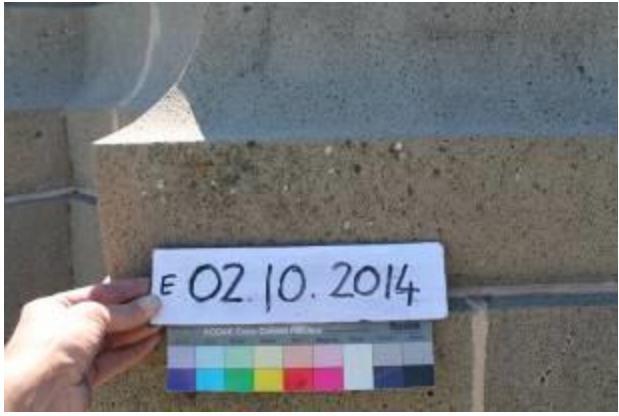
Additional to the algae staining there is a small patch of lichen growing on the southeastern face. There are also small pieces of grass rooting in between the paving stones.

Figure 5.36 Detail algae and lichen growths (SE face).

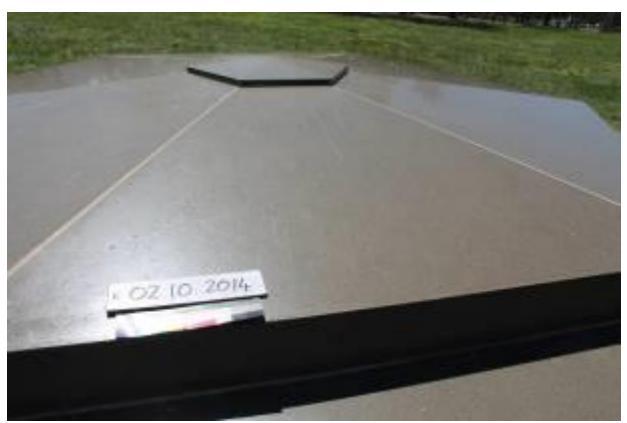
Figure 5.39 Detail algae staining (SE face).

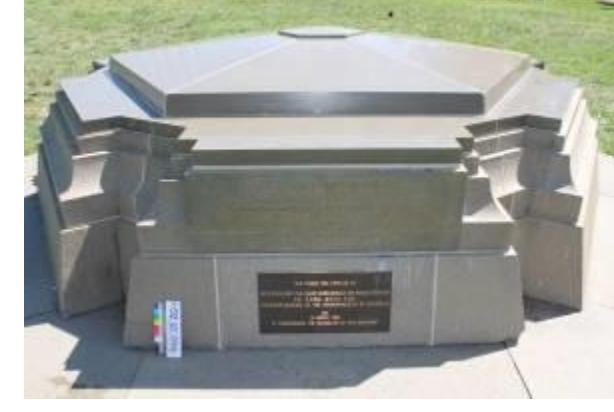
Minor scratching on the polished capping stones is evident. This is consistent with people climbing and sitting on the Monument.

Figure 5.38 Fine scratching on sloping capping (SE

Scratching from people climbing and sitting on the monument is insignificant and does not require treatment or management.

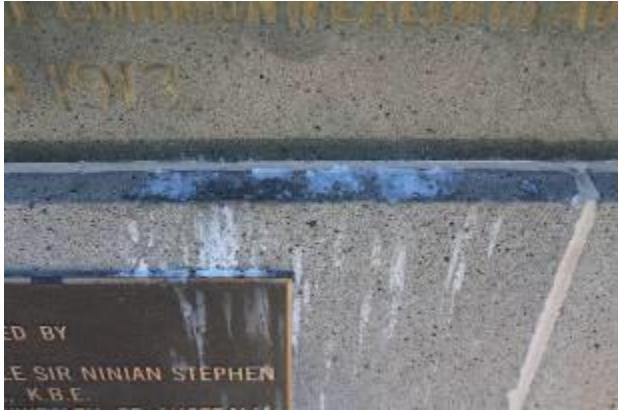
Figure 5.42 Detail candle wax on stone and bronze (NE face).

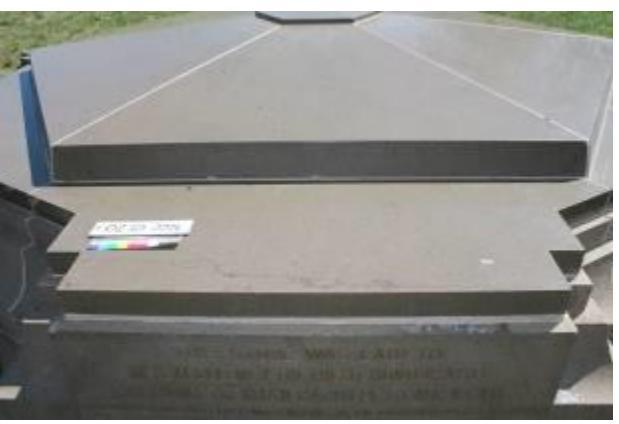
**Figure 5.44** Detail staining and calcium deposits (NE face).

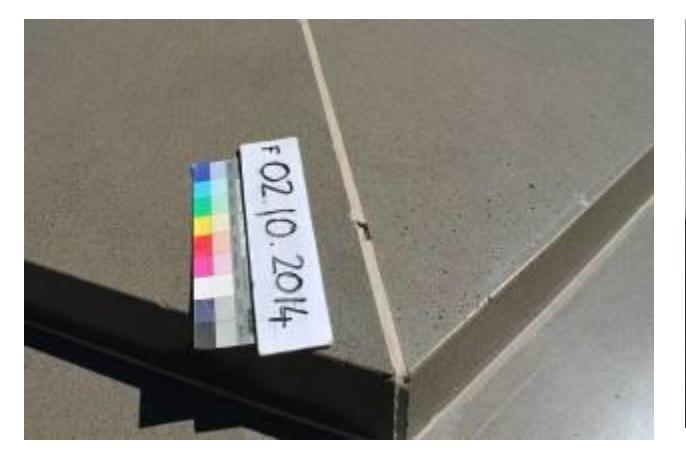
The Sikaflex sealant is doing a functional job of sealing the joints between the stones and preventing water intrusion. There is one small hole in the sealant on the northeast capping stone where water is able to enter.

Figure 5.45 Detail hole in sealant (NE face).

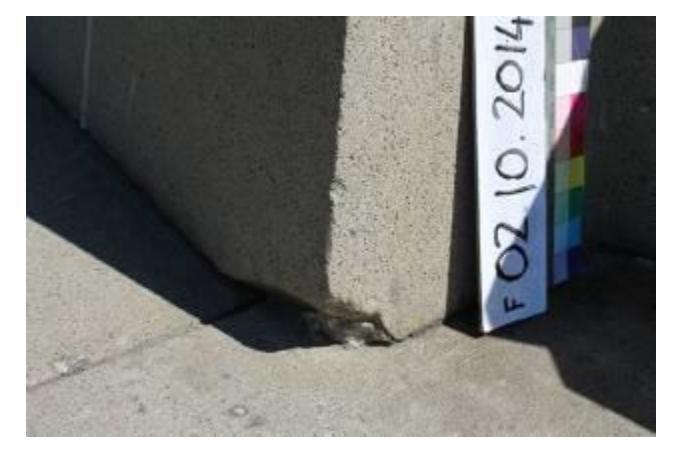
Figure 5.47 Detail cracked corner on skirting stone (NE face).

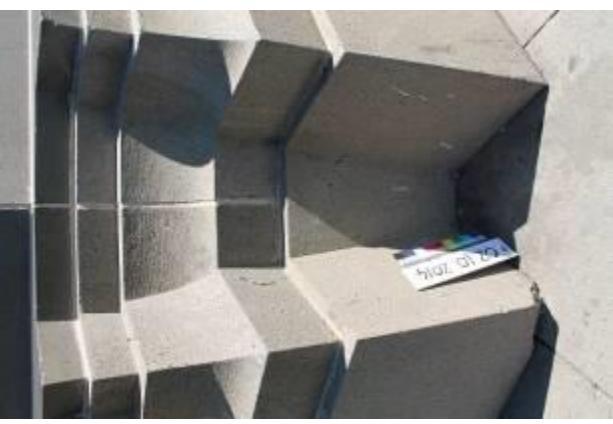
Figure 5.46 Detail corner – accretions (NE face).

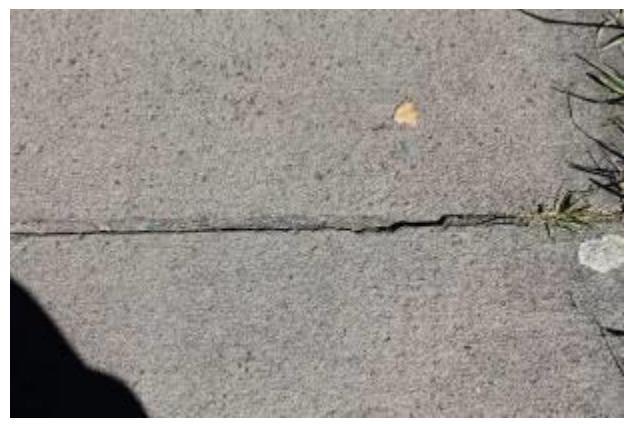
Figure 5.48 Detail of joint in paving (NW face).

The cementacious jointing between paving stones could be replaced at the same time as it has cracked in a few locations.
