# **Tree Management Report 11 Talbot Street, Forrest**

#### Date of report: 31 October, 2023

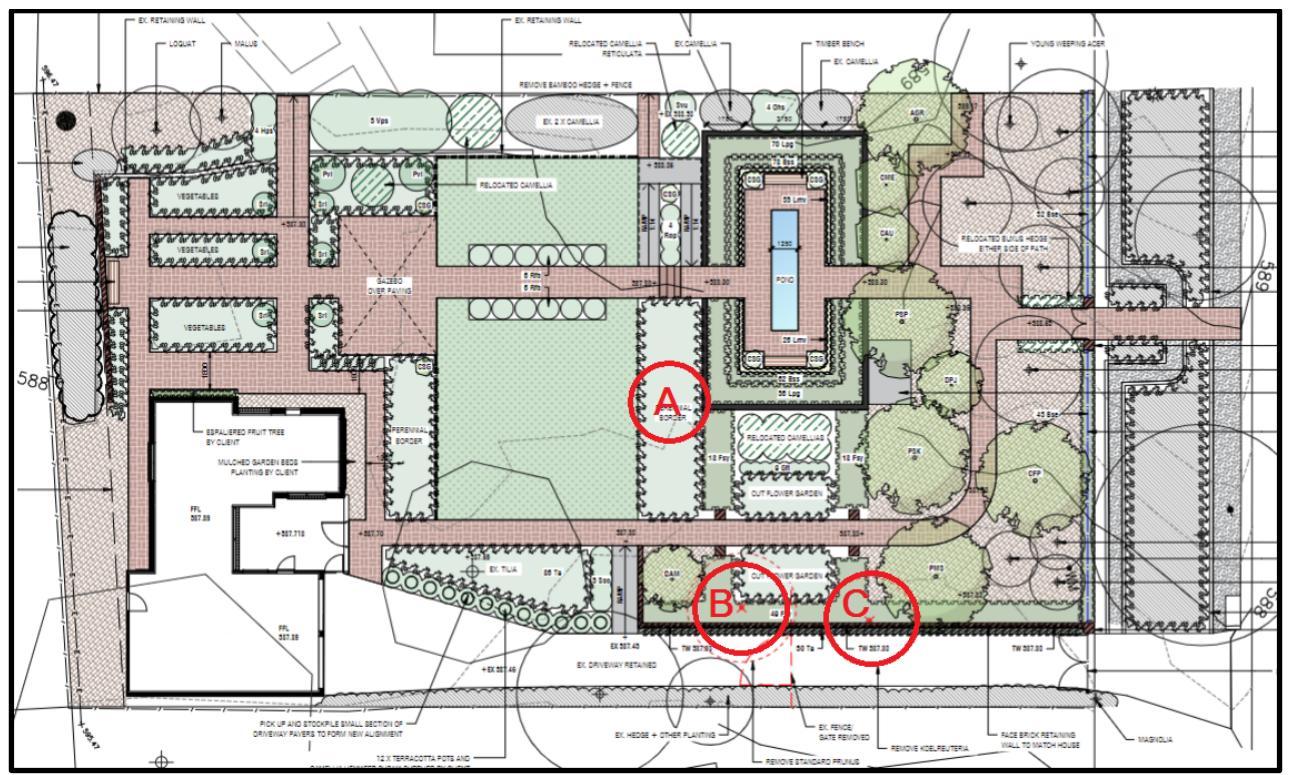
Figure 1. Shows the proposed design and specifications of the installation and trees to be removed (in red).

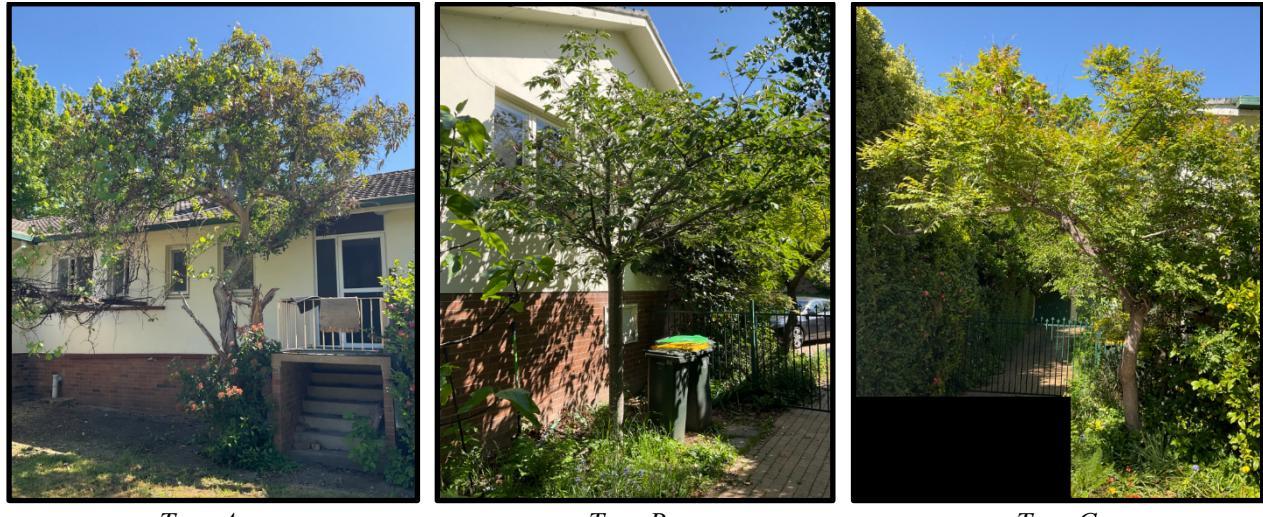
Tree A was assessed as holding a low retention value, largely due to the poor form, dieback and being engulfed by a climbing vine. Two (2) of the smaller leaders have died and the trunk holds large wounds and is becoming structurally compromised. There is a reduced potential risk of harm from Tree A failing due to the small size of the material left in the tree and the reduced height. Tree A currently reduces the overall amenity value for the area and support is requested for its removal.

Tree B was assessed as holding a medium retention value, largely due to the longer life expectancy of the species and form. Tree B is a suitable tree to consider for transplanting, either as part of the new landscape or in another suitable landscape.

The current design cannot be achieved with the retention of Tree B. Given the overall small size of Tree B, it is not visible from the streetscape or surrounding properties. Tree B currently adds value to the garden in place, however will impede the flow of the proposed design. Support is requested for its removal.

Tree C was assessed as holding a low retention value, largely due to its poor form and reduced life expectancy. Tree C is not a suitable tree for transplanting due to the poor form and lengths it would take to work in another part of the landscape or another garden.

The current design cannot be achieved with the retention of Tree C. Given the overall small size of Tree C, it is not a landscape feature that stands out from the streetscape. Tree C is currently an awkward shape, due to the poor form, and impedes complete access to the rear of the yard through the driveway gates. Support is requested for the removal of Tree C.

**Recommendation:** Final recommendation is to seek approval for removal of Trees A-C and proceed with the current design.
