King George V Memorial

Heritage Management Plan

Volume 2: Conservation Works and Maintenance Program

May 2014

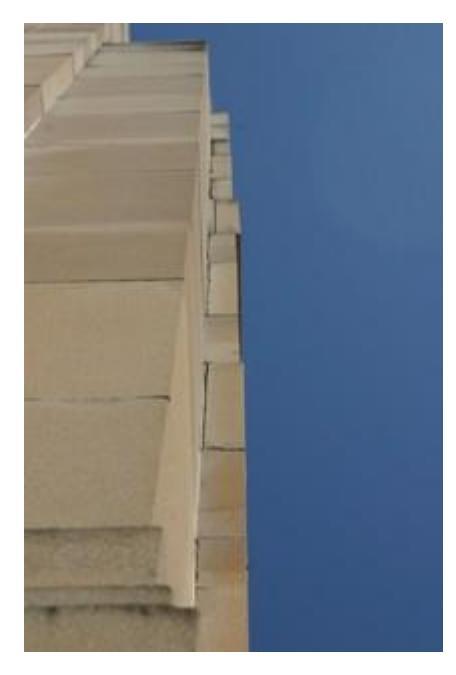
The expansive growth of the brickwork has turned what was intended as a composite structure of brick and stone into a central brick core with a loose 'cladding' of sandstone blocks. Many, if not most, mortar joints are open or cracked, allowing water penetration vertically and horizontally into the structure. The brick growth has relieved much of the overlying load on the sandstone and so the unrestrained blocks have bowed due to excessive moisture, causing swelling of their rear surfaces (relative to the faces which remain drier and are case-hardened, reducing their movement). Bowing was apparent in the early 1990s and may have worsened since. As well as bowing about a vertical axis, some stones show slight cupping about a horizontal axis, though this may be due to a slight concaving of the surface, during original finishing, or perhaps as a result of rubbing down the stones during the 1968 reconstruction in the present location.

Figure 2: Example of open joints and movement of sandstone blocks on the northern face.

It is unclear whether there are any restraining cramps tying stones together and back to the brick core. The 1937 specification called for the use of galvanised iron cramps but there are no records of their frequency and location, nor is it clear if they were replicated during the 1968 reconstruction. While there may be some cramps tying stones together and back to the brickwork (most likely near the top of the pylon), there are unlikely to be any pins as the stone and brickwork was built as a single entity with a composite structure typical of the time of its design. Bowing and displacement of many stones indicates that they are not restrained by cramps. The lack of staining from corroding metals suggests that cramps were not used, but were incorporated instead and have subsequently failed.

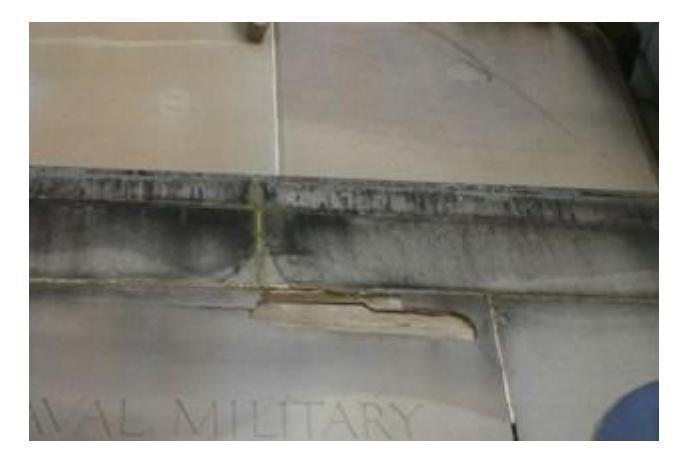
Many of the sandstone blocks show evidence of delamination of surfaces and related cracking which is parallel and close to the outer margins of the stones. Some stones were so severely decayed they were dressed back to remove the delaminating material during the 1996 works, the complete course just below the inscription on the west face being an example of this. Other stones have been redressed only in those areas that were delaminating, leaving uneven surfaces that are particularly apparent in raking light.

Figure 3: Example of cracking, delamination and granular disintegration on the southern face.

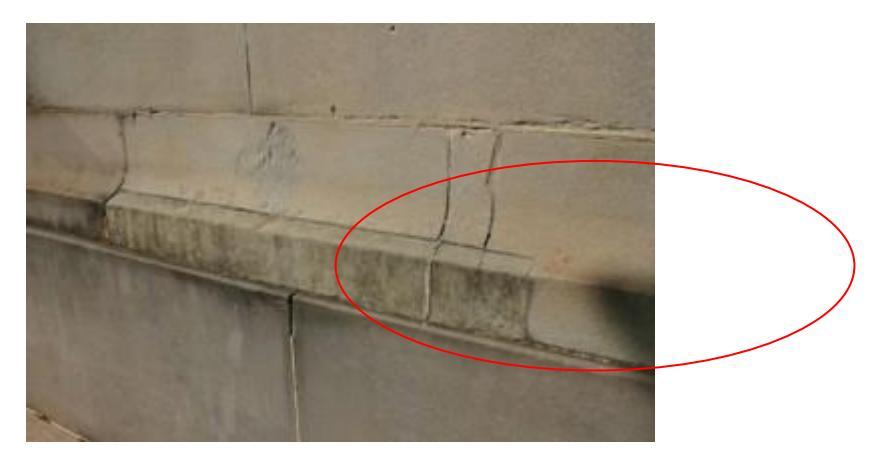
Similar disintegration probably occurred at the exposed top corners and edges of many stones, leading to their repair in epoxy-bound sand patches as part of the 1996 works. These patches are

understood to have discoloured fairly quickly to a distinct green colour which is now muted to a more neutral colour, although still not a good match for the sandstone. The epoxy-based repairs are deteriorating, showing a distinct loss of material and surface retreat below that of the adjacent sandstone, with the stainless steel armatures exposed in places. Though decaying, the epoxy-patching is appropriately weaker than the stone and is therefore probably not contributing to further decay of the stone.

Figure 4: Example of epoxy resin repair on the southern face.

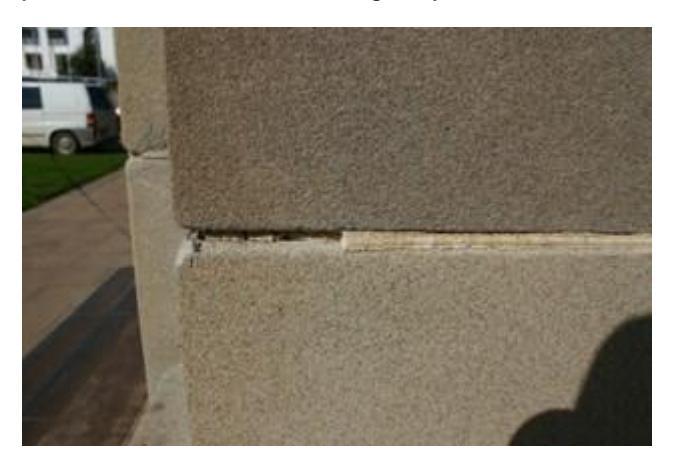
Failure of many of the 'real' joints is expressed as deep cracking between stone and pointing mortar which is often loose and easily removed. In places the 1996 pointing is missing entirely; and where present, it is weak and crumbly. Failure of the pointing is due to two factors; ongoing brick growth widening the joints and allowing water penetration as already noted, and decay of the pointing mortar itself, which may be due to poor curing of the new mortar. It is understood that there were problems with the pointing within 12 months of completing the 1996 work.

Because of the growth of the brick core, the 'real' joints are progressively getting wider and now, at up to 10mm wide, look very out of place compared to the intended 3mm joint width as evidenced by the 'fake' joints and the 1937 specification (Foskett, 1937). This problem, which contributes to the disfiguring of the memorial, may have been compounded during the 1968 relocation by building in joints that were wider than originally intended.

Figure 5: Example of mortar pointing failure.

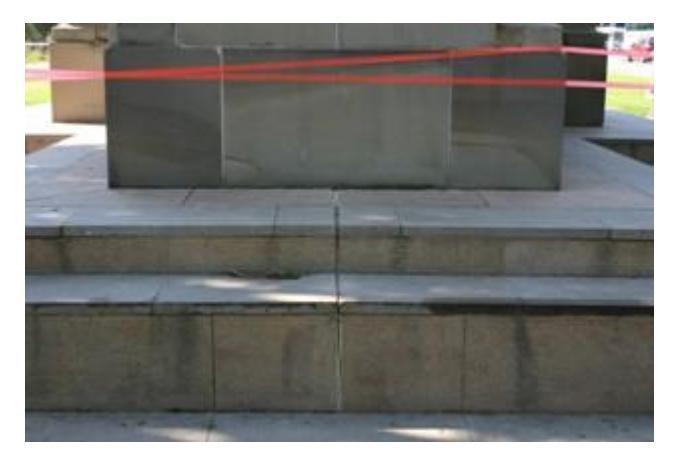
These elements generally appear to be structurally sound. There is a slight camber on the platform surface, higher at the centre (which is presumably to allow water to run off the surface), though it may be partly due to settlement of the outer edges of the concrete platform on which the granite steps are laid.

Figure 6: Central platform joint.

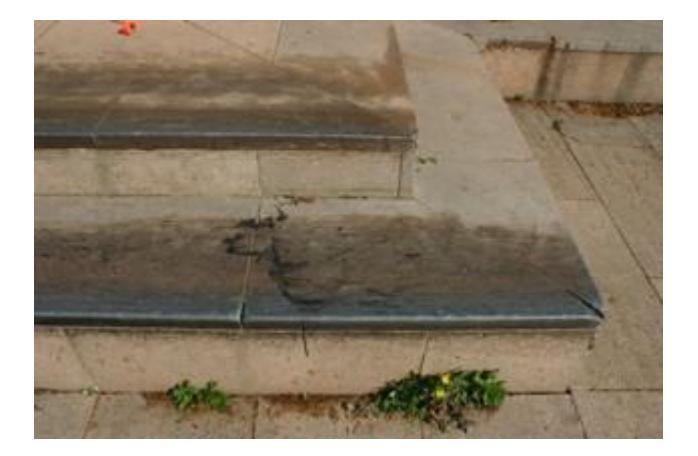
The granite is in good condition except that the eastern steps are badly disfigured as a result of skateboarding activity. Thick accumulations of wax and mechanical damage to the edges of some stones are apparent.

Stainless steel anti-skateboard guards had been installed in the vertical joints between granite paving slabs, but these have all been removed. Installation of guards in the joints may seem like the appropriate minimal intervention solution, but it doesn't work; thermal expansion of the steel and the granite will weaken the bond in the joint, making removal more straightforward, as well as stressing the stones and potentially widening the joints. Guards should be inserted into holes drilled in the granite, midway along each slab.

Figure 7: Example of skateboard damage to granite steps—note wax and missing skateboard deterrents.

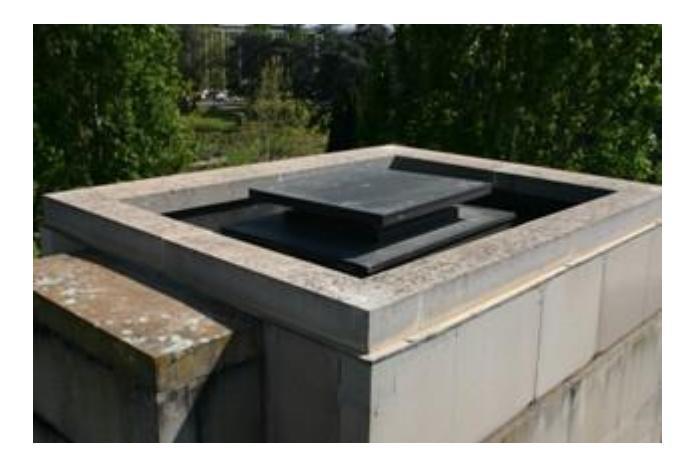
The top of the memorial has a low parapet wall of sandstone (replaced in 1996). The roof surface is copper sheeting on a screed over concrete. The roof is accessed through the interior, via the manhole in the pavement and out a hinged hatch at the top of the pylon. The 1996 ventilated roof hatch is jammed and cannot be readily opened.

The manhole on the ground has a broken lock and is unsecured. There are beer bottles up the top indicating that someone makes use of this space.

Figure 9: External view of roof.

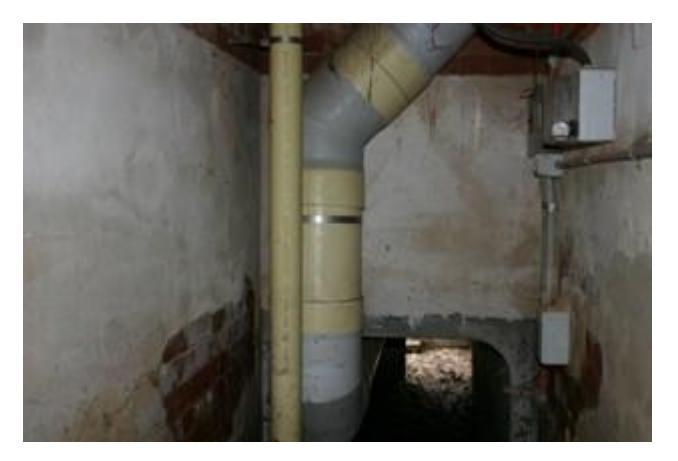
Despite the long-term slow expansive growth of the bricks, the brick core of the memorial is in good condition with no significant cracking or other signs of damage, the exception being some salt attack damage. This is due to excessive moisture penetration through the core and rising damp at the base. The latter is made many times worse by the accumulation of debris trapping water within the interior. Among the accumulations of white salts, some may be less harmful carbonates, these indicate dissolution of mortars and concrete slabs.

Figure 10: Interior, note sacrificial plaster, salt and water damage.

A sacrificial plaster was applied to the lower parts of the interior wall surfaces in 1996 as a protective measure (salts evaporate at the plaster surface rather than the brick surface, and all associated damage occurs at the plaster face rather than the brick). It has performed its protective function well as the dampness and associated salt attack has caused the loss of much of the 1996 plaster (it is totally missing in some areas). Salt attack damage extends beyond the plaster and into the brickwork above.

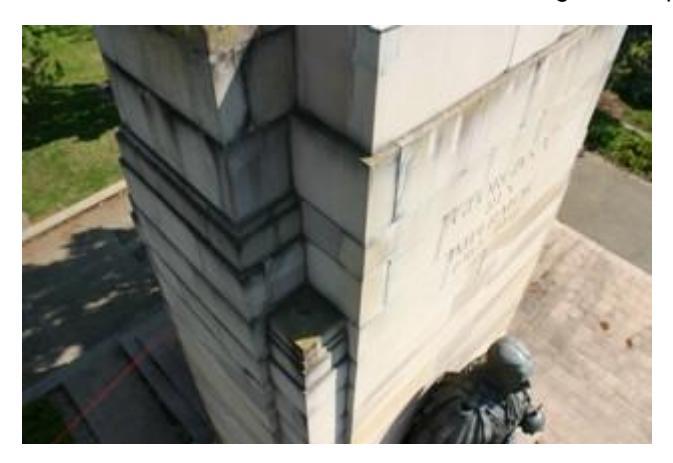
Lichen and algae have colonised the stonework in many places, particularly the south side horizontal surfaces and at the top of the pylon. This biological growth contributes to the (slow) breakdown of the surface of the stone, making it more prone to moisture ingress and decay.

Figure 11: Dark algae staining and lichen on highest stonework.

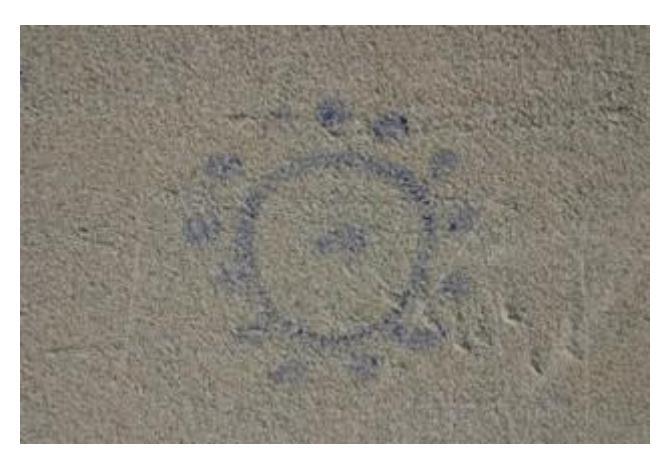
There are numerous small pieces of graffiti on the stone walls; there is also some scratching damage that may have been deliberate. The graffiti contributes to the worn and battered appearance of the memorial.

Figure 12: An example of applied and incised graffiti.
