29 October 2019

Ref: 5519

A Report on 6 *Cupressus sempervirens* 'Stricta' (Italian Cypress) at 41 National Circuit, (Block 16, Section 7) Forrest, ACT

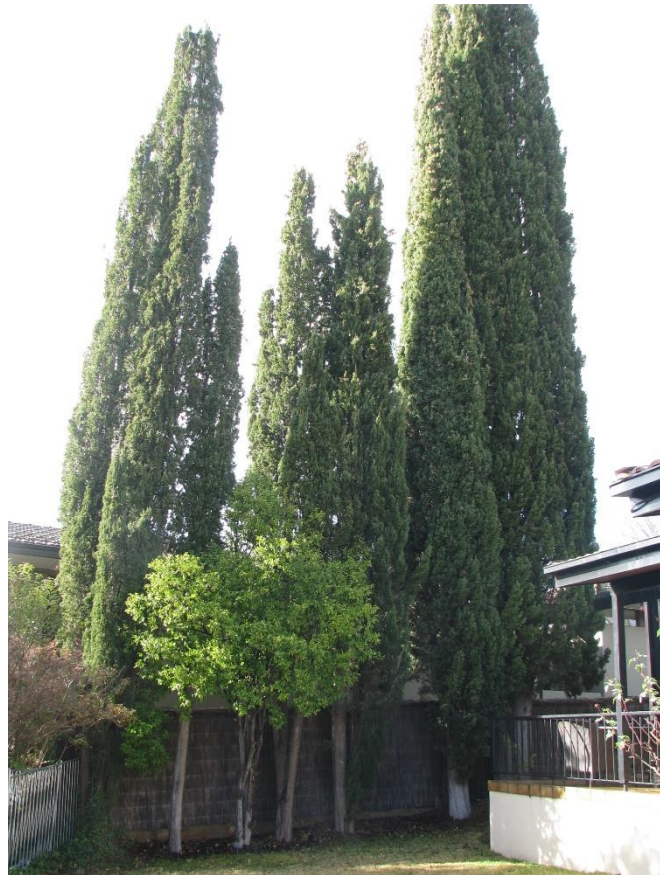
Figure 2 The row of Pencil Pines. Tree 1 is at left; Tree 6 at right. A small *Magnolia figo* is between Tree 3 and Tree 4.

- Roots from Trees 5 & 6 are disrupting the adjacent concrete footpath
- The root zone of these trees has been significantly reduced by deep excavation on the adjacent block: there is a retaining wall approximately 1m from the trees' trunks. The redevelopment of that block was carried out prior to 2012.

The trees are in good health despite the adjacent excavation; however, the excavations might compromise the trees' ability to withstand strong SE winds that occasionally occur in Canberra.
