Preliminary Tree Report. NCA Canberra Grammar School, Alexandria Drive, Yarralumla Bay

Site Address	Canberra Grammar School, Alexandria Drive, Yarralumla Bay, Yarralumla ACT. Block 3 Section 19.			
Client	Kent Peters M: 0412 029 146			
Contacts	E: <u>lucy@saarch.com.au</u> M: 041 823 7962			
Date	14 February 2018			
Author	Steve Griffiths, Level 5 Arborist, Treeworks			
Job #	422676

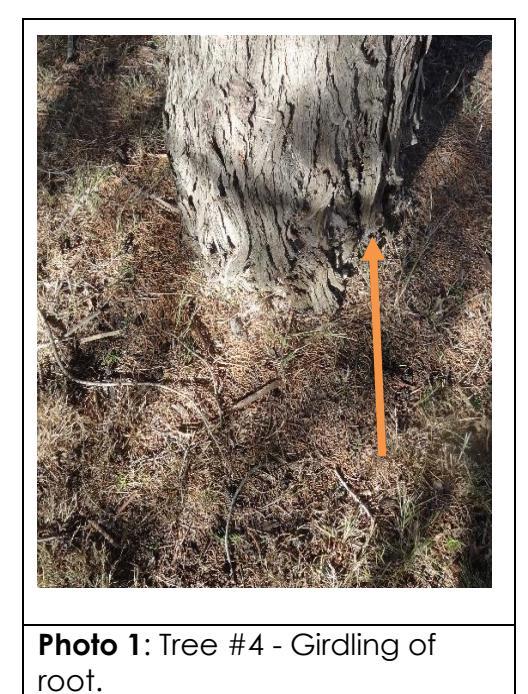
Girdling of Roots

Girdling of roots is where roots circle and ringbark themselves as they enlarge. Here in this photo on the left, shows as a flattening of the trunk (no trunk flare) in a section - see arrow. This could be a potential structural weakness and should be monitored in 12 months' time.

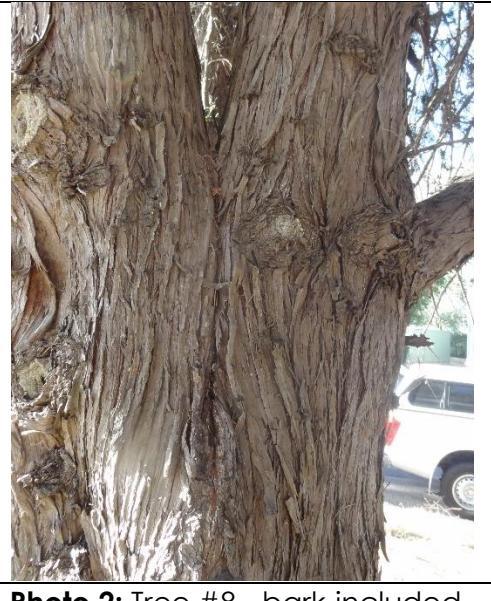
Photo 2: Tree #8 - bark-included forks or compression unions. Also found on Trees #2 and #3.

Poor Structure; Bark-included Forks

This photo shows Tree #8 with a possibly poor structured union. As the two trunks grow, an extra ring of wood is added to the thickened trunk thus separating apart. This disease is an abiotic disease.

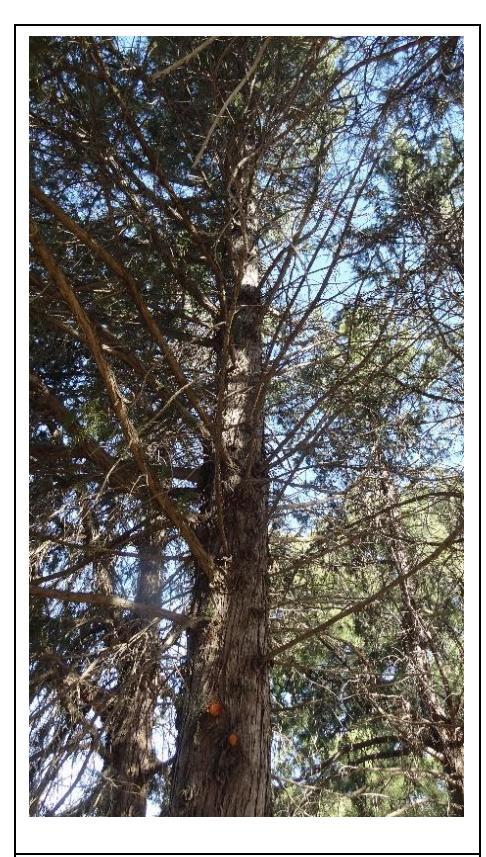
Photo 3: Tree #7 - dead branches in the tree caused by over planting.

Lack of Light Problems

This photo shows supression or lack of light, found in Trees #4, 5, 6 and 7, which is common in a forest type setting where branches that are no longer exposed to light die off, leaving the tree in a assymetrical appearance. Phototropism is another form of this abiotic disease where the tree's growth is towards the light. This can cause slender ratio problems, where structural strength is weakened. This is also common on the inner trees' of a forest setting. Tree #6 has a slender ratio near 42:1 (height by trunk diameter)
