5/61 Dundas Court PHILLIP ACT 2606
PROJECT
CSIRO HQ- CAMPBELL

LANDSCAPE MANAGEMENT AND PROTECTION PLAN (UNLEASED LAND)

TREE ASSESSMENT

TREE MANAGEMENT PLAN (LEASED LAND)

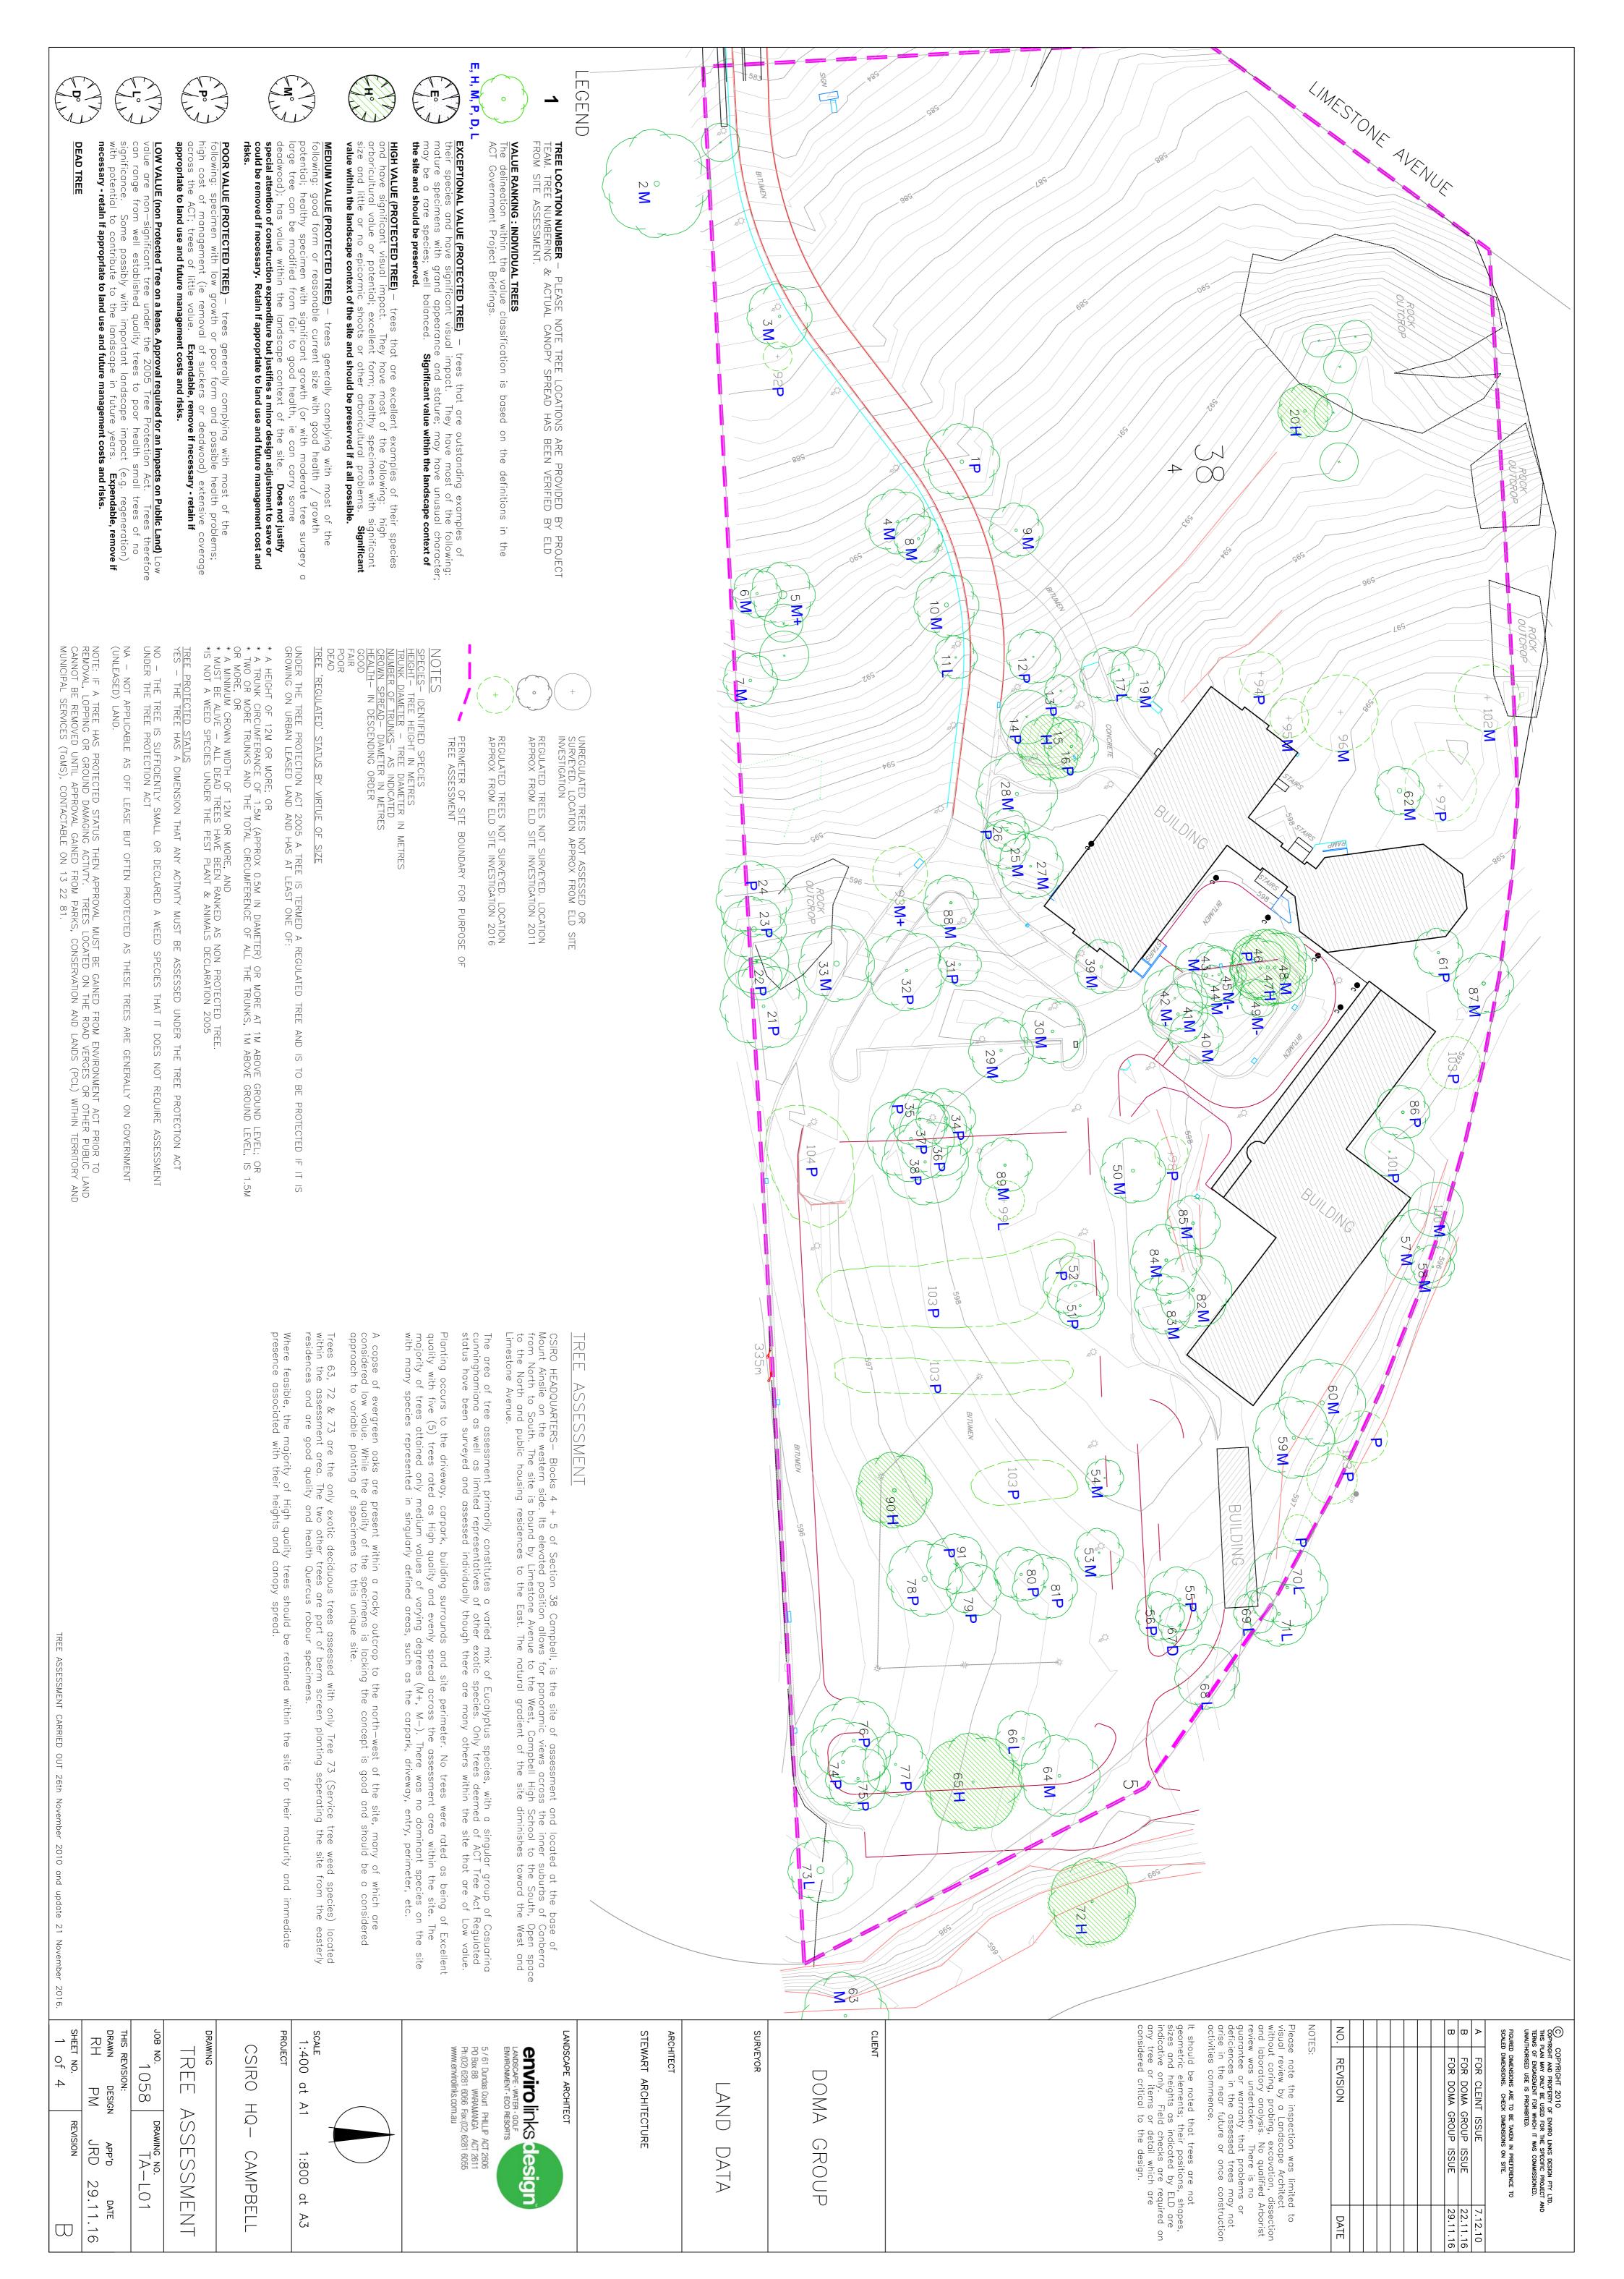
- little to no DW	P - DW to 50% of canopy	F - minor DW	P / F - minor DW	F - minor DW	F - minor DW	G - no DW present, broad open canopy			G - minor DW	F - minor DW	G	G - minor DW	G - minor DW	G - minor DW	F- Minor DW	F - Minor DW	F - minor DW	F - DW	G	F - DW	F - DW	F - DW	G - minor DW	F - minor DW	F - minor DW	F - minor DW	P - minor DW	G- little to no DW	G	F- Minor DW	F - minor DW	F	G - minor DW	G - little to no DW	G - minor DW	G - minor DW	P-DW	Health and Vigour (G- good, F-fair, P-poor, DW- deadwood)
of 5 limbs, dieback to 50% canopy located close to building	pparent	Occluded fork	Kino, poor form & canopy structure	Coppice shoots, poor form	Coppice shoots, poor form	Forks @ 900 AGL, Occluded fork, limbs grown together	apparent	none apparent	Occluded fork, kino, multi limbs previously removed but good form	fork	DW stump occuring in upper limb where enveloped by growth	none apparent	none apparent	Occluded fork	lean to trunk, poor form overall due to close proximity of planting	lean to trunk, poor form overall due to close proximity of planting	to trunk, poor form	ack occur	Sprawling form with lower limbs hanging to GL	Minor dieback occuring	Lean to south	Minor dieback occuring, occluded fork	Occluded fork, open canopy, good form	none apparent	none apparent	apparent	Minor kino, previously pruned limbs resulting in reduced canopy	forks at 1.2m AGL - Minor Dead Wood	Occluded fork, 15 degree lean to south	Minor Dieback occuring to upper canopy	none apparent	none apparent	2-3 minor lower DW limbs	minor kino present	none apparent	Tightly forked	Extensive Cockatoo damage at forks	Structural defects and decay

0 1 0	none apparent	none apparent	e none apparent	none apparent	none apparent	none apparent	none apparent	none apparent	none apparent	none apparent	none apparent	none apparent	Scar at base up to 1m height, borer holes present	Scar at base, borer holes present	none apparent	none apparent	none apparent	none apparent	Bark loss and scarring at trrunk base, animal diggings	scarring at base	none apparent	none apparent	none apparent	none apparent	none apparent	none apparent	minor scarring at base of trunk	none apparent	exposed suface roots	none apparent	none apparent	none apparent		past use fencing wire enveloped by lower limb	none apparent	none apparent	limb loss, possible hollow in trunk	Past Damage or root disturbance
Z Z	N A	Z A	N A	NA	NA	N A	N A	NA	NA	N A	NA	NA	Boreers	Borers possible	minor scale / lerp attack	minor scale / lerp attack	minor scale / lerp attack	minor scale /	Z	NA	N _A	NA	NA	N A	N A	NA	NA	NA	N A	NA	minor scale /	minor scale / lerp attack	minor scale / lerp attack	NA	NA	NA	NA	Disease or infestation
