**HERITAGE MANAGEMENT PLAN  
FOR THE  
YORK PARK NORTH OAK PLANTATION  
BARTON ACT**

Prepared by  
**Duncan Marshall AM**  
and with assistance from  
**Matt Badham (Arbor Management Australia)**

for the  
**National Capital Authority**

**2022**

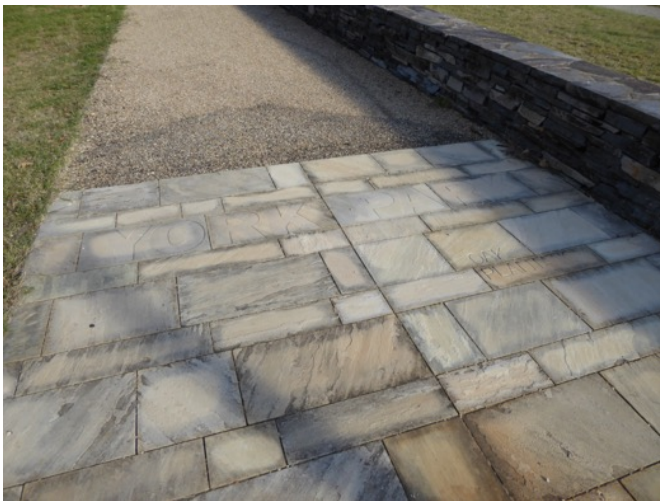
**Figure 17. Stone entry paving to plantation with carved name at the northwest corner**  
Duncan Marshall 2021

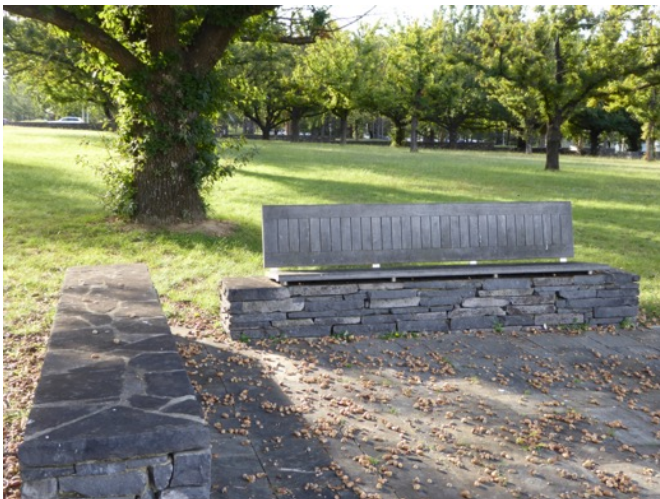
**Figure 18. Example of stone walling and timber seating**  
Duncan Marshall 2021

Within the plantation are several seating areas formed by stone walls and timber seats, along with several stainless steel and Corten interpretative/commemorative signs.

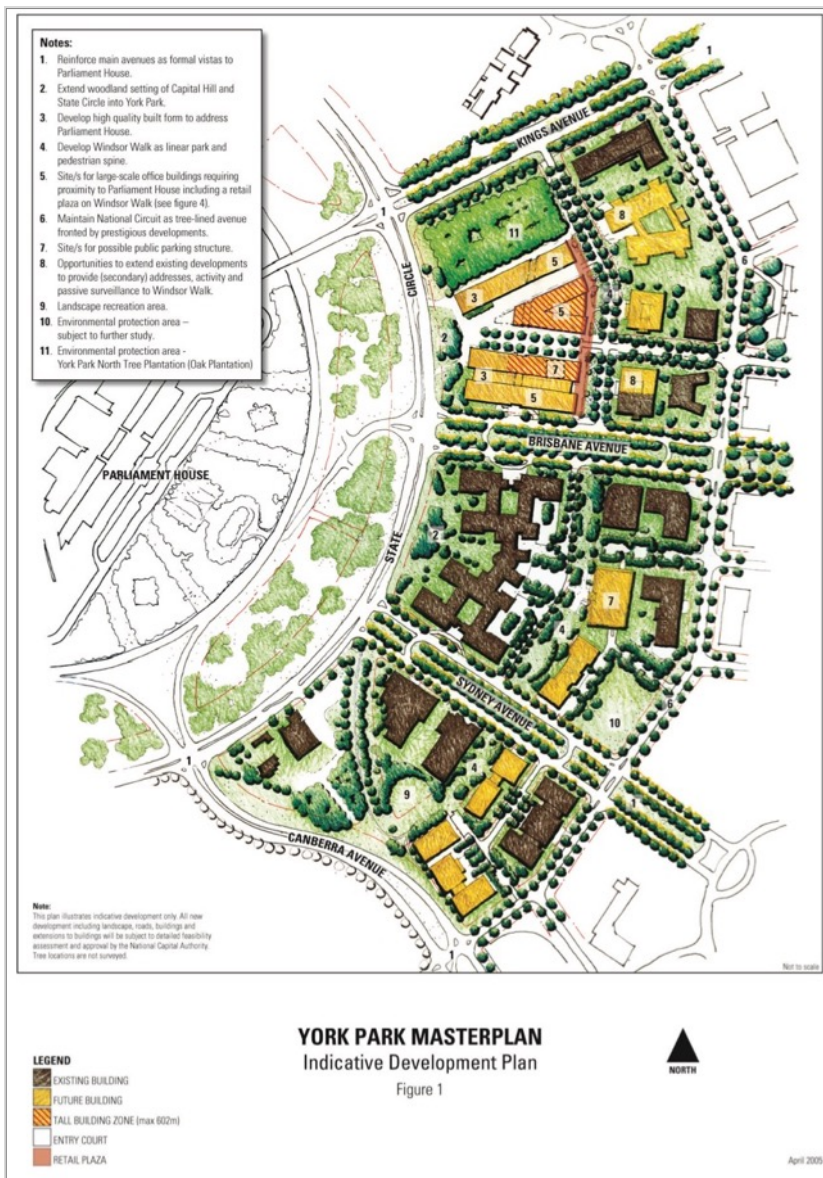
**Figure 35. Indicative Development Plan for York Park**

The National Capital Plan includes an indicative development plan for the overall York Park area, as below. The indicative development plan includes the possibility of a building development to the south of the plantation.

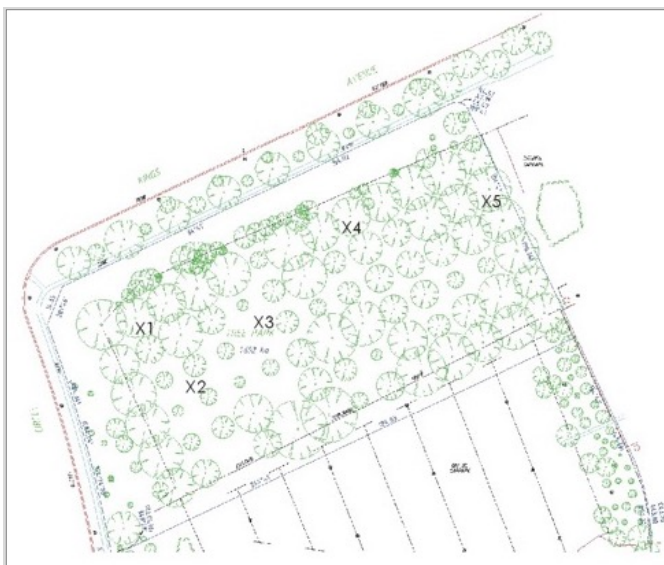
**Figure 39. Location of soil profiles**  
Source: Base drawing by Earth Tech

The soil data does not shed any light on the decline of the condition of the oaks in the centre of the site. The two profiles in the area of poor oak condition vary little from the profiles in the area where the oaks are in good condition. There are no impeding layers for plant roots, and no features which would significantly impact on soil moisture availability. Indeed, profile 5 which was relatively shallow and gravelly, and would have much lower moisture holding capacity is in an area where the oaks are in good condition.
