Light Rail Stage 2A

Environmental Assessment – Contamination

15th December 2022

Project No.: 0527116

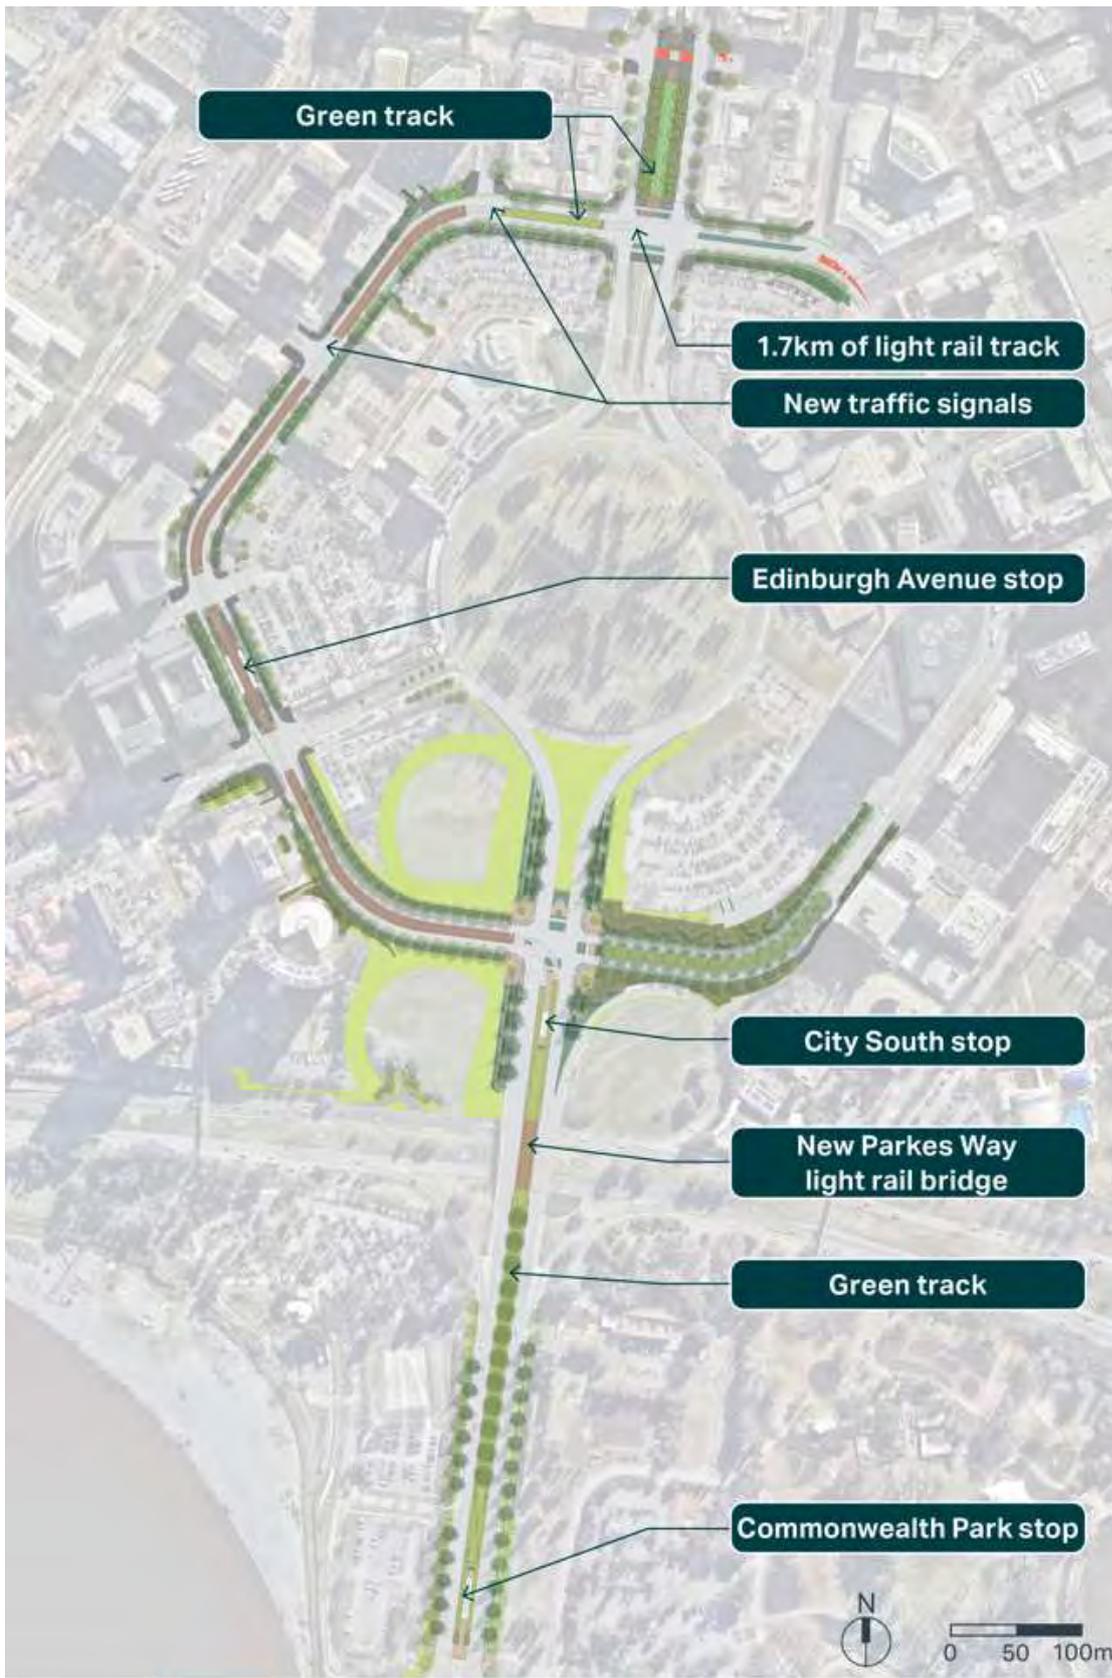
Figure 1 – The Project and Key Features

The completed Project, including its key features and elements, is shown on **Figure 1** below.

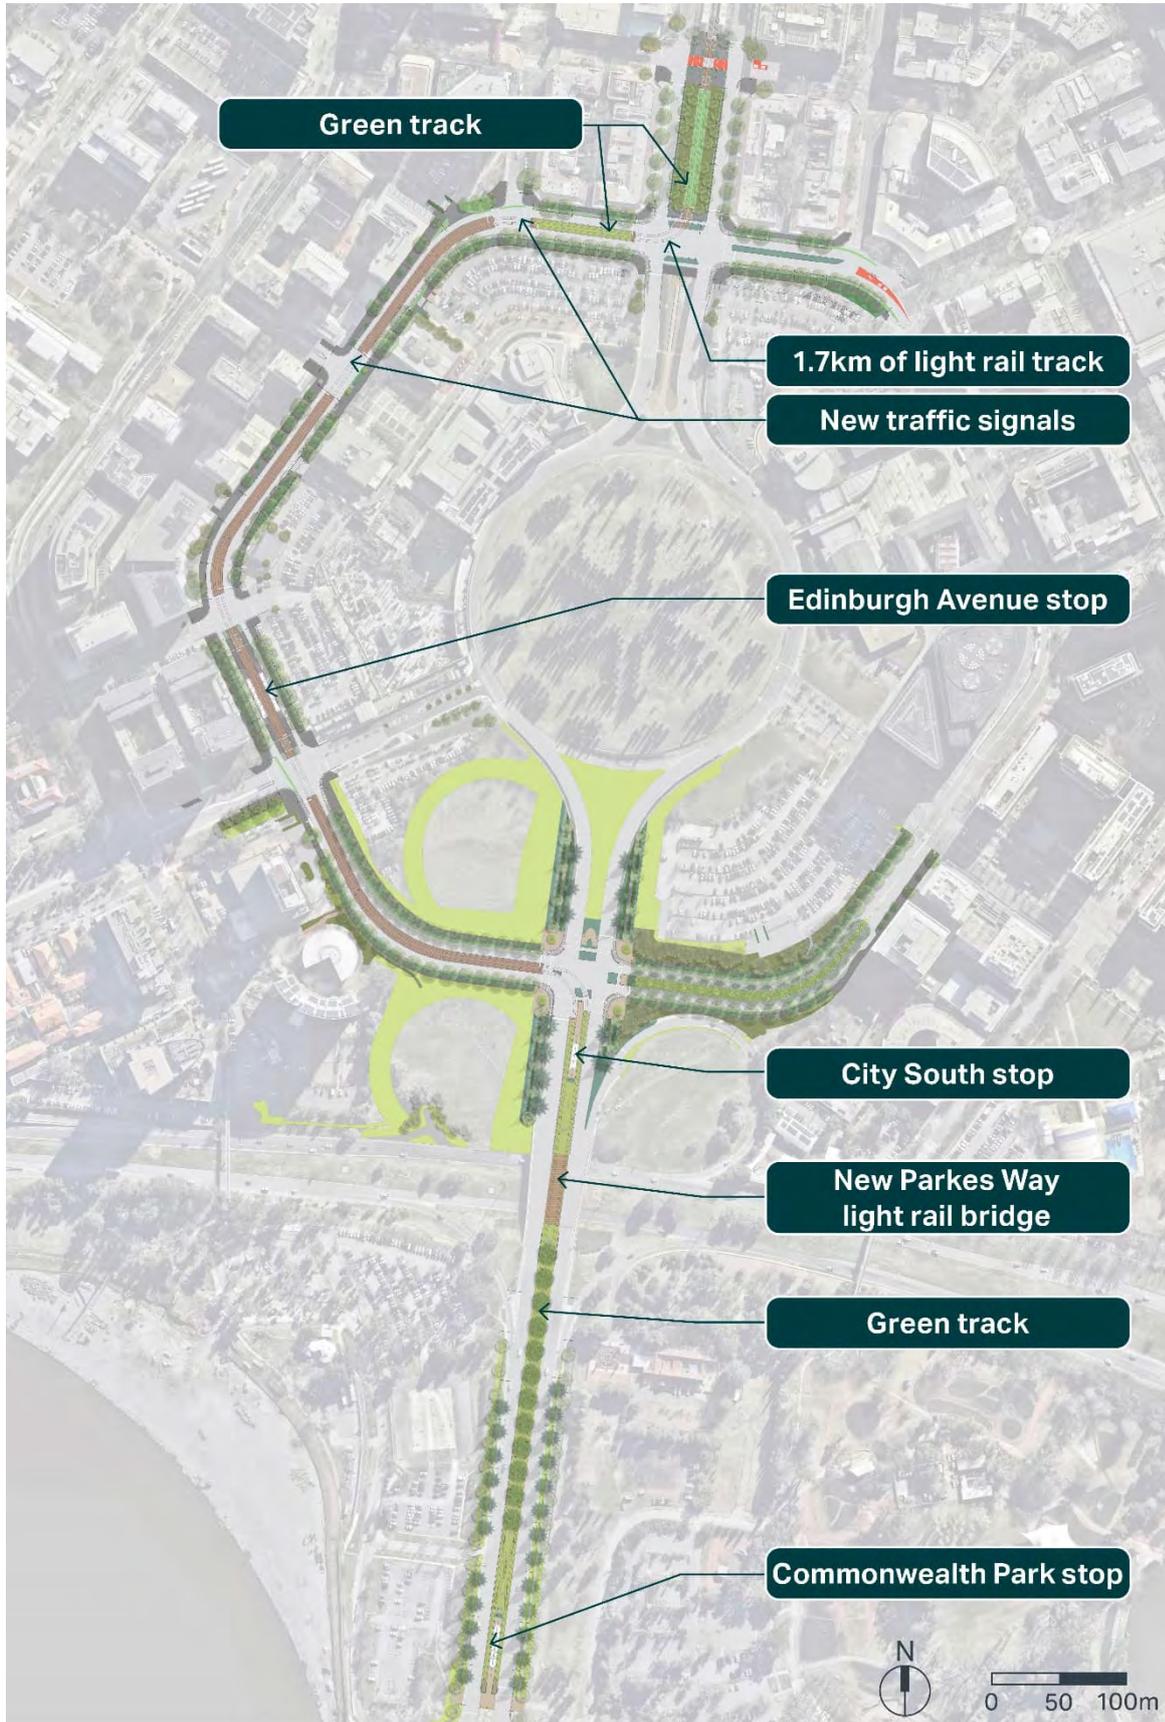
Figure 1 The Project and its key features

The completed Project, including its key features and elements, is shown on **Figure 1**.

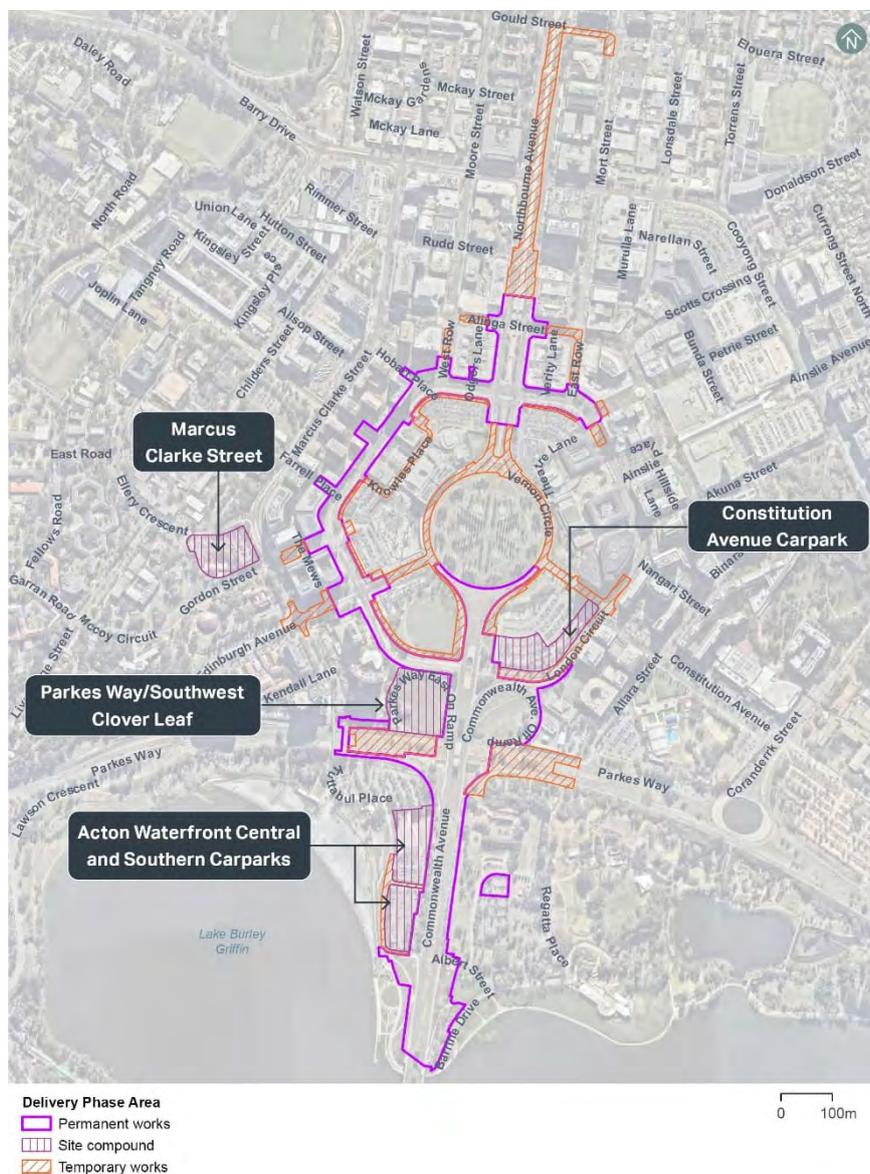
Figure 2 Delivery phase area

Construction activities associated with the Project would occur within a footprint referred to as the 'delivery phase area' (**Figure 2**). The operation of the Project would occur within a subset of the delivery phase area. The delivery phase area includes both Designated Land and Territory land. This Assessment addresses the Project in its entirety to allow for consideration of the Project as a whole.

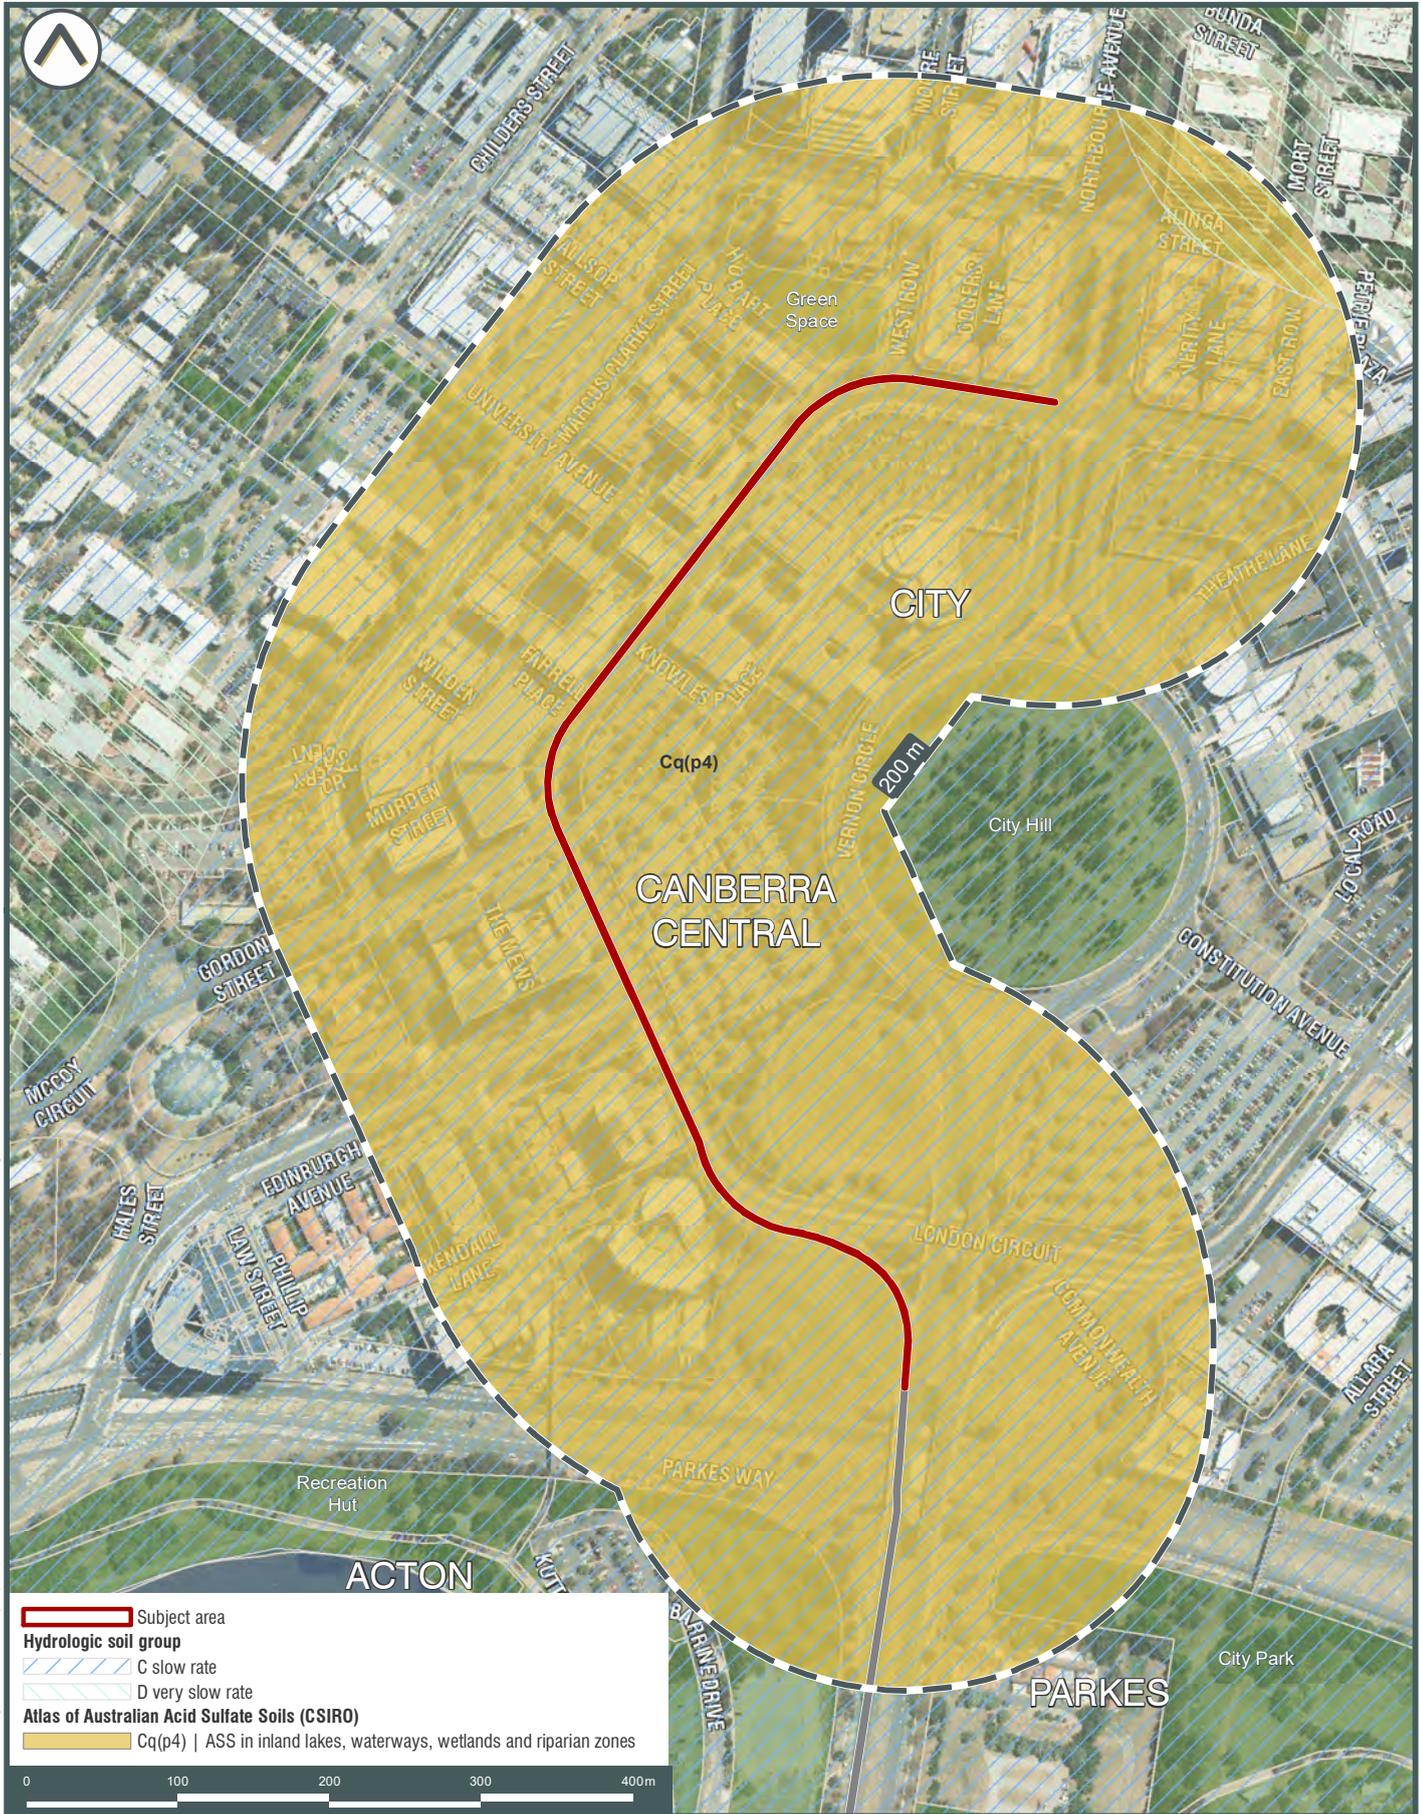
ATLAS OF AUSTRALIAN ACID SULFATE SOILS AND SALINITY

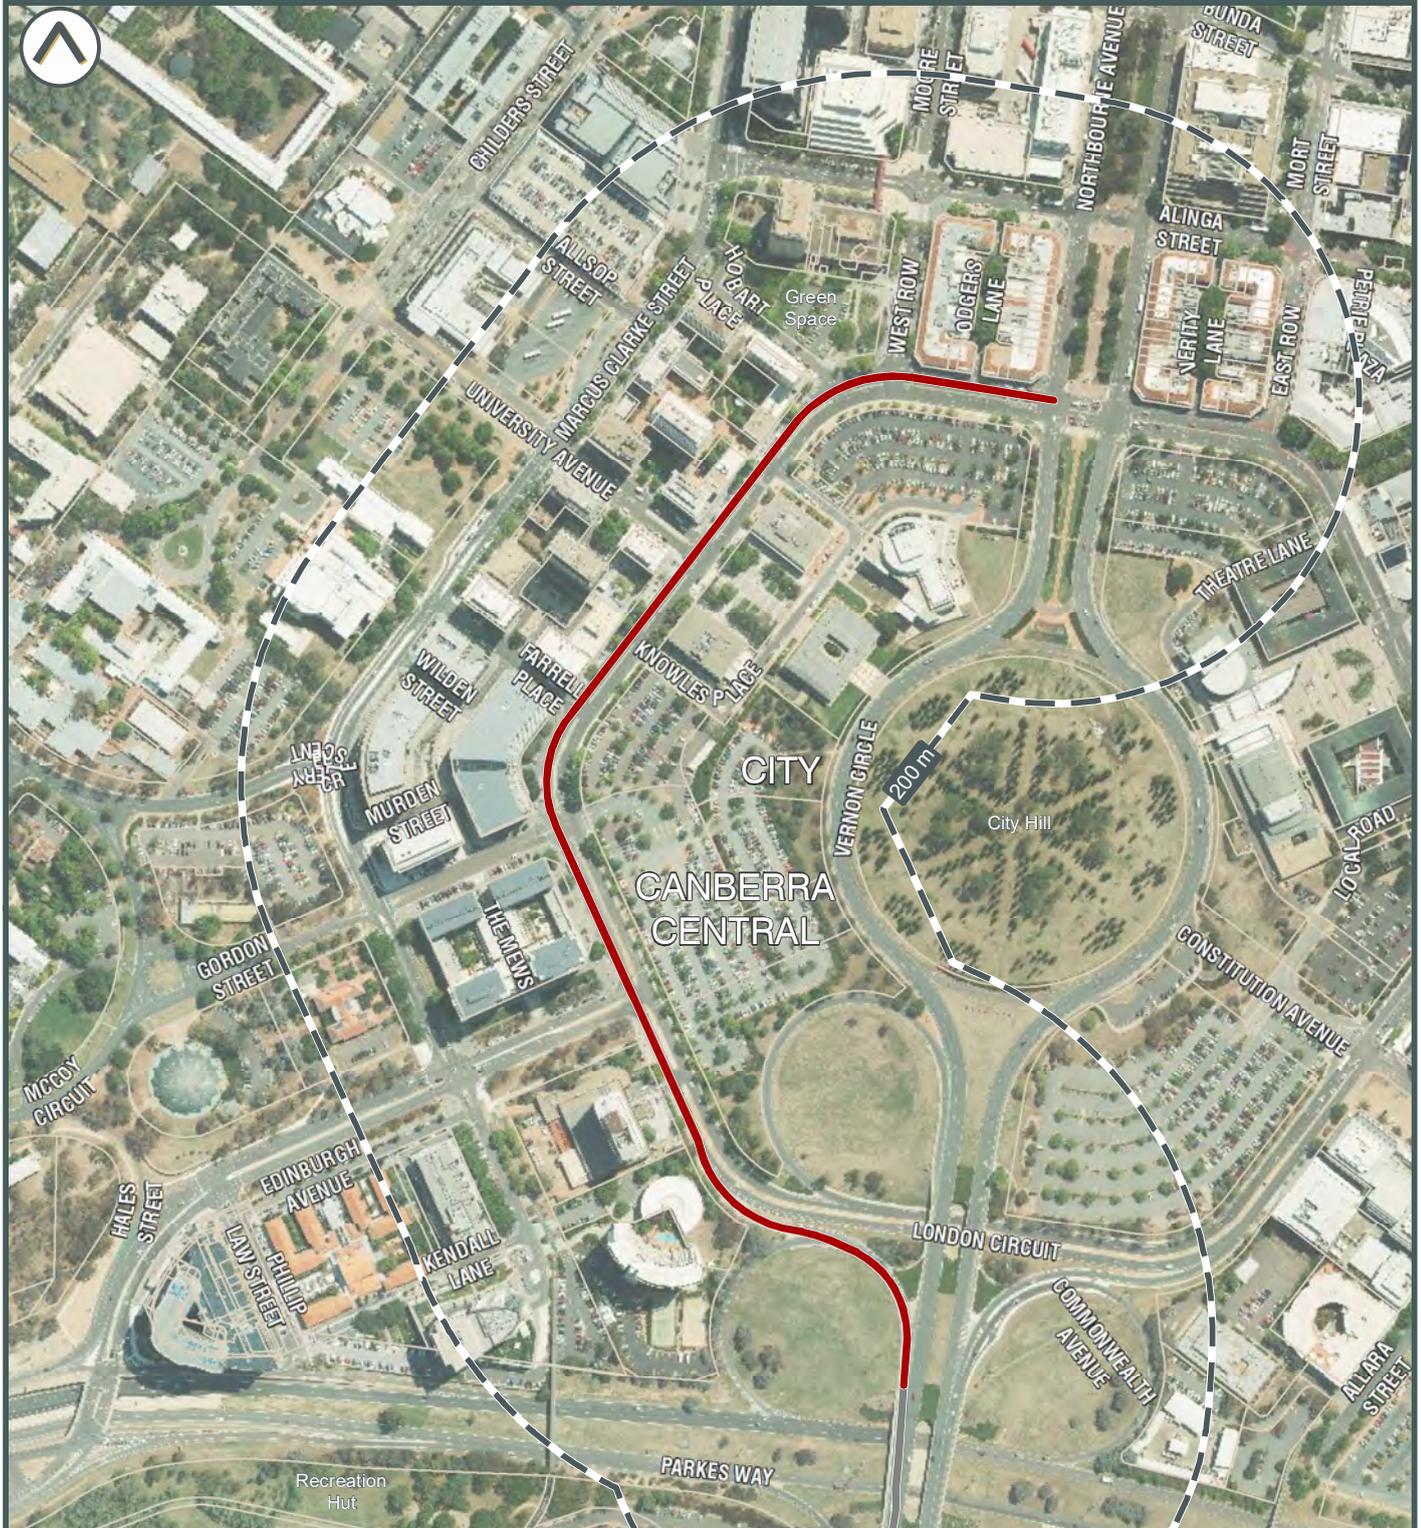
POTENTIALLY CONTAMINATING ACTIVITIES

Subject area		Aviation fuel depots		Dry cleaners		Substation locations
	Historical (Legacy) Landfills		Aviation rescue and fire fighting facilities		Liquid fuel depots		Telephone exchanges
	Operational Service stations		Cattle dip		Liquid fuel terminals		Waste management facilities
	Former Service stations		Derelict mine/quarry		Power stations		Wastewater Treatment Facility

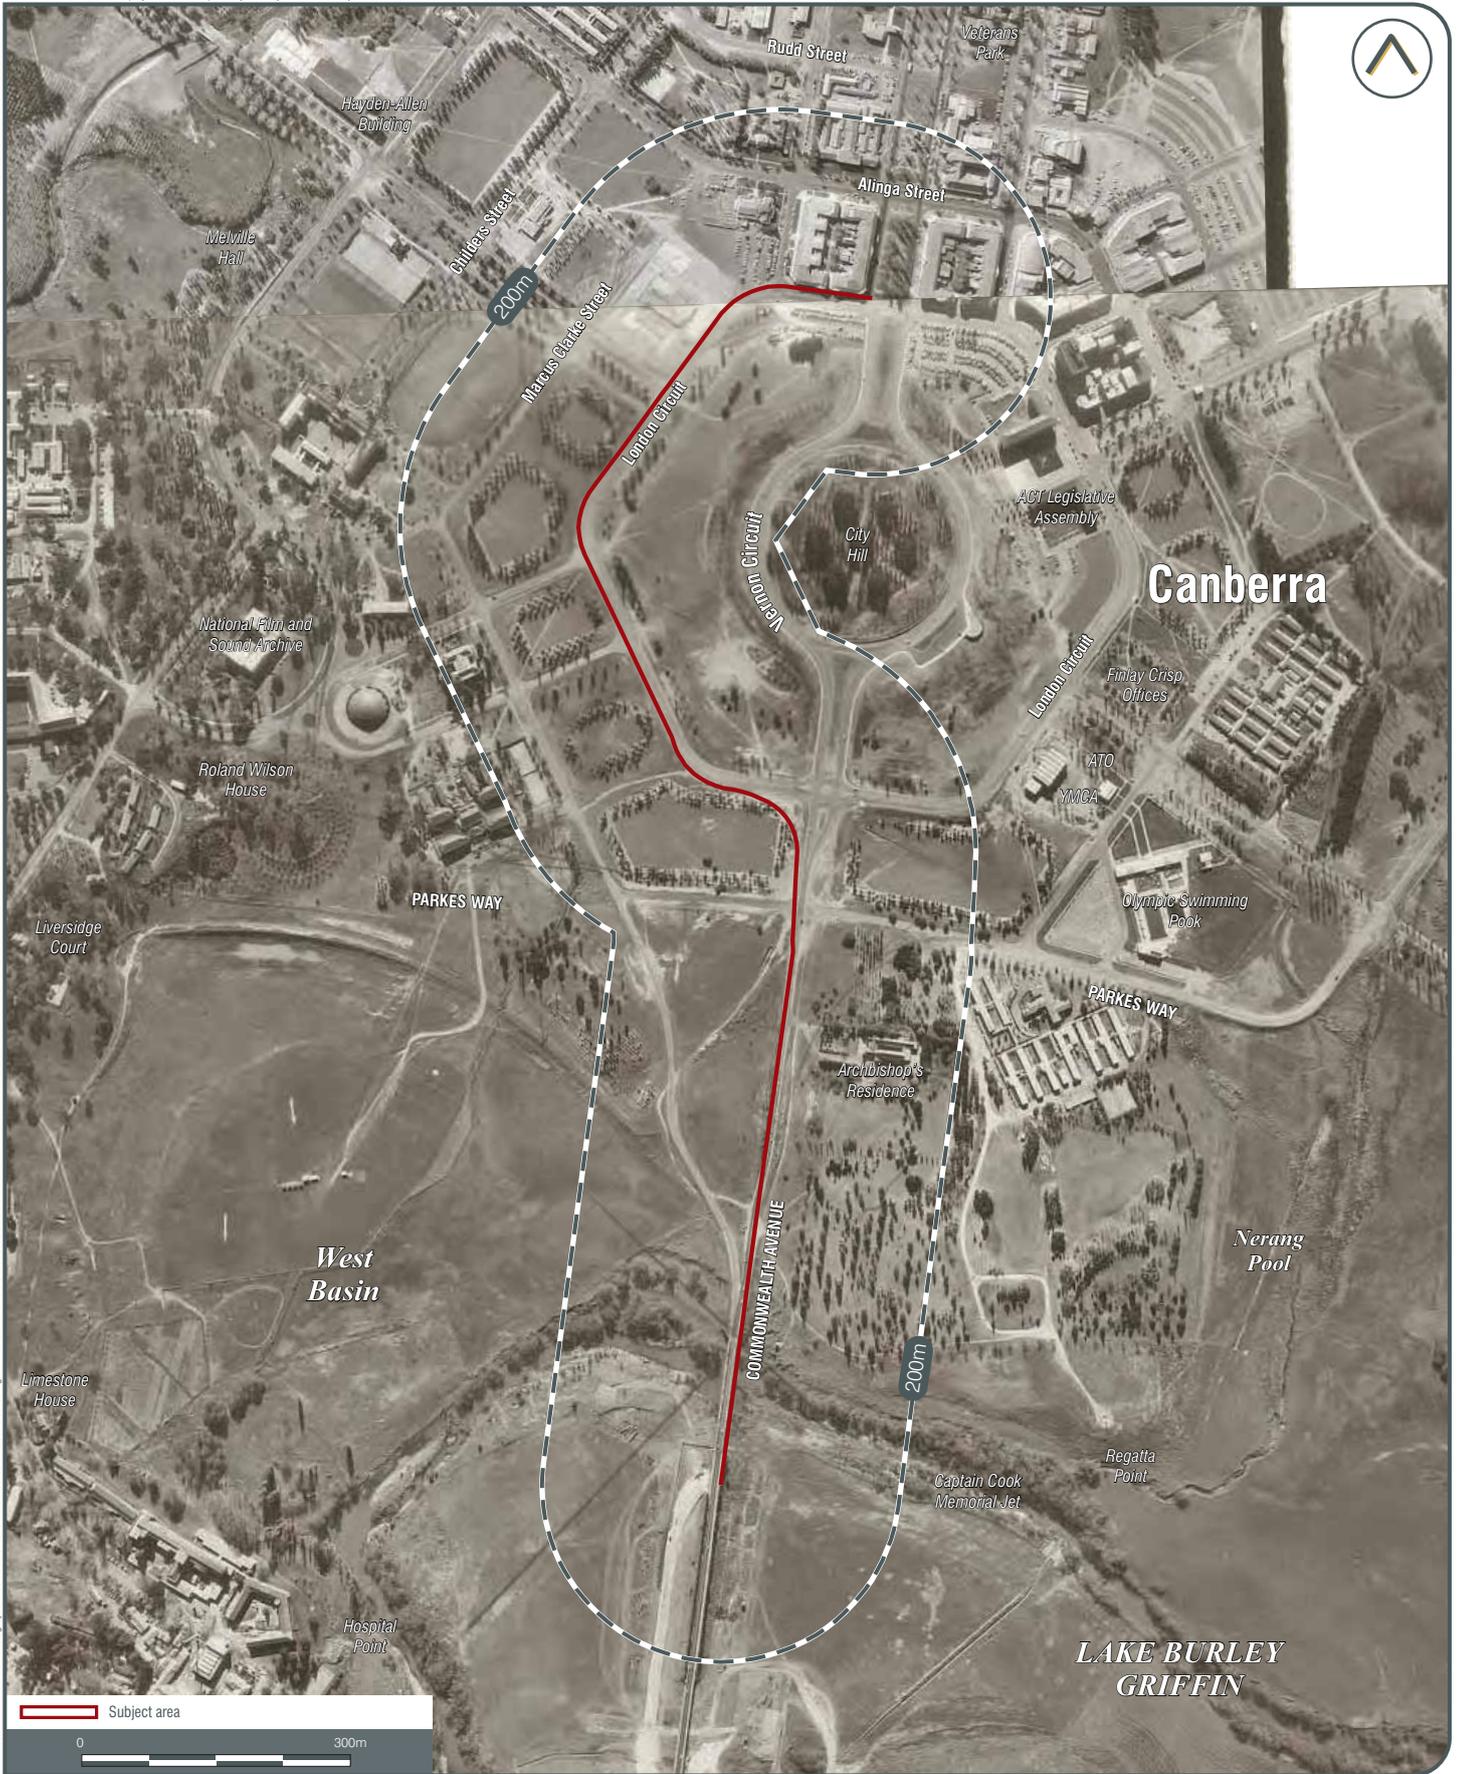
LIR-00892: Historical Aerial Photograph - 1961: 08:10:2019. Data source: Please refer to 'Digital Data Sources' in the Product Guide

HISTORICAL AERIAL PHOTOGRAPH - 1961

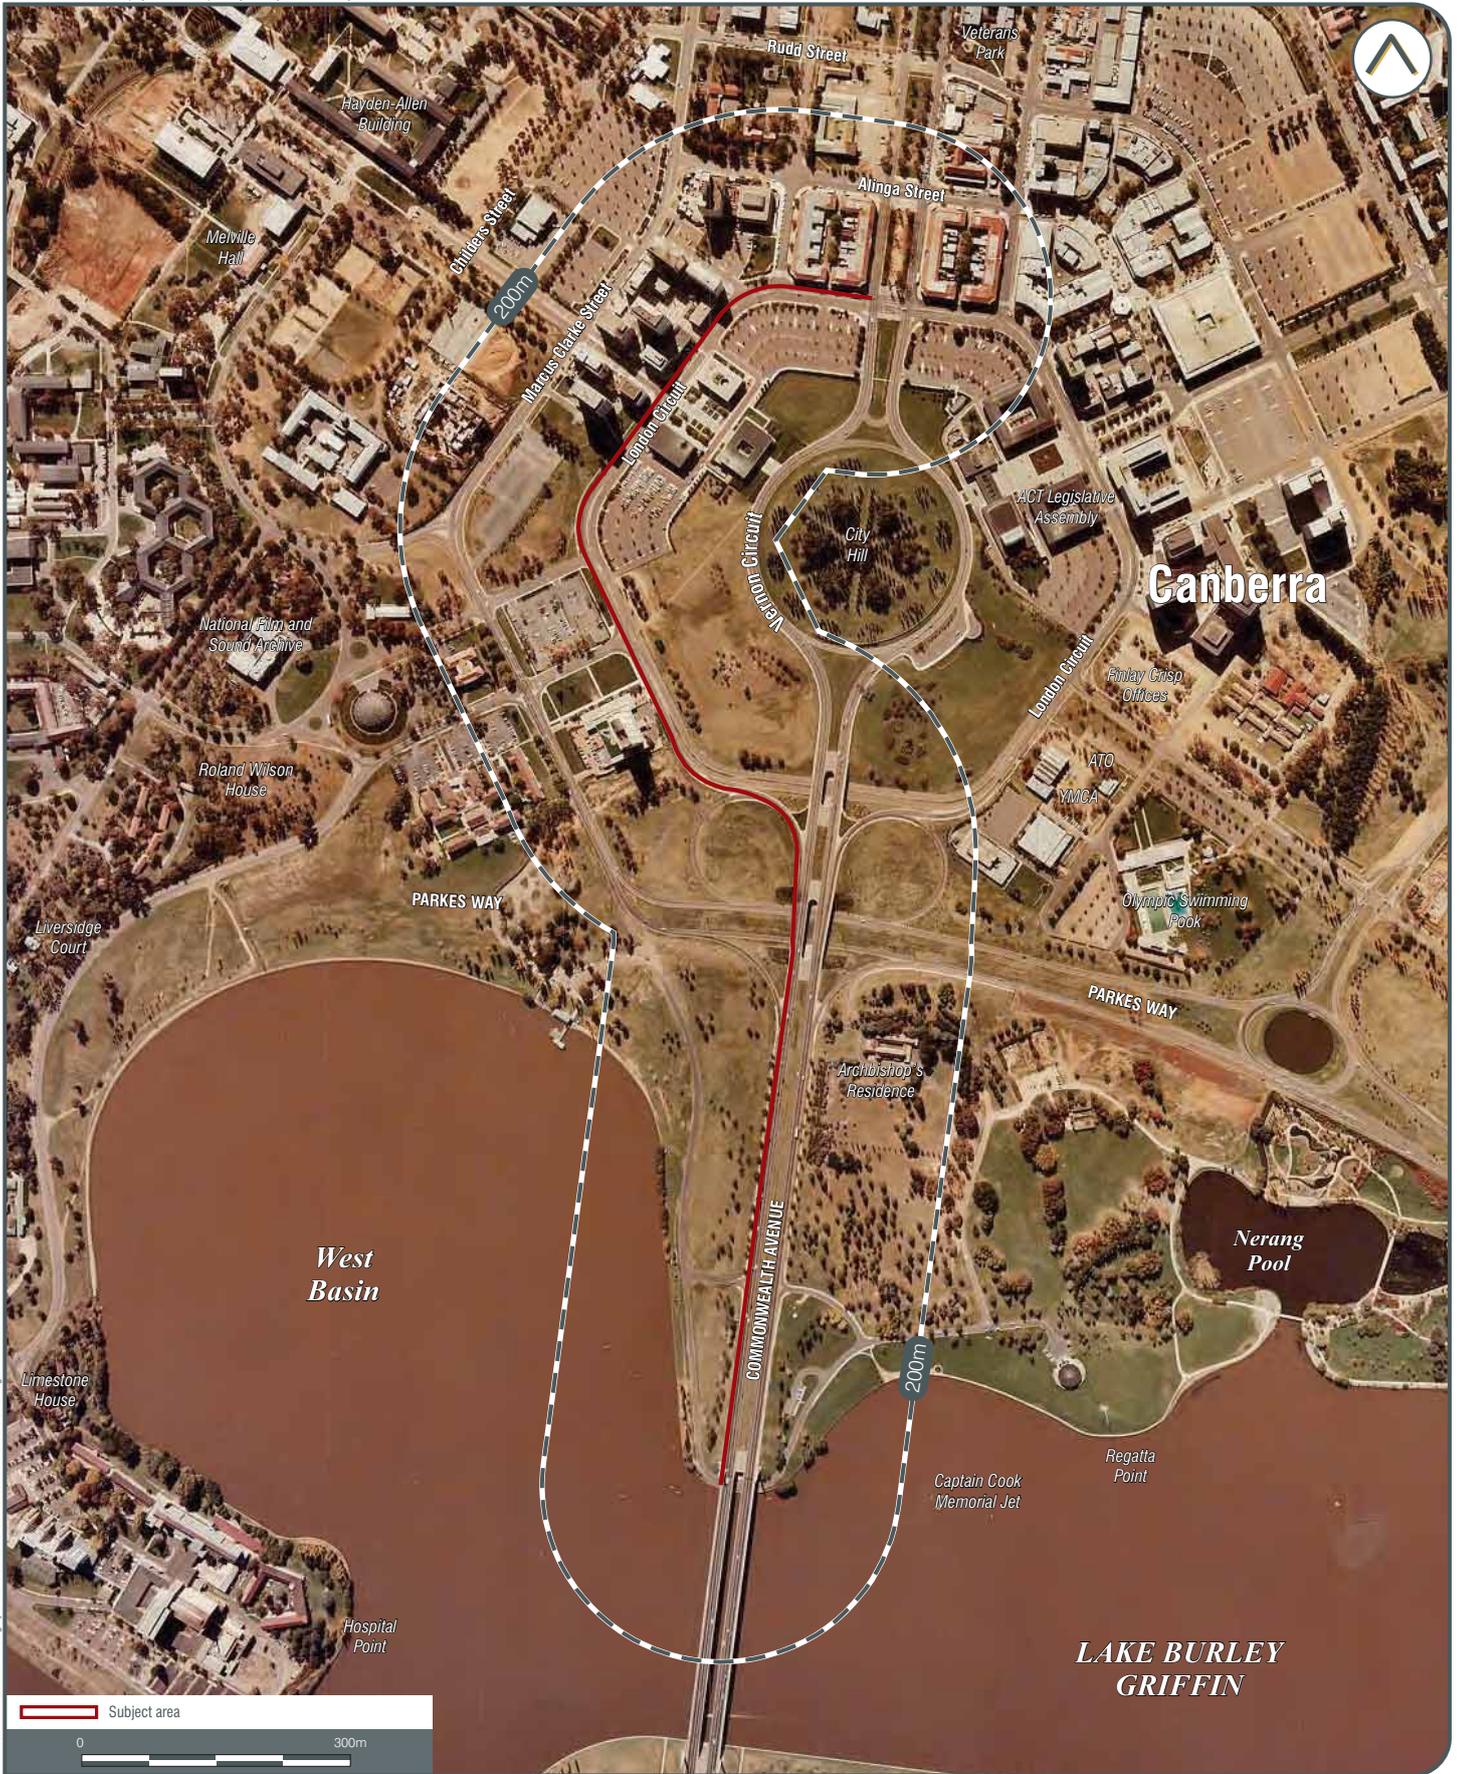
LIR-00892: Historical Aerial Photograph - 1975.08.10.2019. Data source: Please refer to 'Digital Data Sources' in the Product Guide

HISTORICAL AERIAL PHOTOGRAPH - 1975

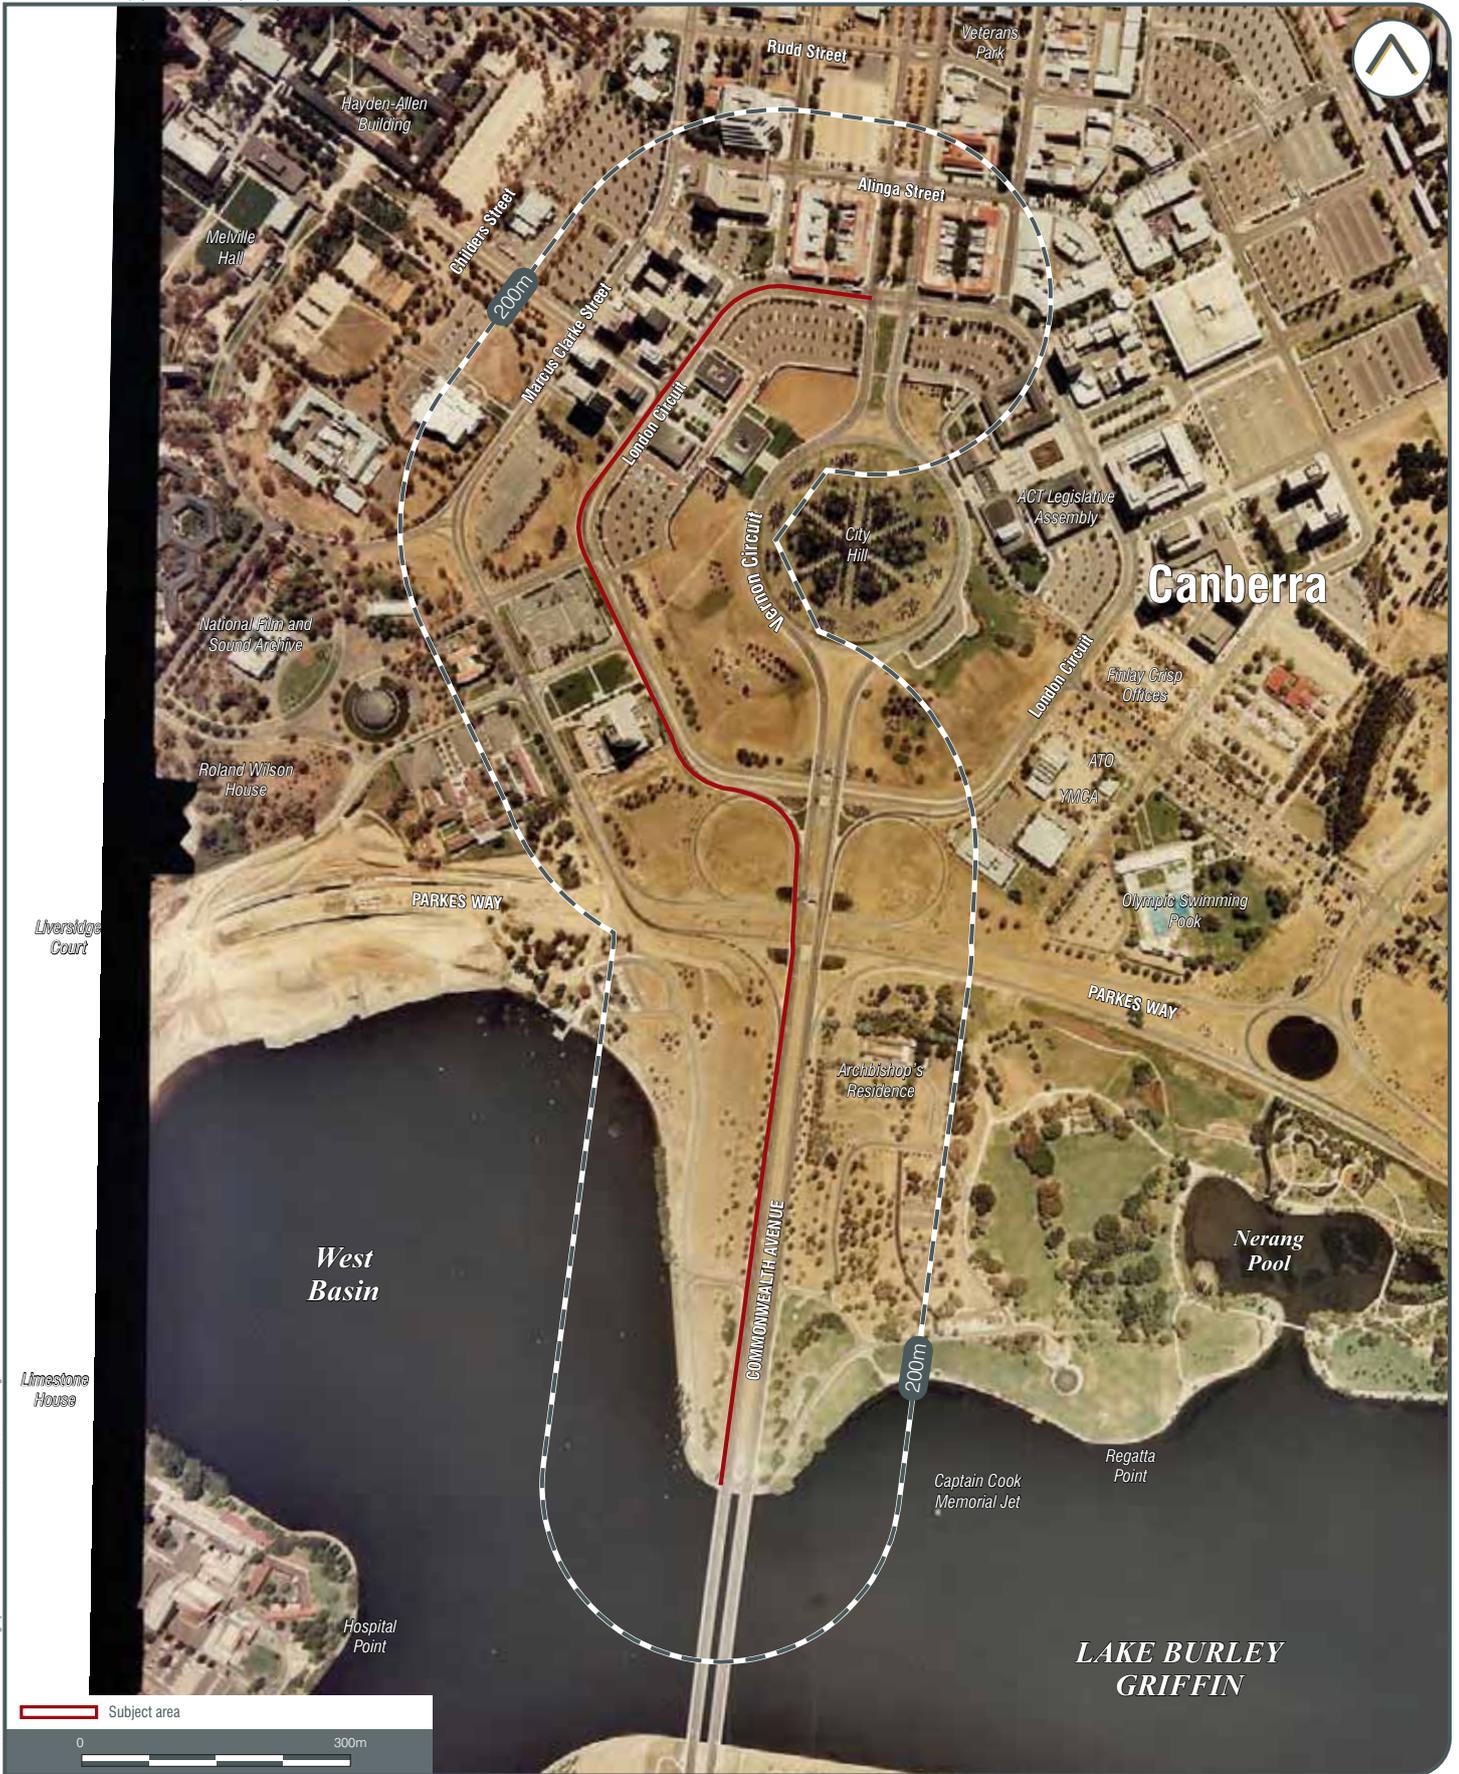
LIR-0082: Historical Aerial Photograph - 1978.08.10 2019. Data source: Please refer to 'Digital Data Sources' in the Product Guide.

HISTORICAL AERIAL PHOTOGRAPH - 1978

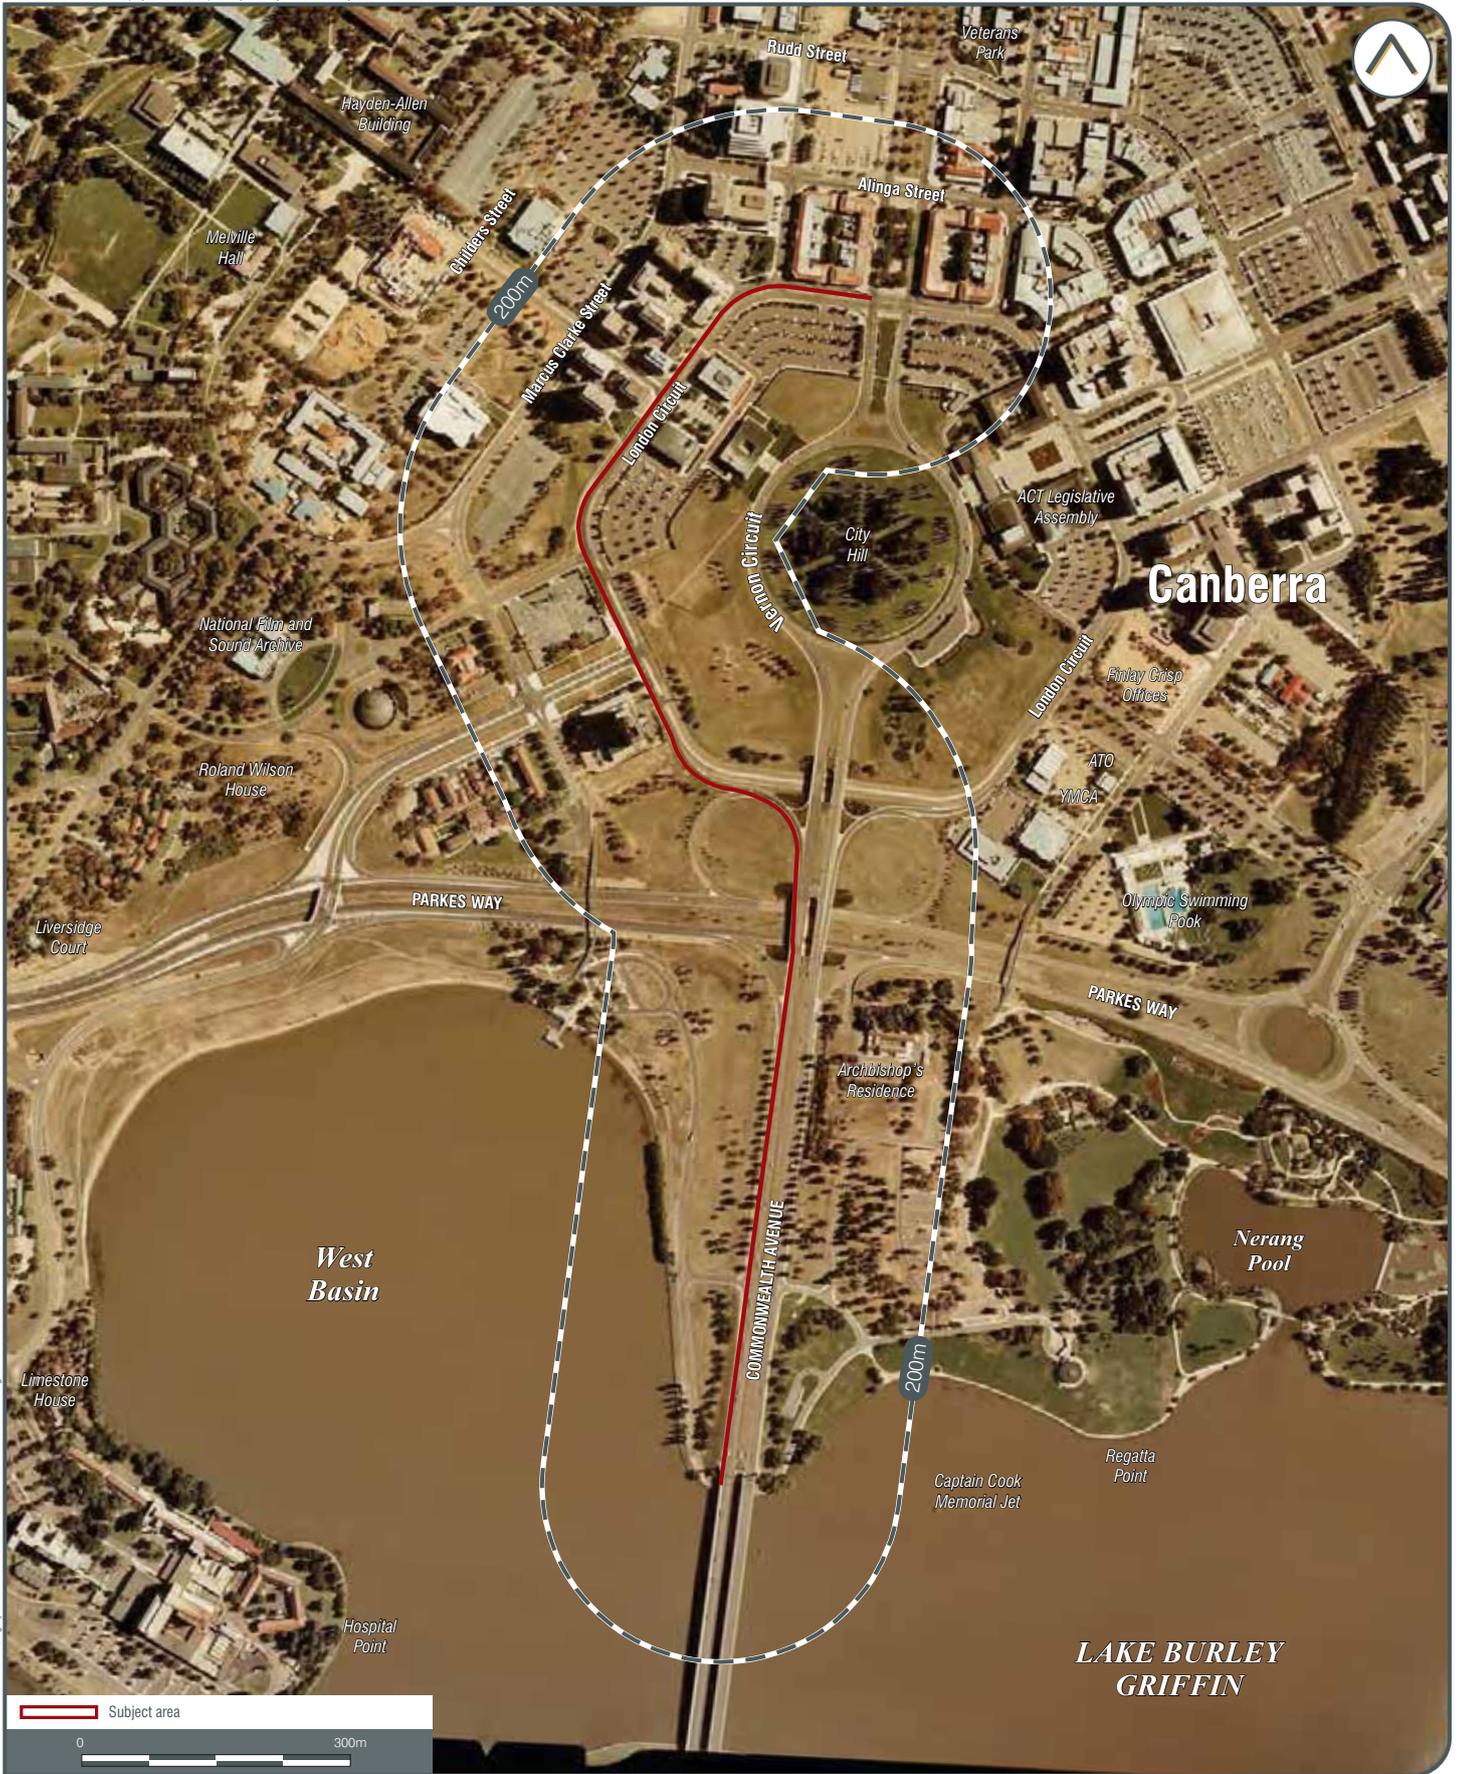
LIR-0082: Historical Aerial Photograph - 1980.08.10 2019. Data source: Please refer to 'Digital Data Sources' in the Product Guide.

HISTORICAL AERIAL PHOTOGRAPH - 1980

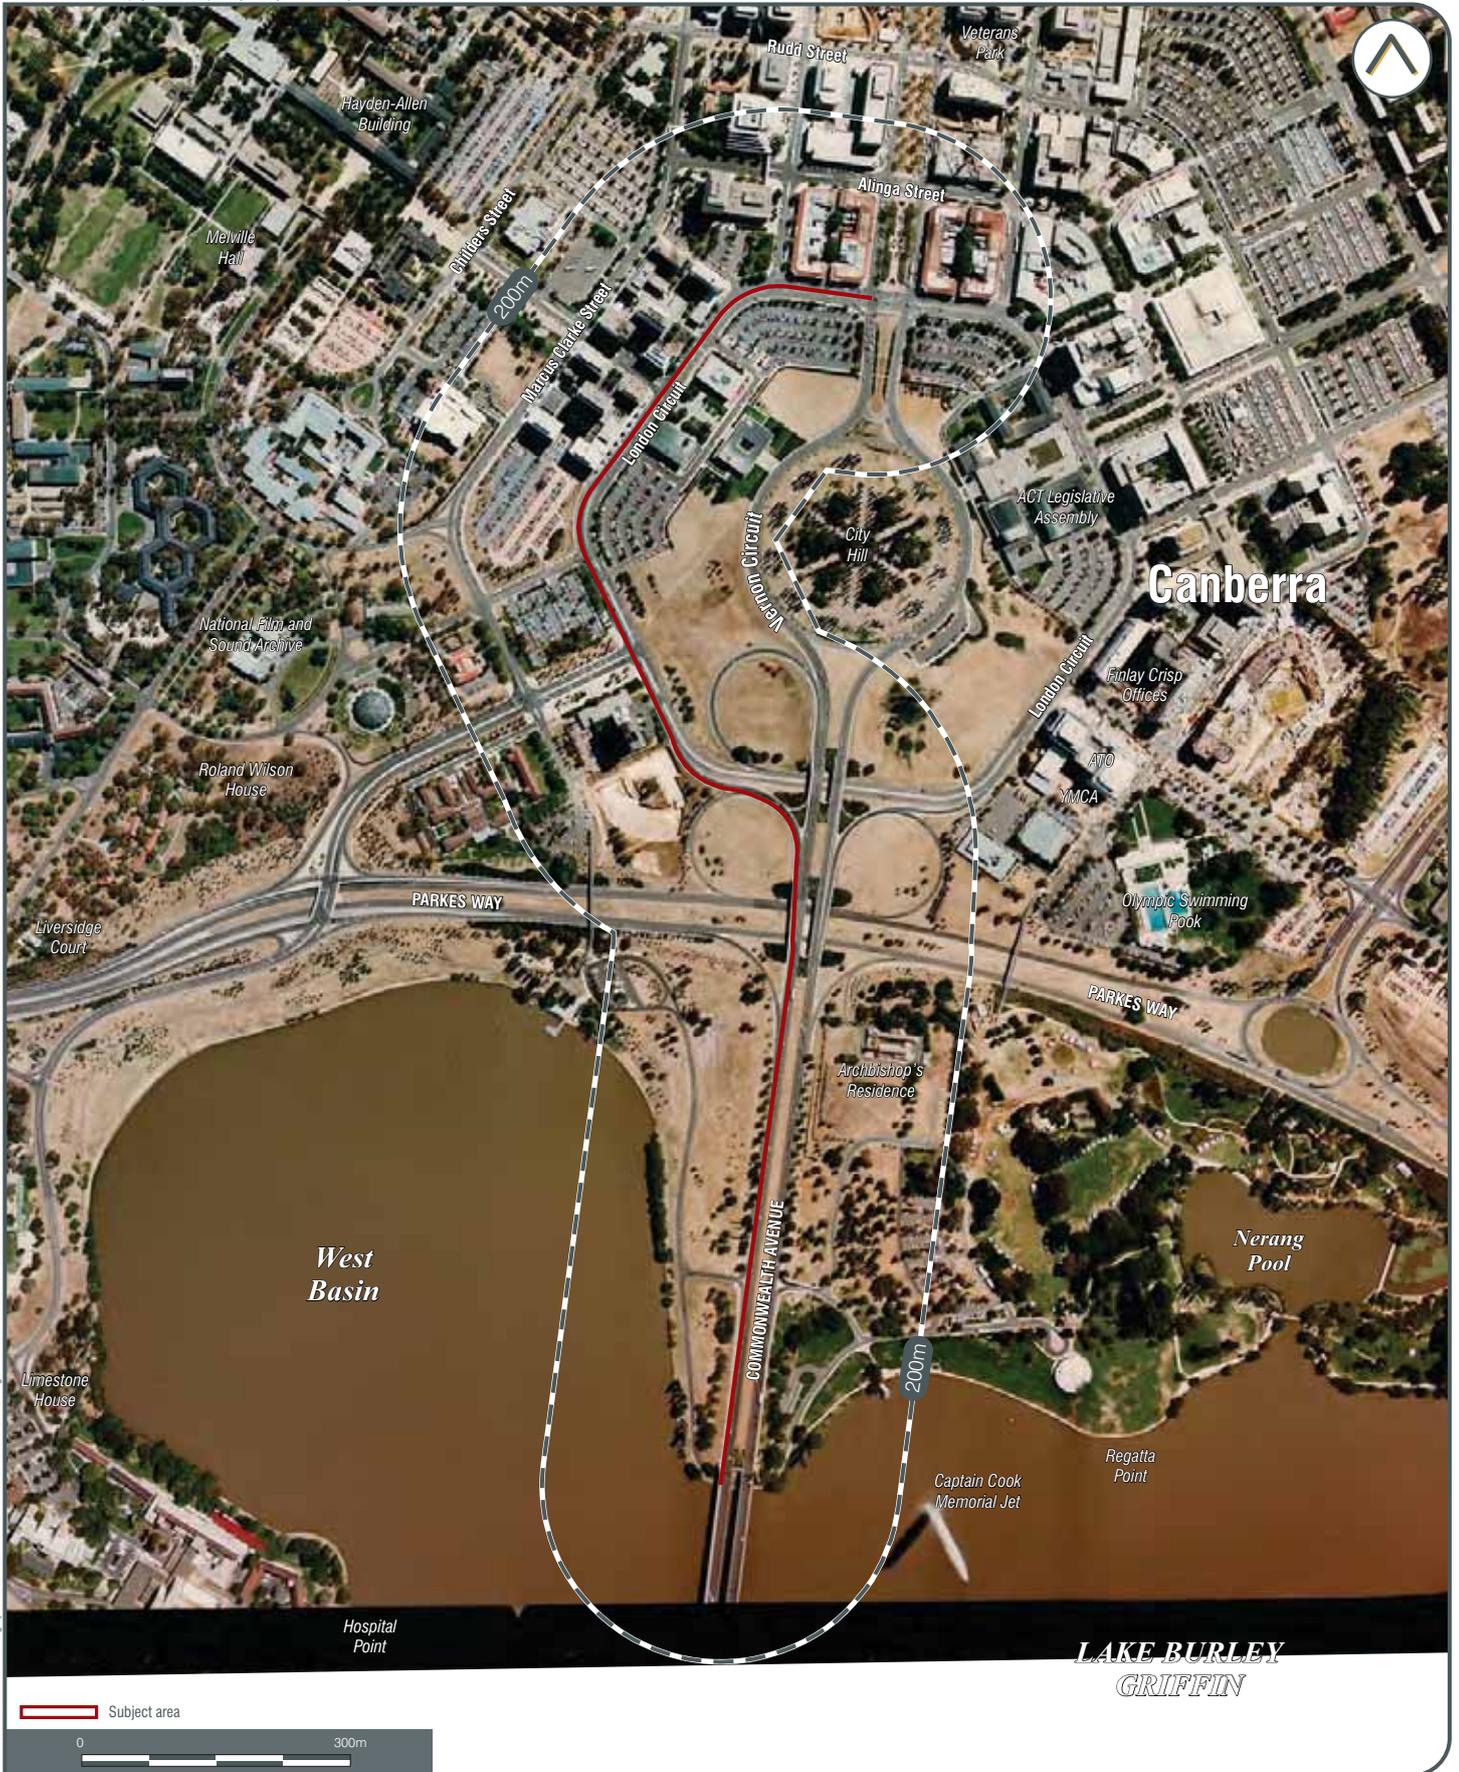
LIR-00892: Historical Aerial Photograph - 1986.08.10.2019. Data source: Please refer to 'Digital Data Sources' in the Product Guide

HISTORICAL AERIAL PHOTOGRAPH - 1986
