Light Rail Stage 2A

Environmental Assessment – Contamination

15th December 2022

Project No.: 0527116

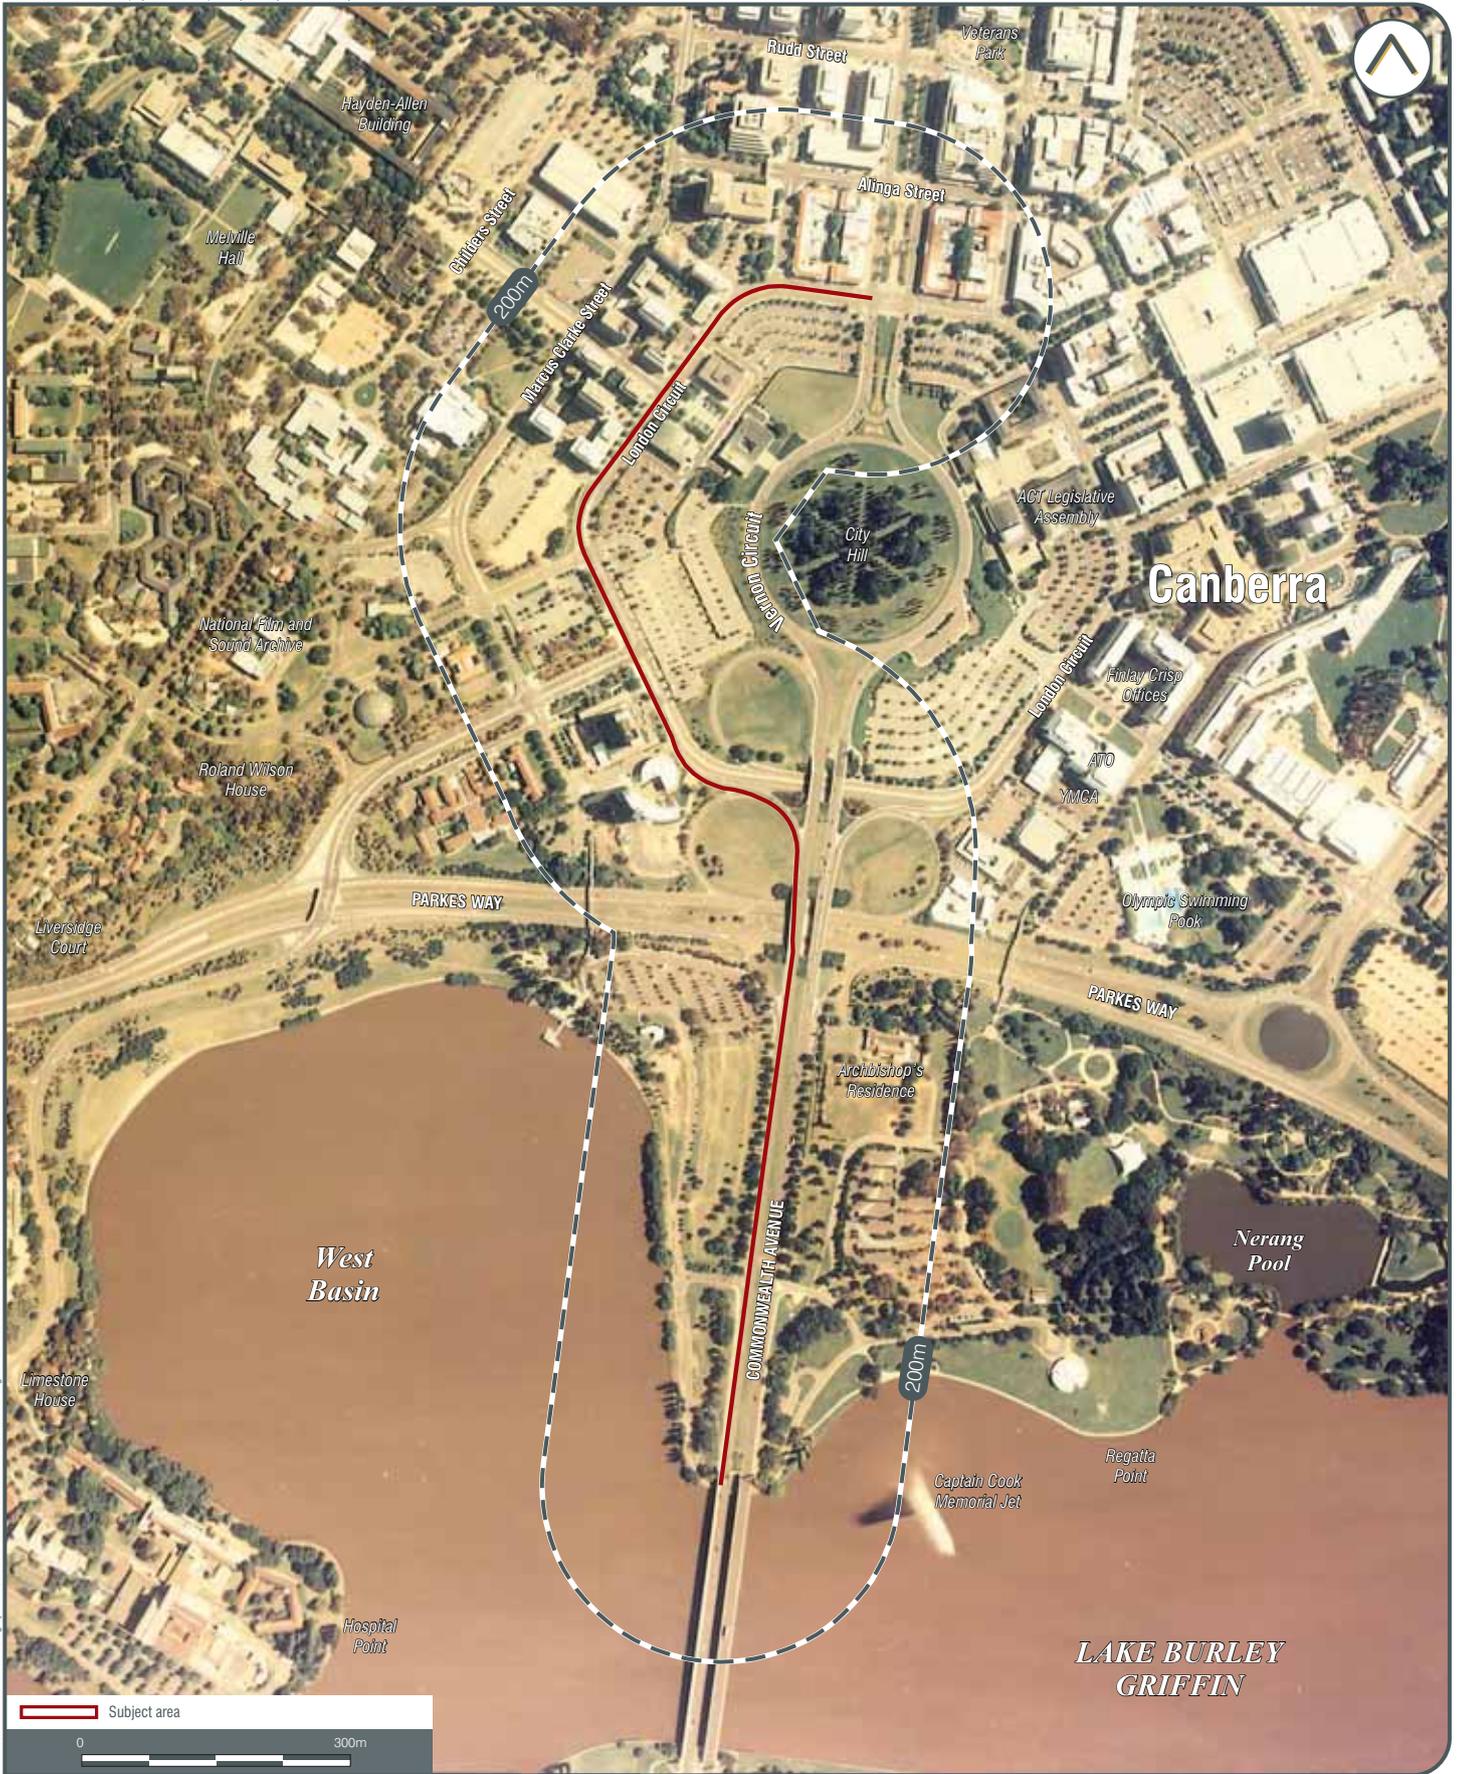
LIR-00892: Historical Aerial Photograph - 1993.08.10 2019. Data source: Please refer to 'Digital Data Sources' in the Product Guide.

HISTORICAL AERIAL PHOTOGRAPH - 1993

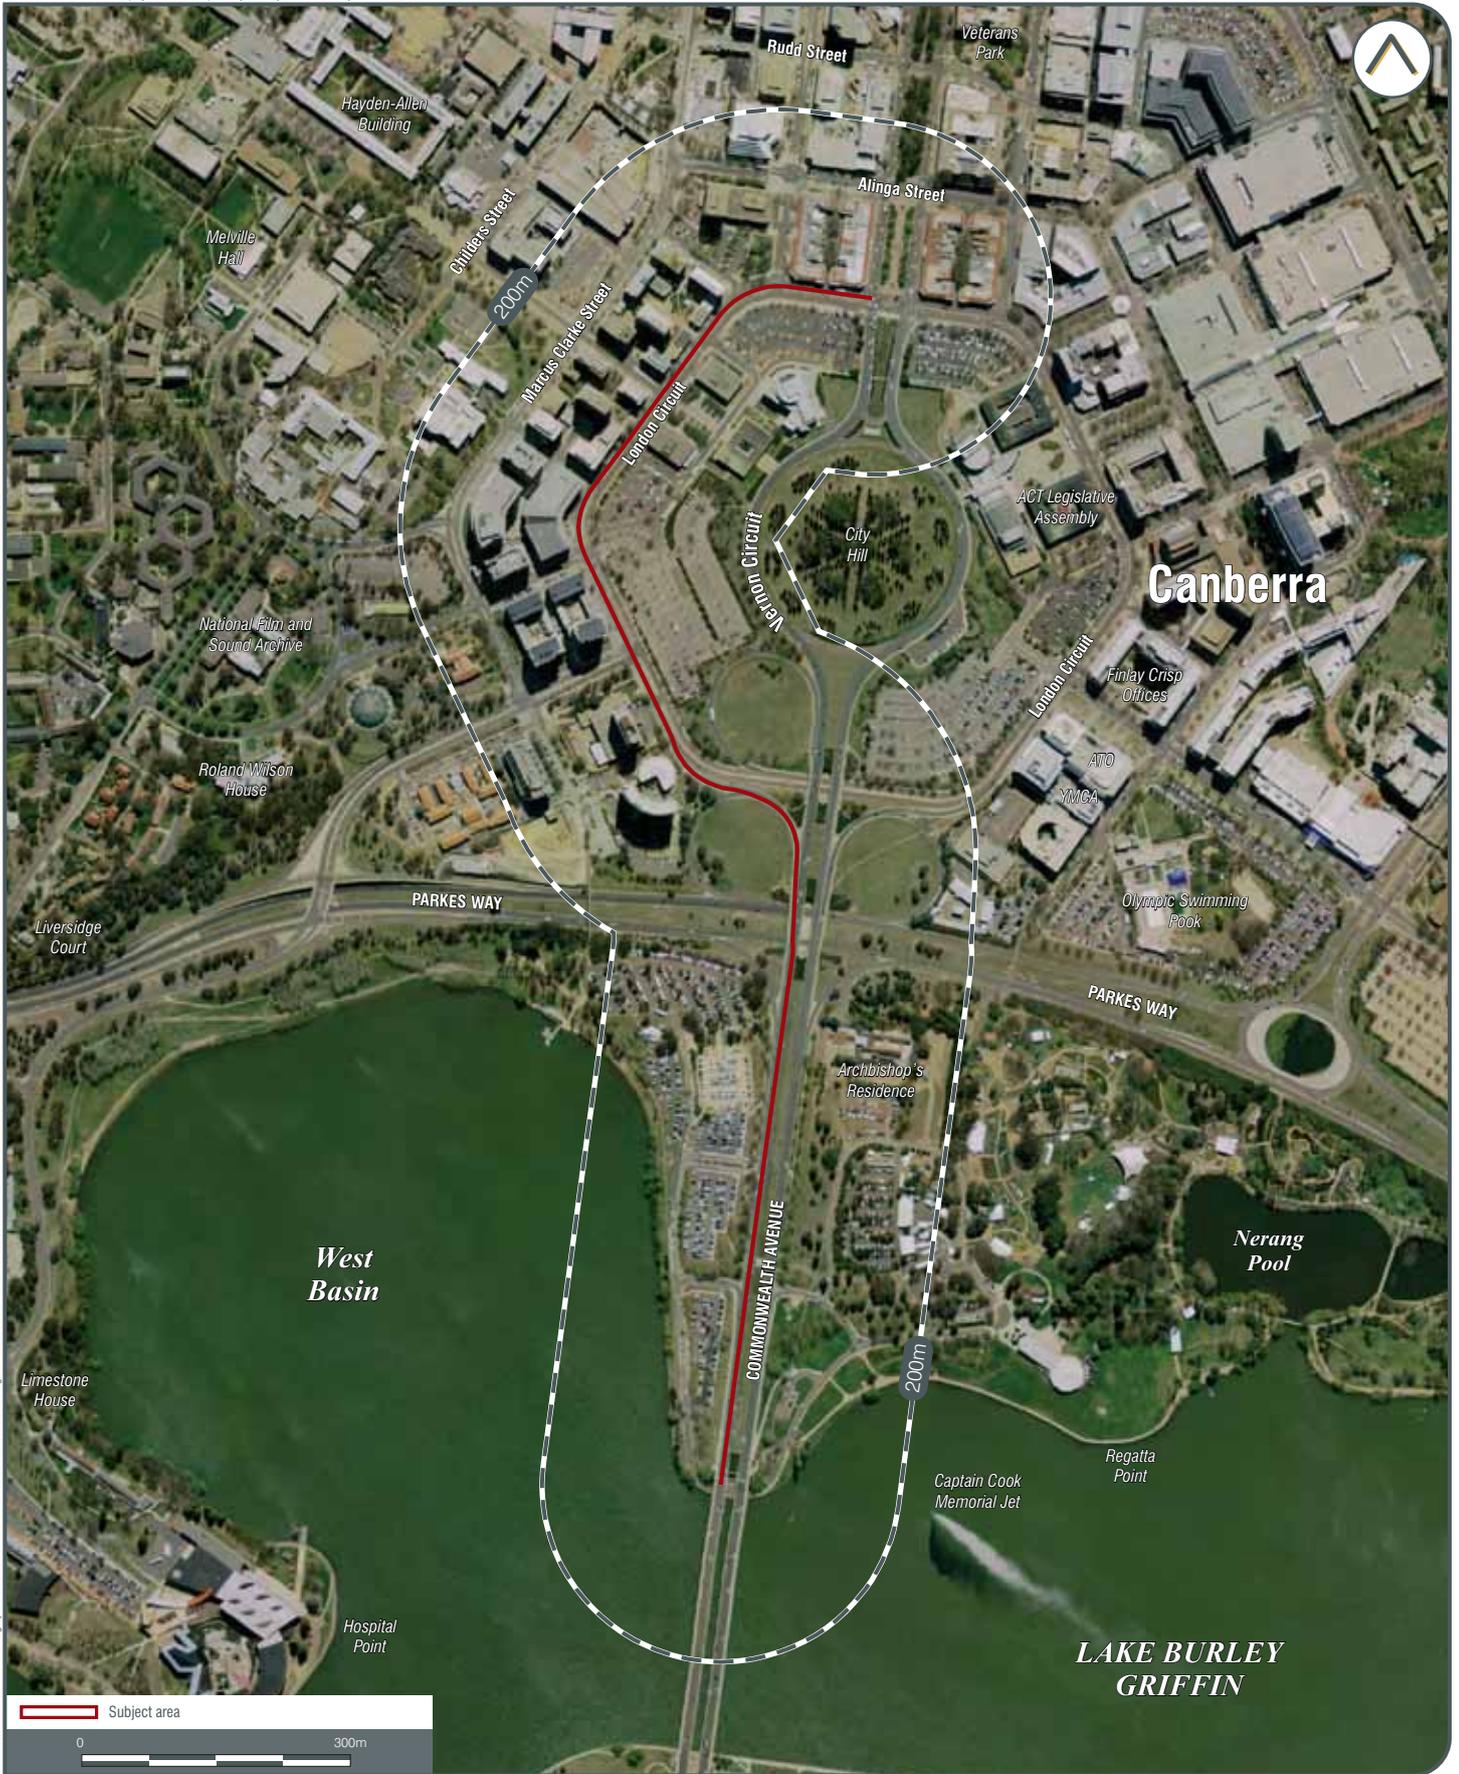
LIR-0082: Historical Aerial Photograph - 2008.08.10.2019. Data source: Please refer to 'Digital Data Sources' in the Product Guide

HISTORICAL AERIAL PHOTOGRAPH - 2008

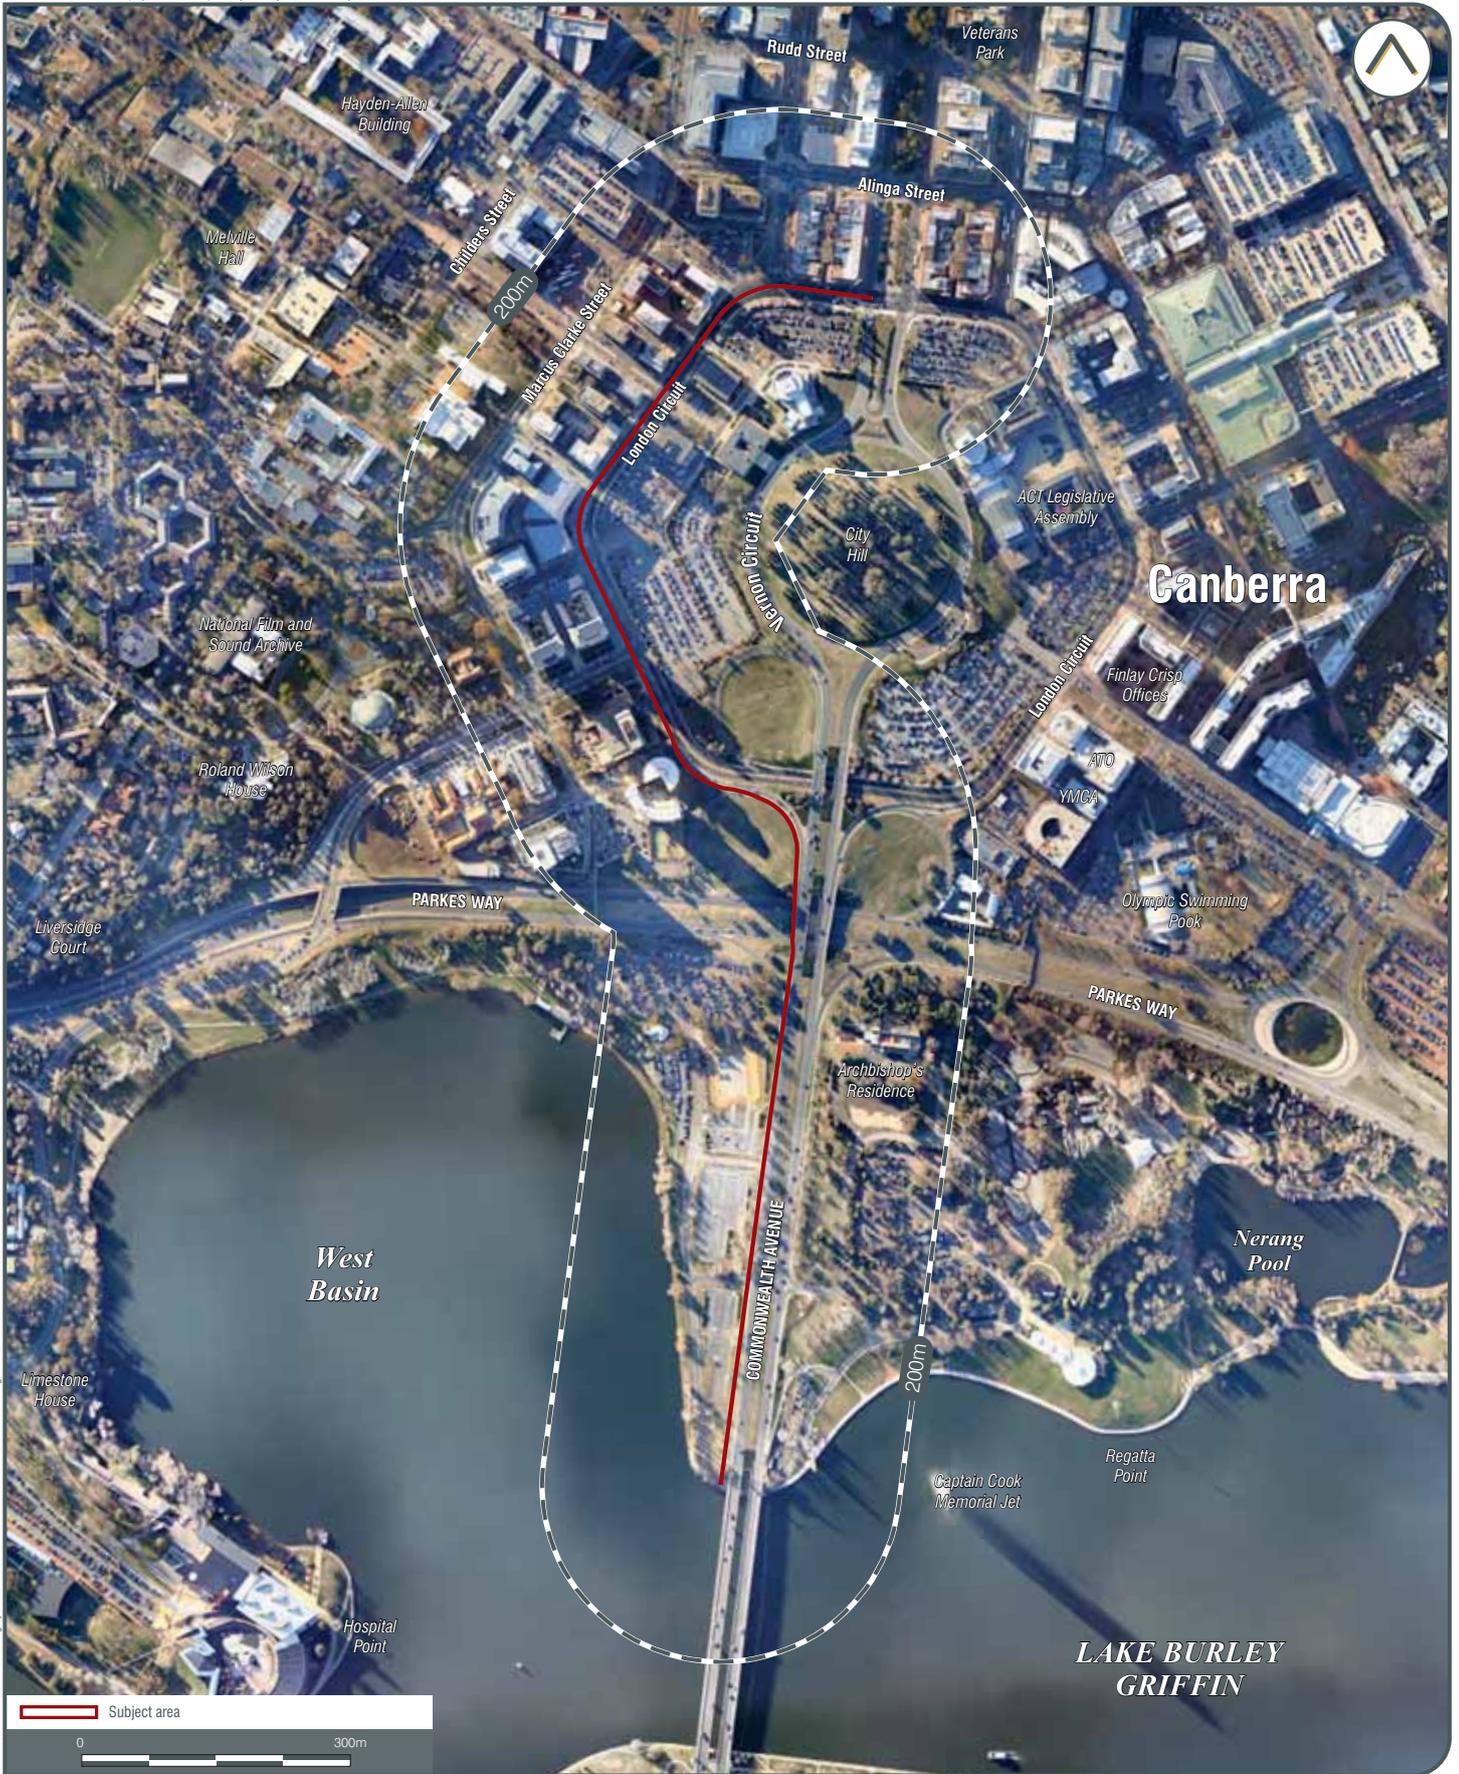
LIR-0082: Historical Aerial Photograph - 2010.08.10 2019. Data source: Please refer to 'Digital Data Sources' in the Product Guide

HISTORICAL AERIAL PHOTOGRAPH - 2010

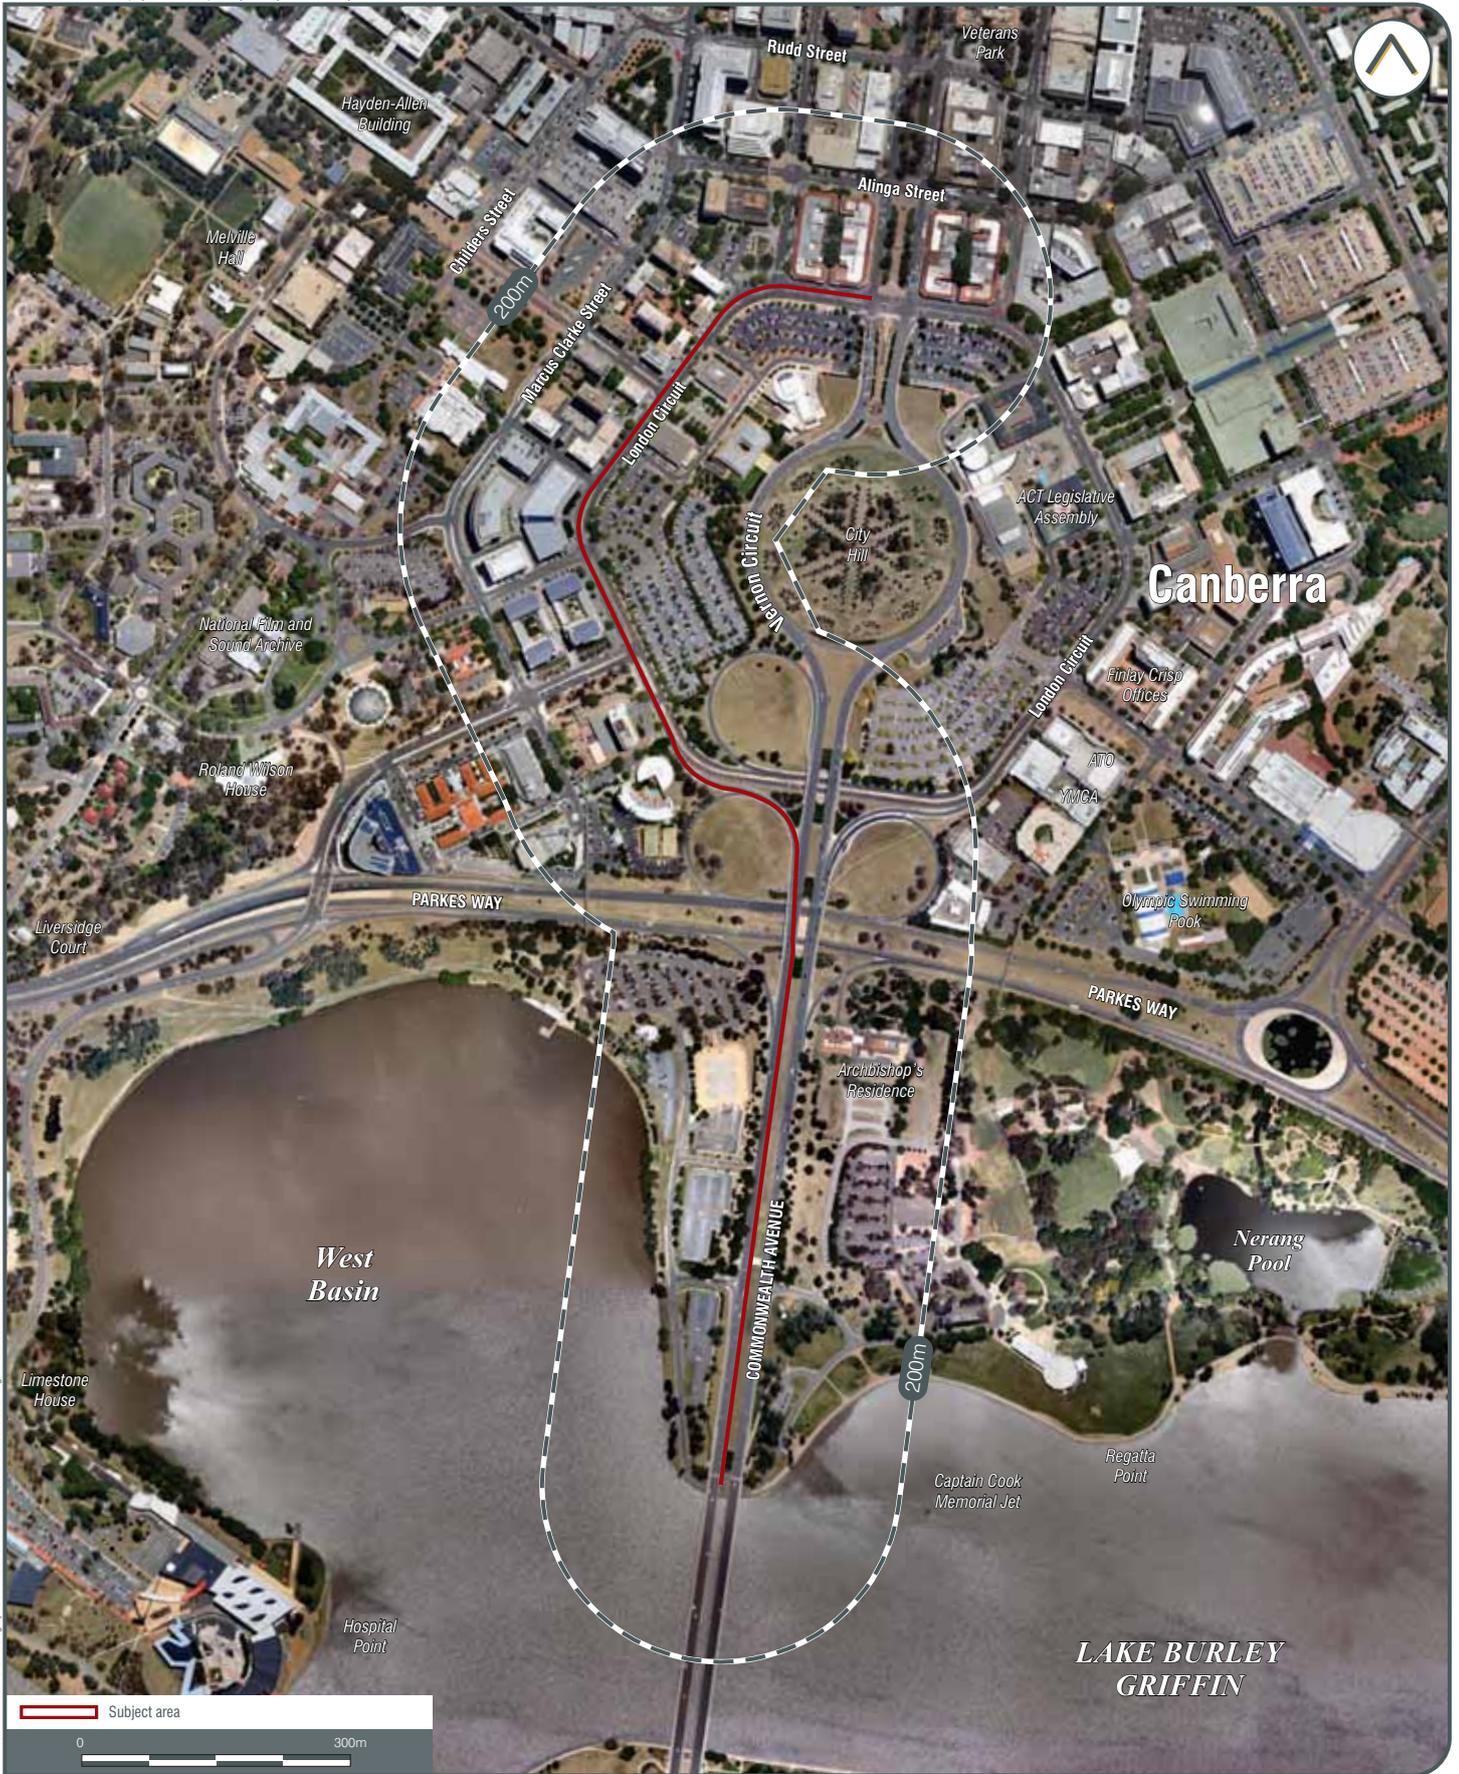
LIR-00892: Historical Aerial Photograph - 2013.08.10 2019. Data source: Please refer to 'Digital Data Sources' in the Product Guide

HISTORICAL AERIAL PHOTOGRAPH - 2013

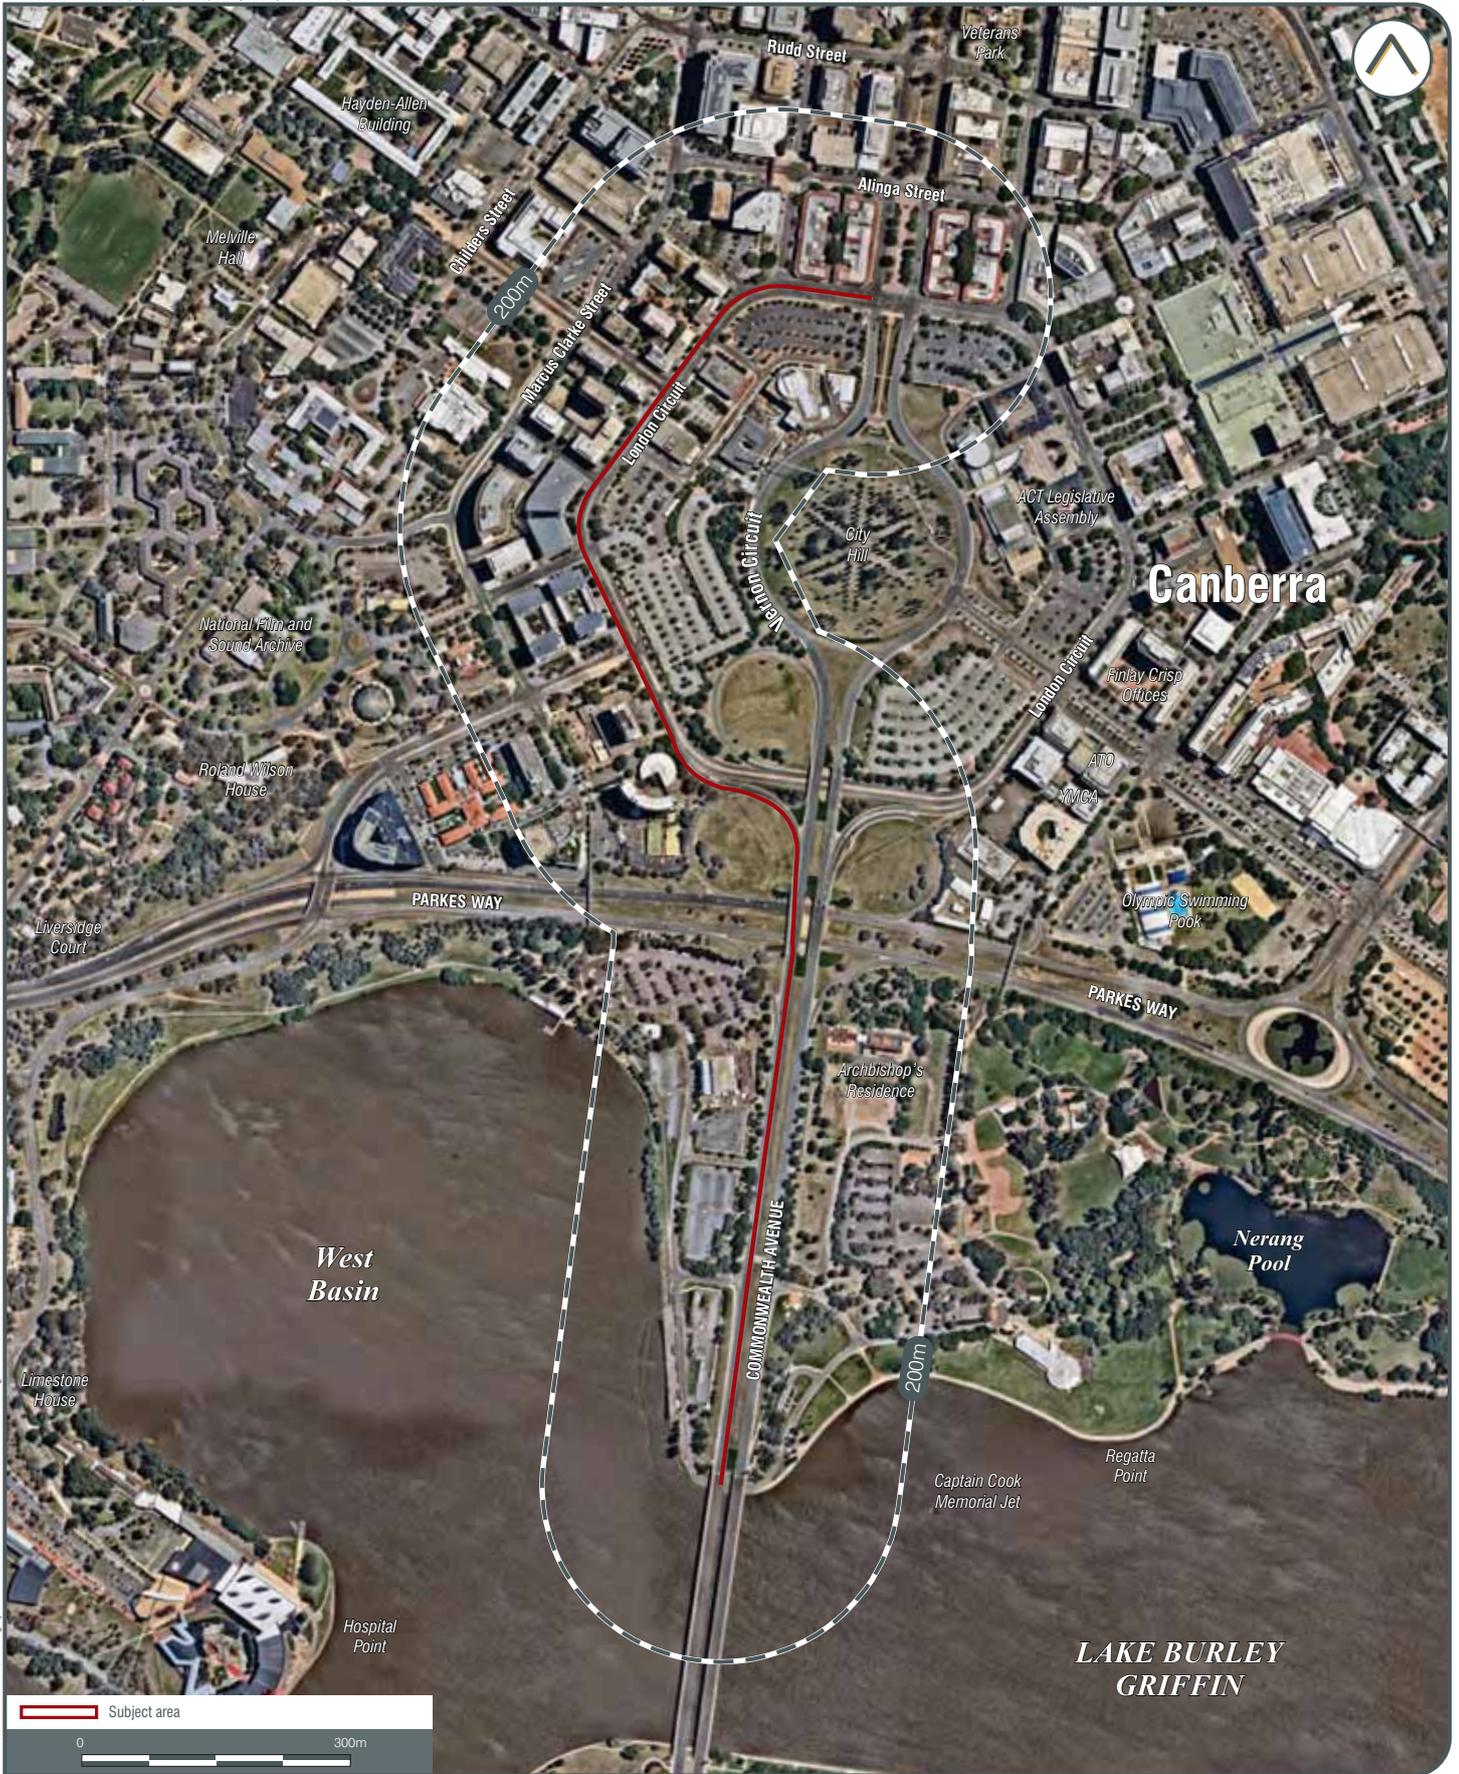
LR-0082: Historical Aerial Photograph - 2016.08.10.2019. Data source: Please refer to 'Digital Data Sources' in the Product Guide

HISTORICAL AERIAL PHOTOGRAPH - 2016

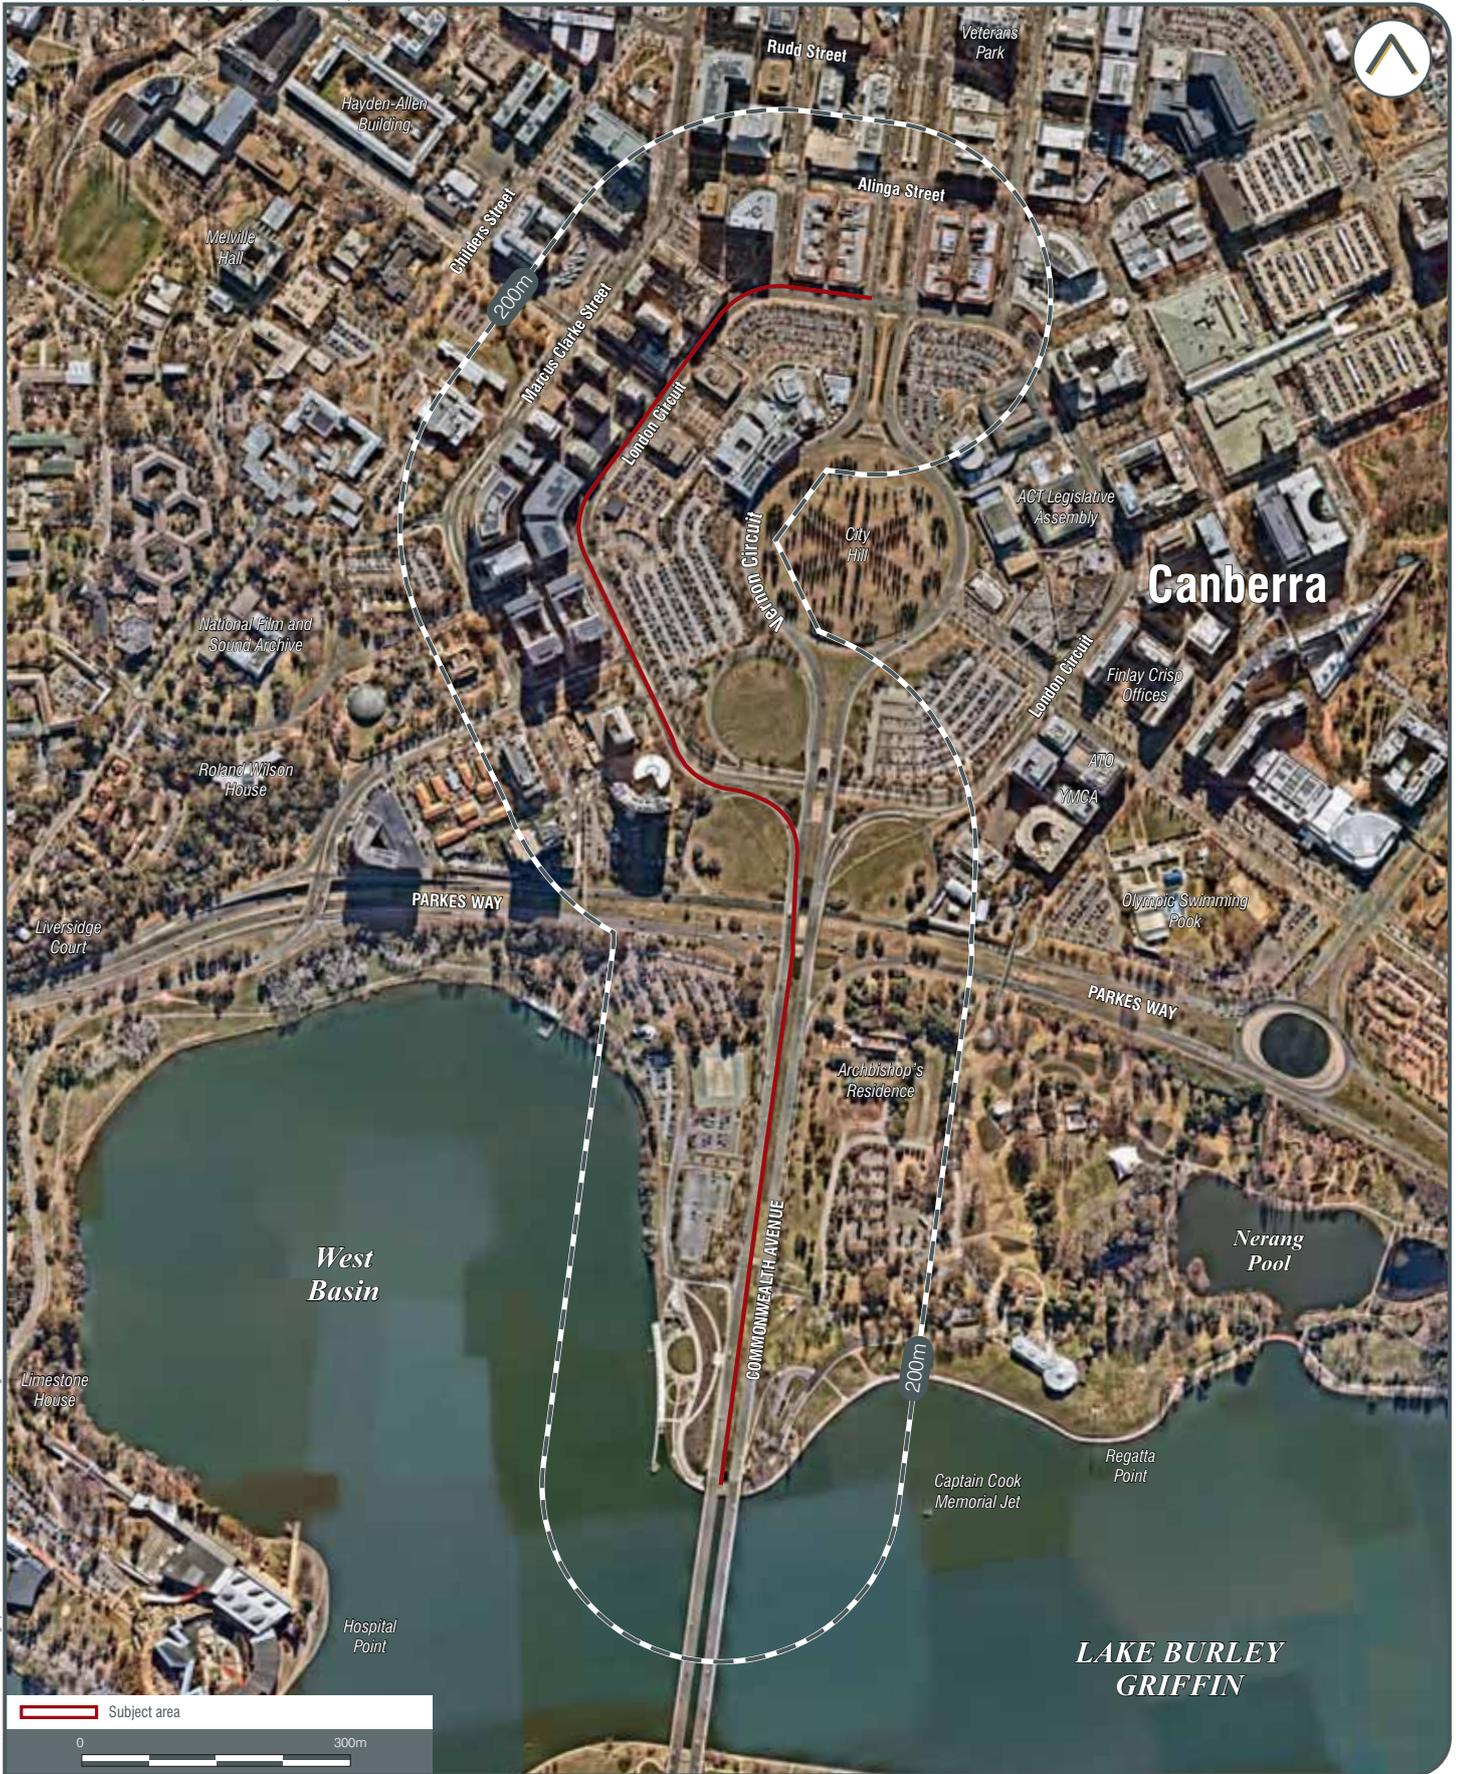
LIR-0082: Historical Aerial Photograph - 2019.08.10 2019. Data source: Please refer to 'Digital Data Sources' in the Product Guide

HISTORICAL AERIAL PHOTOGRAPH - 2019

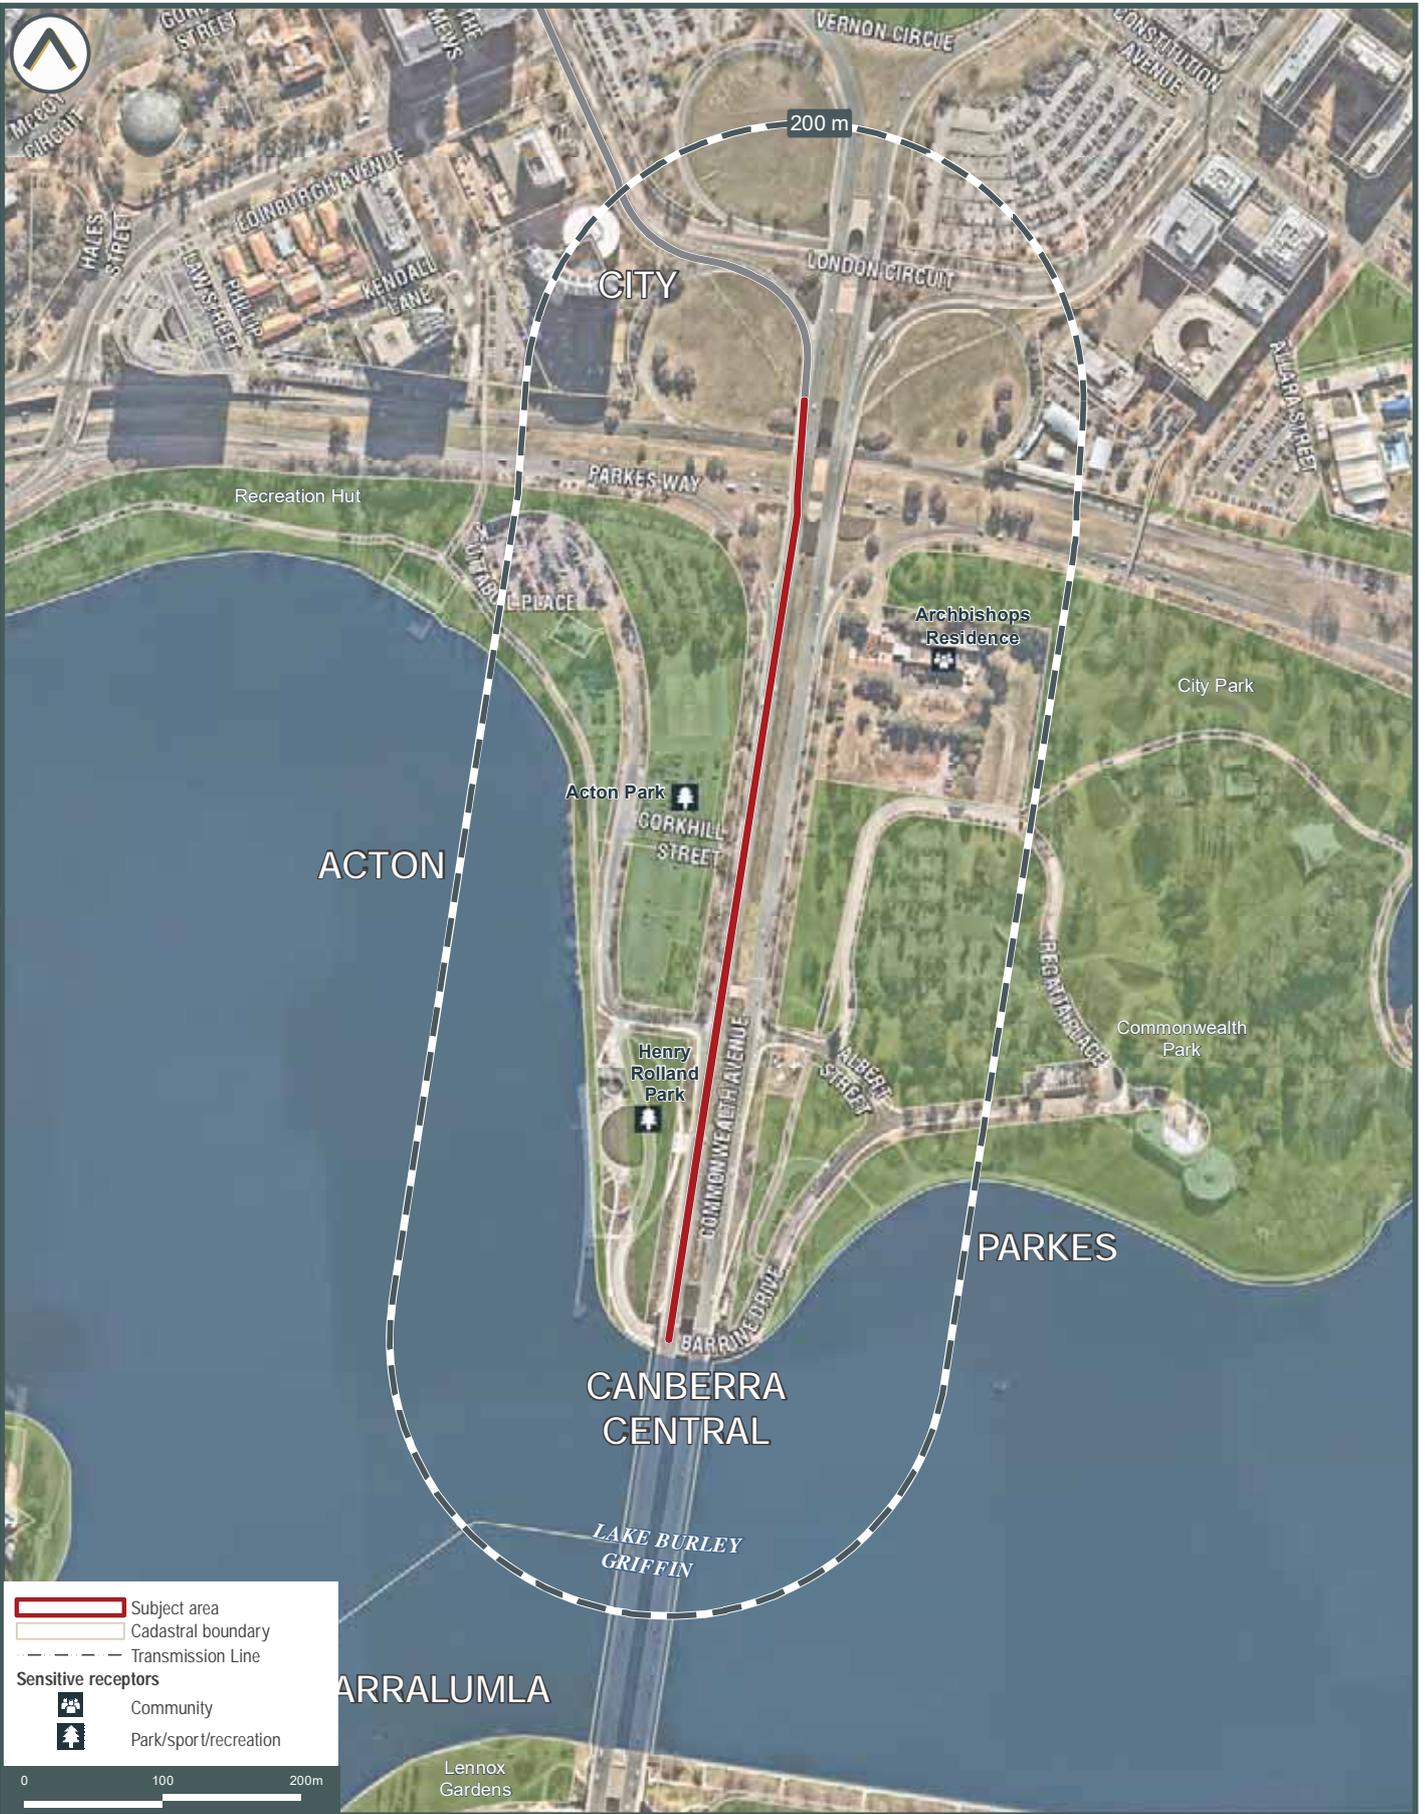
SUBJECT AREA AND SENSITIVE RECEPTORS

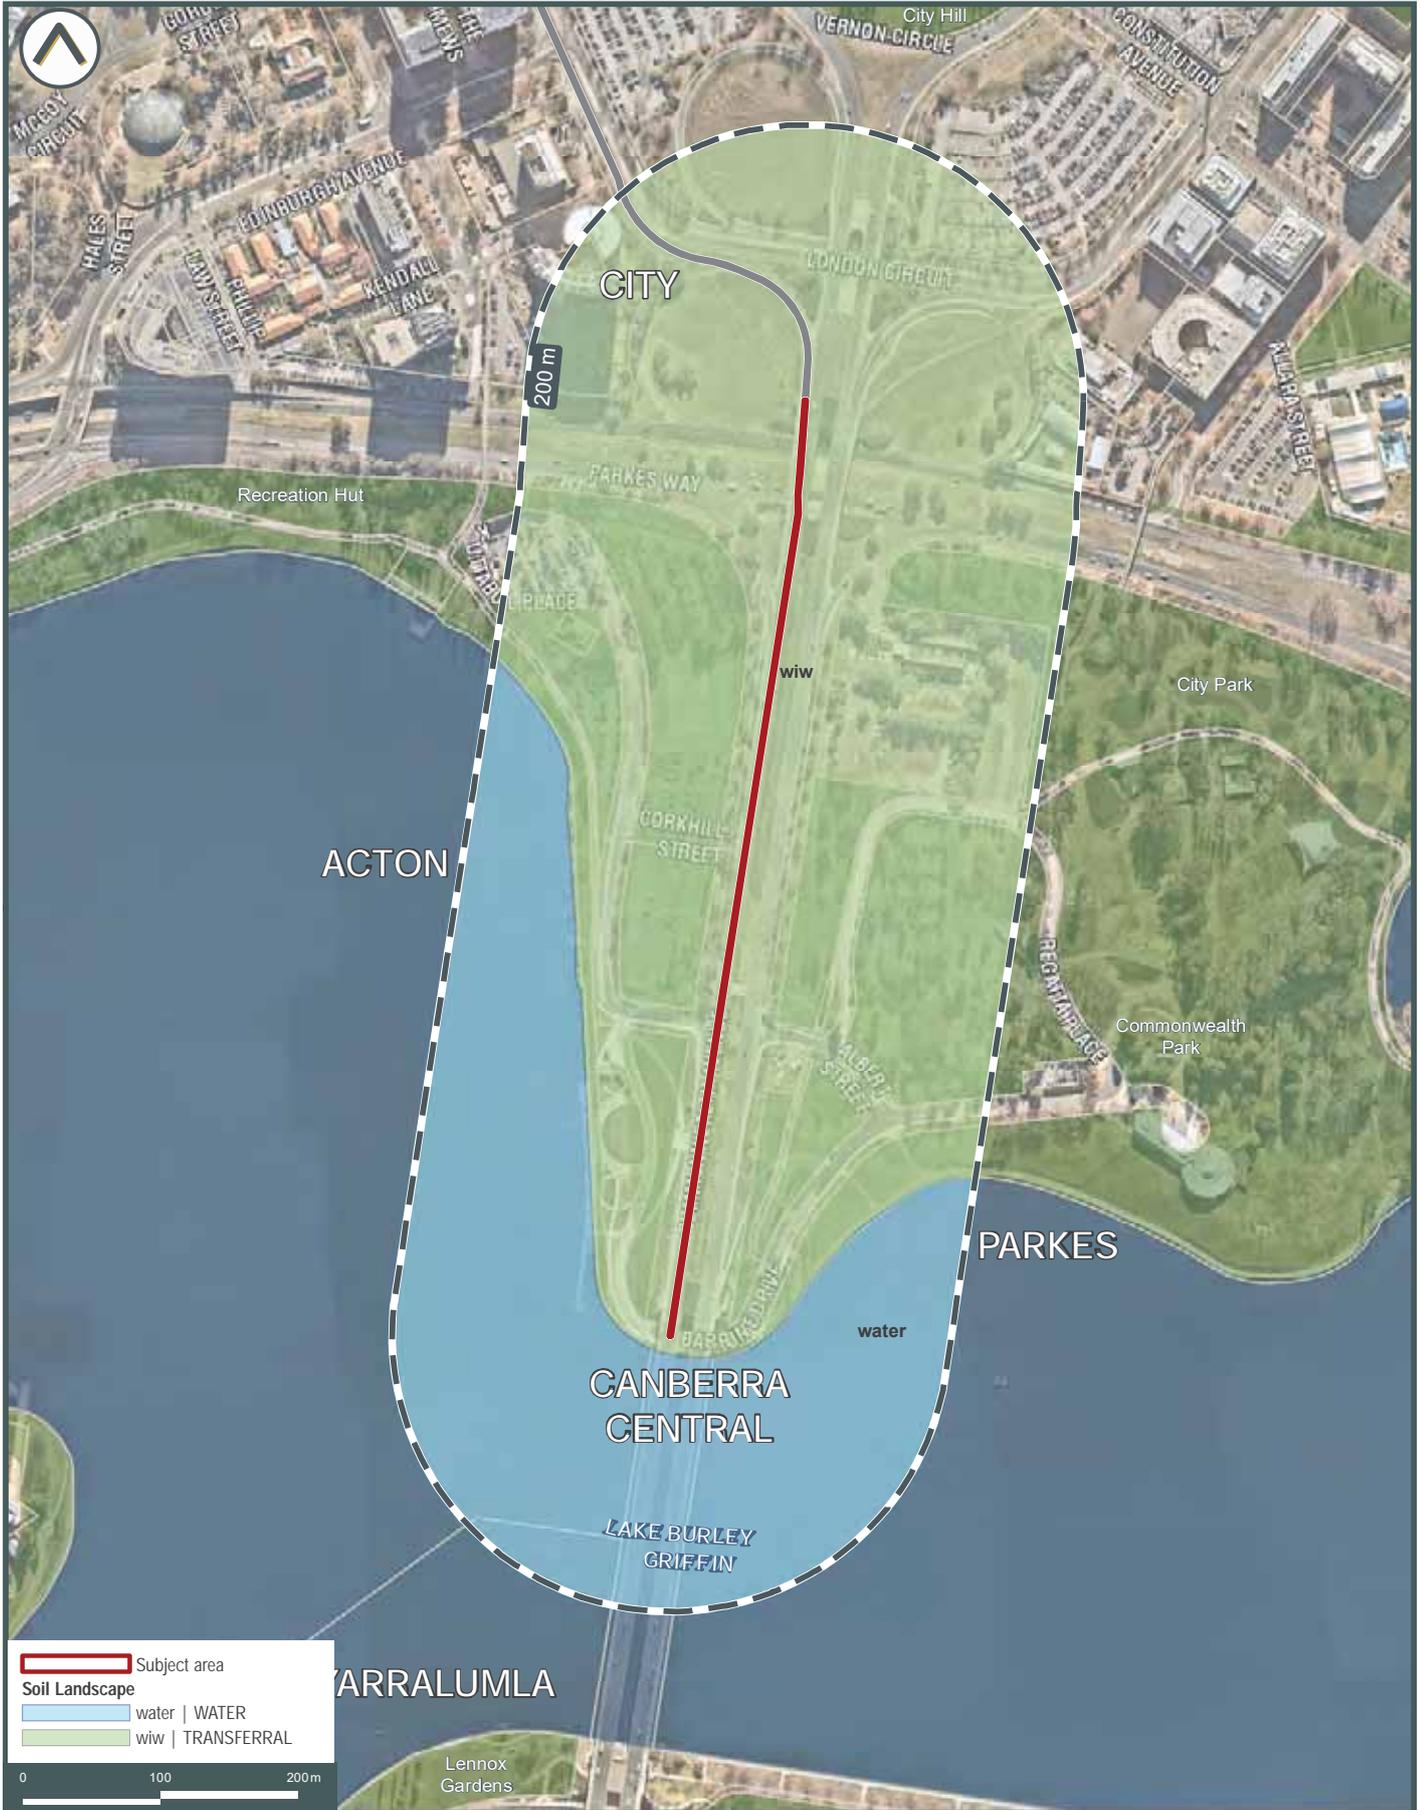
SOIL LANDSCAPES AND ACID SULFATE SOIL RISK
