Light Rail Stage 2A

Environmental Assessment – Contamination

15th December 2022

Project No.: 0527116

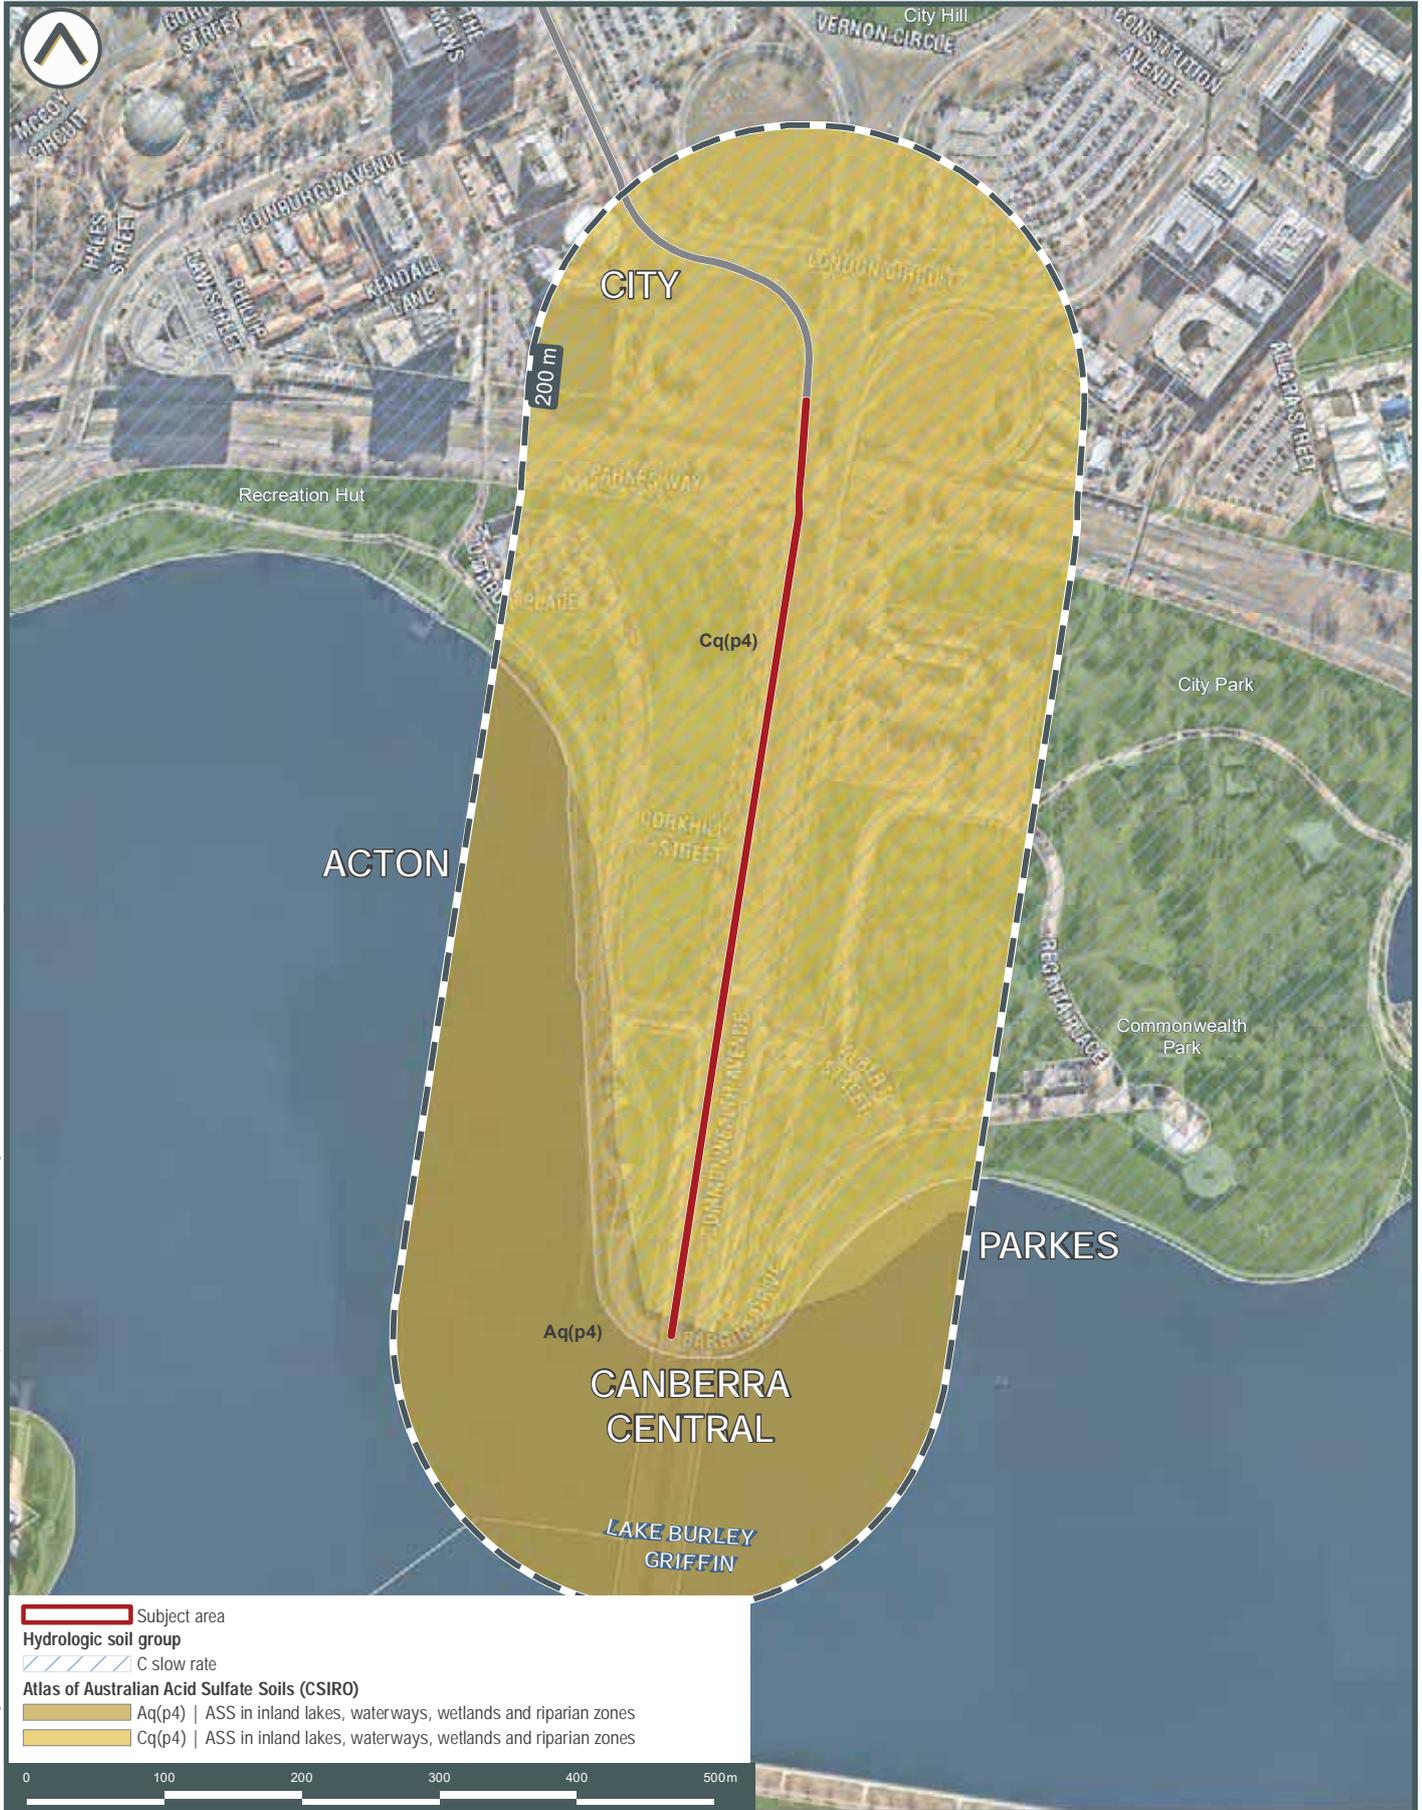
ATLAS OF AUSTRALIAN ACID SULFATE SOILS AND SALINITY

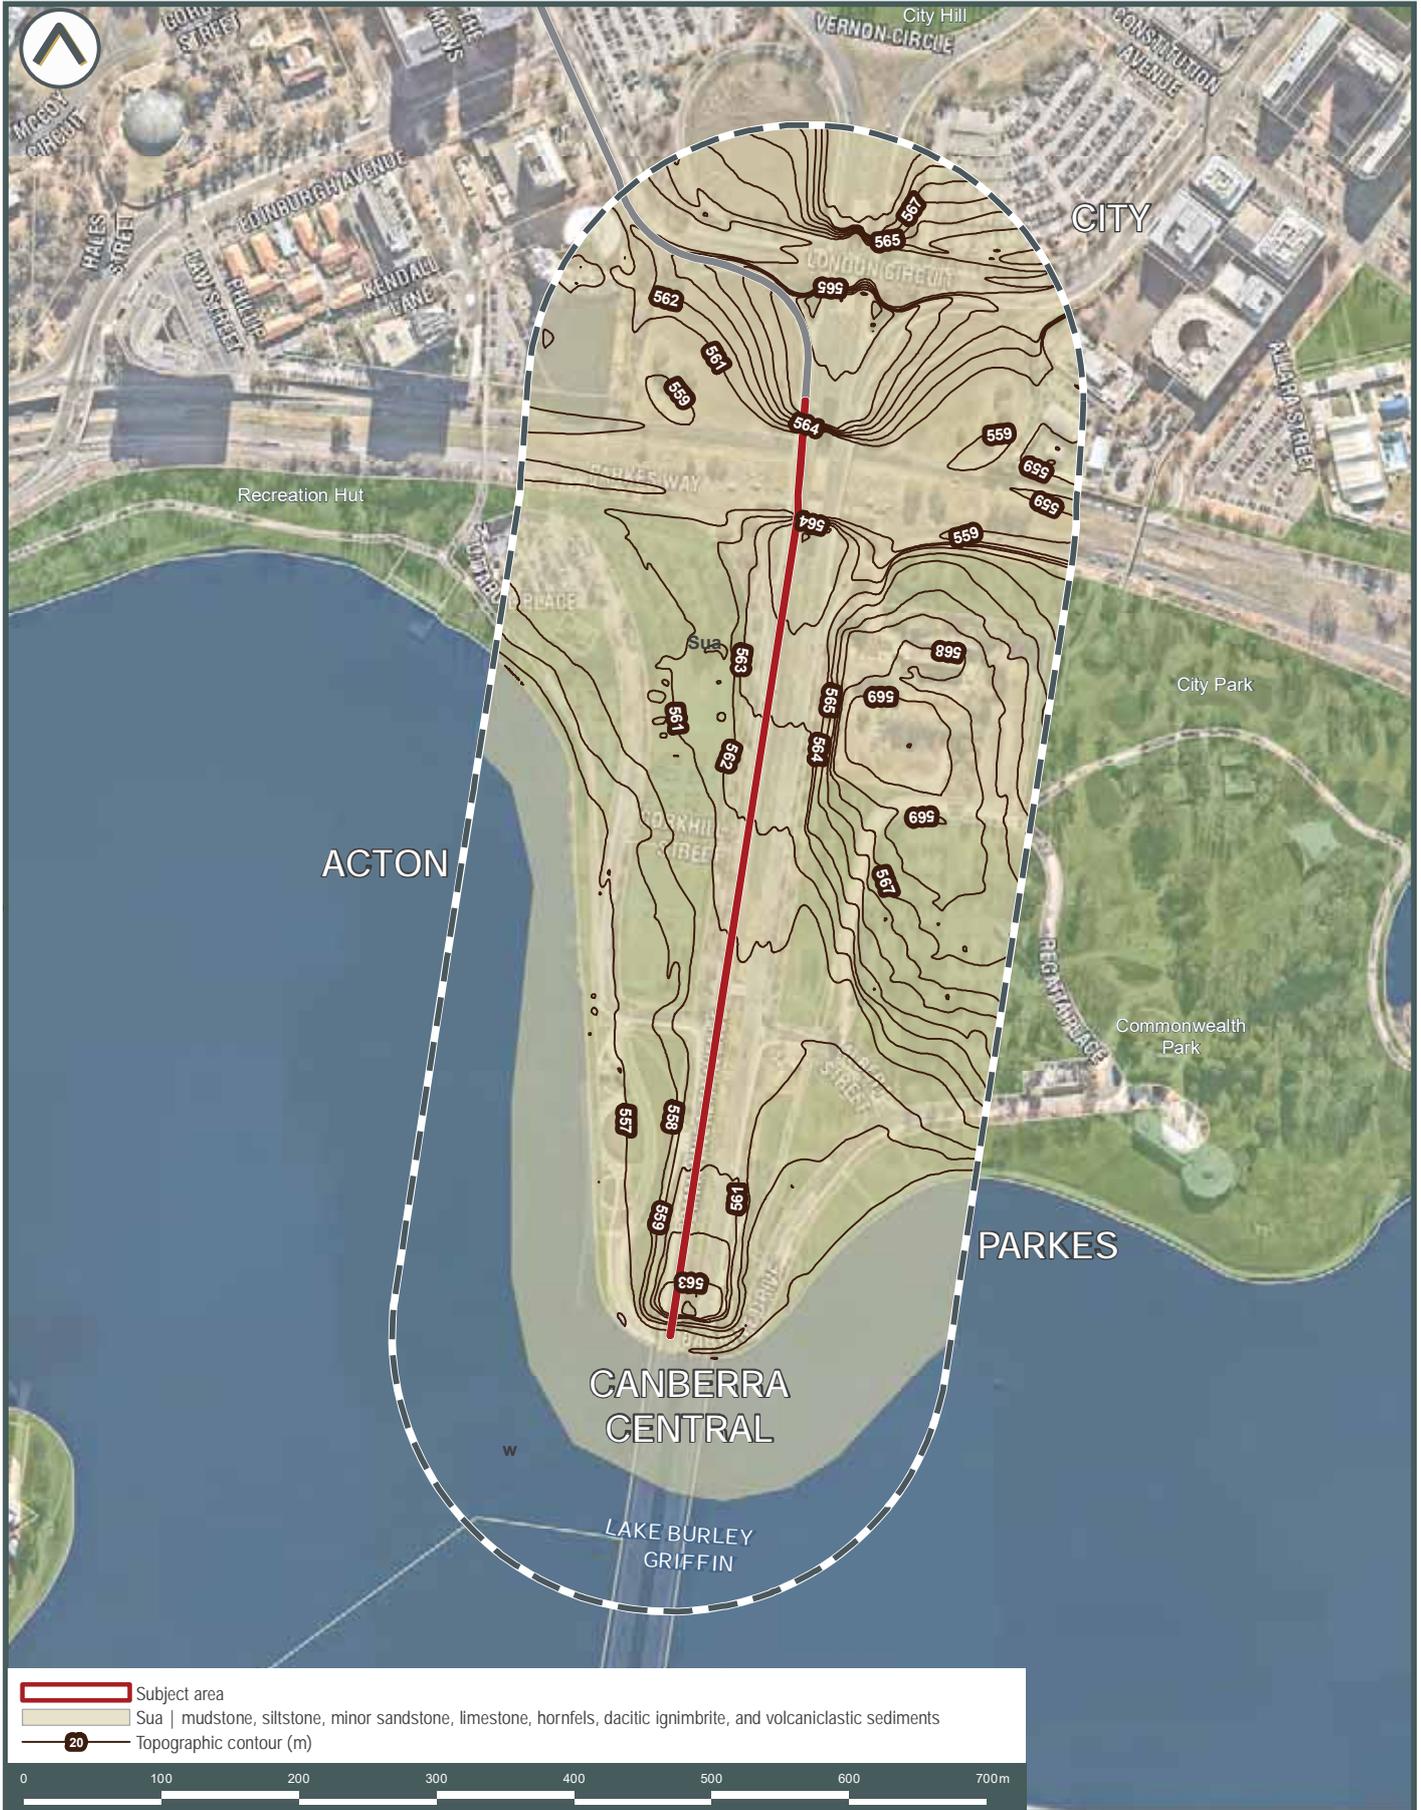
GEOLOGY AND TOPOGRAPHY

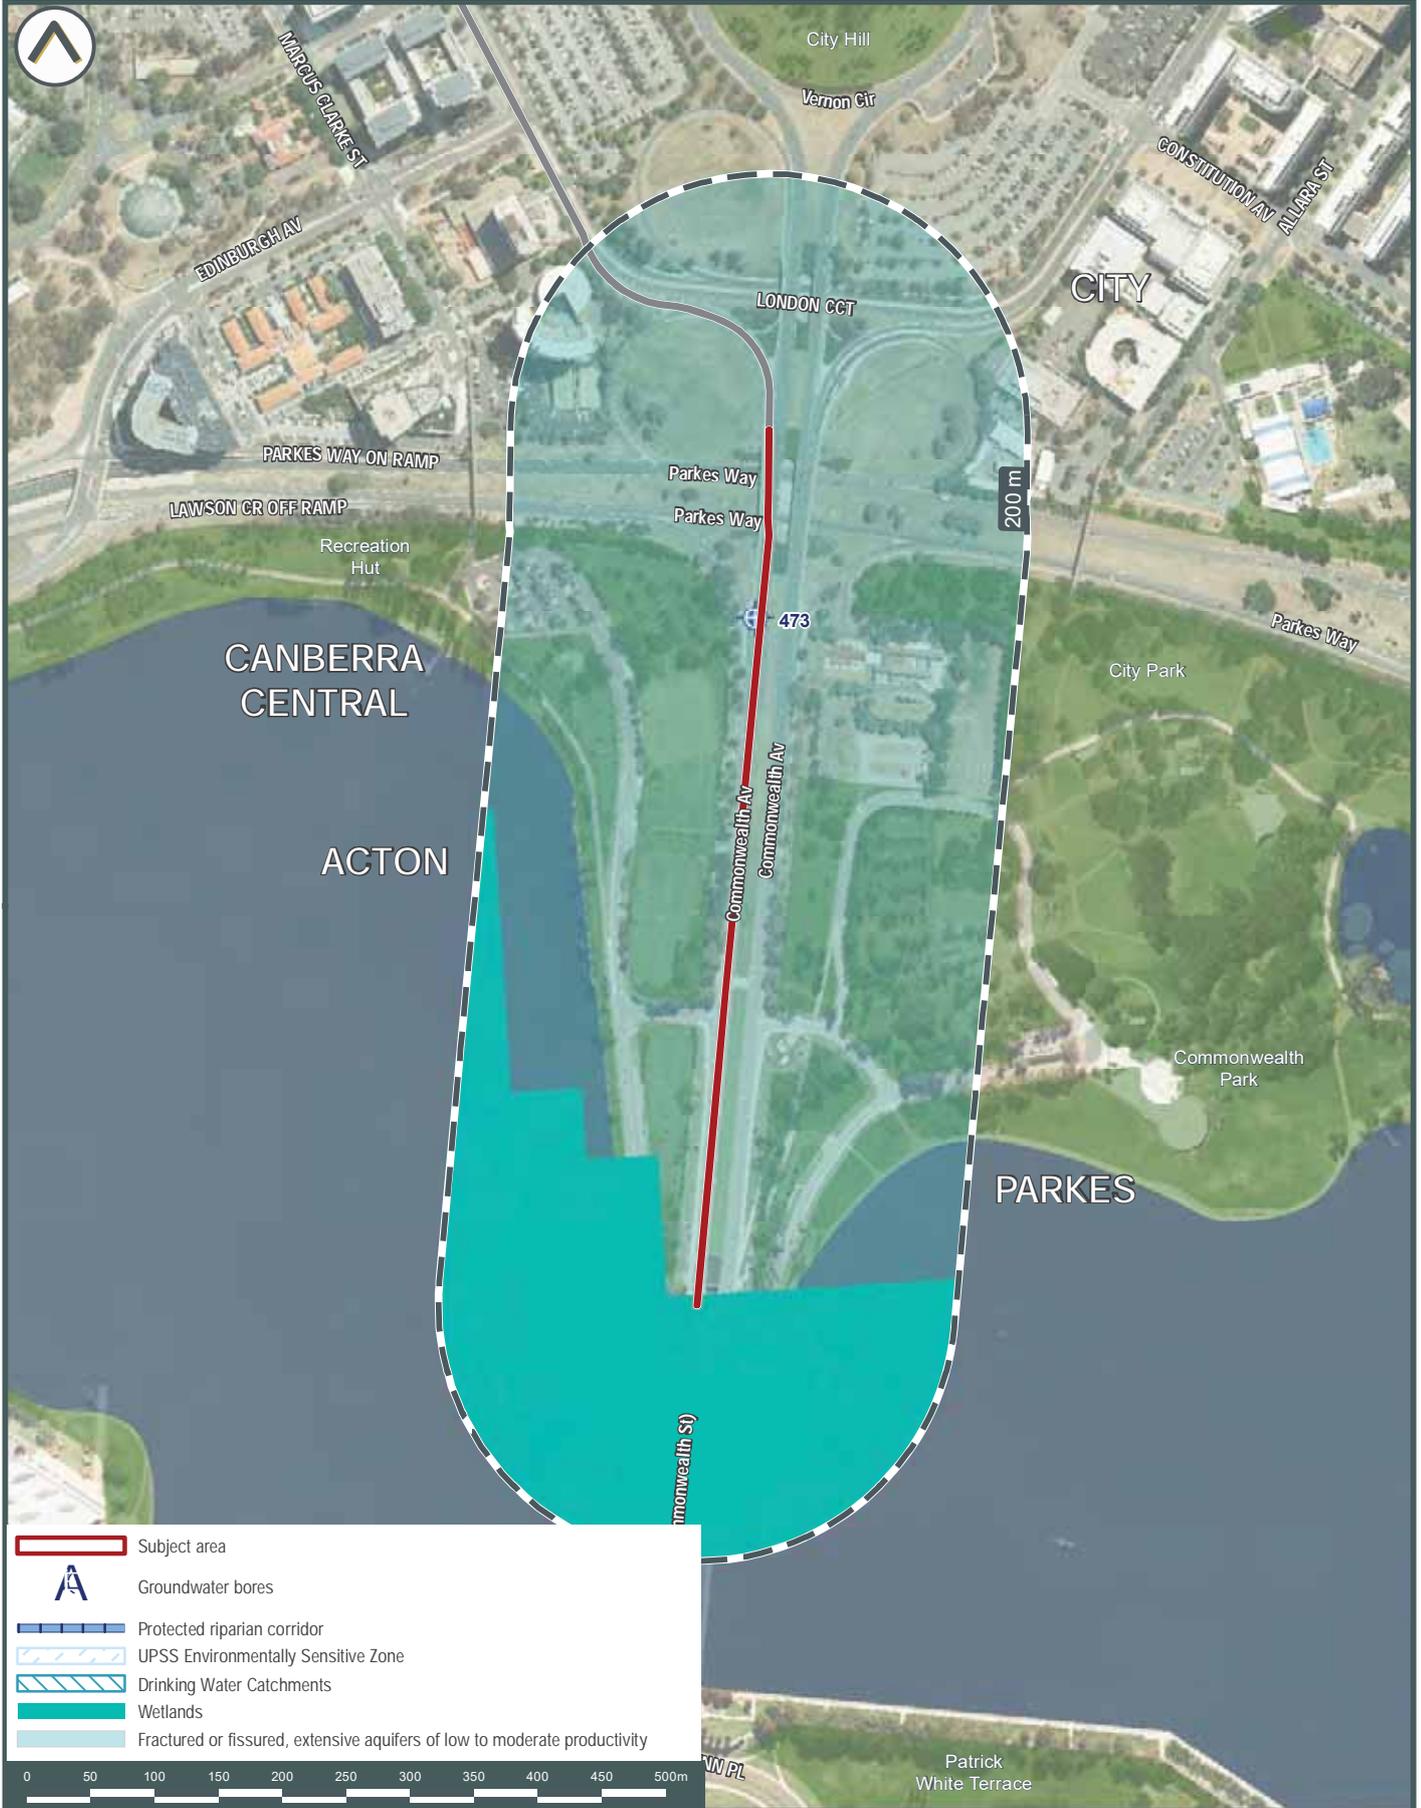
HYDROGEOLOGY AND GROUNDWATER BORES

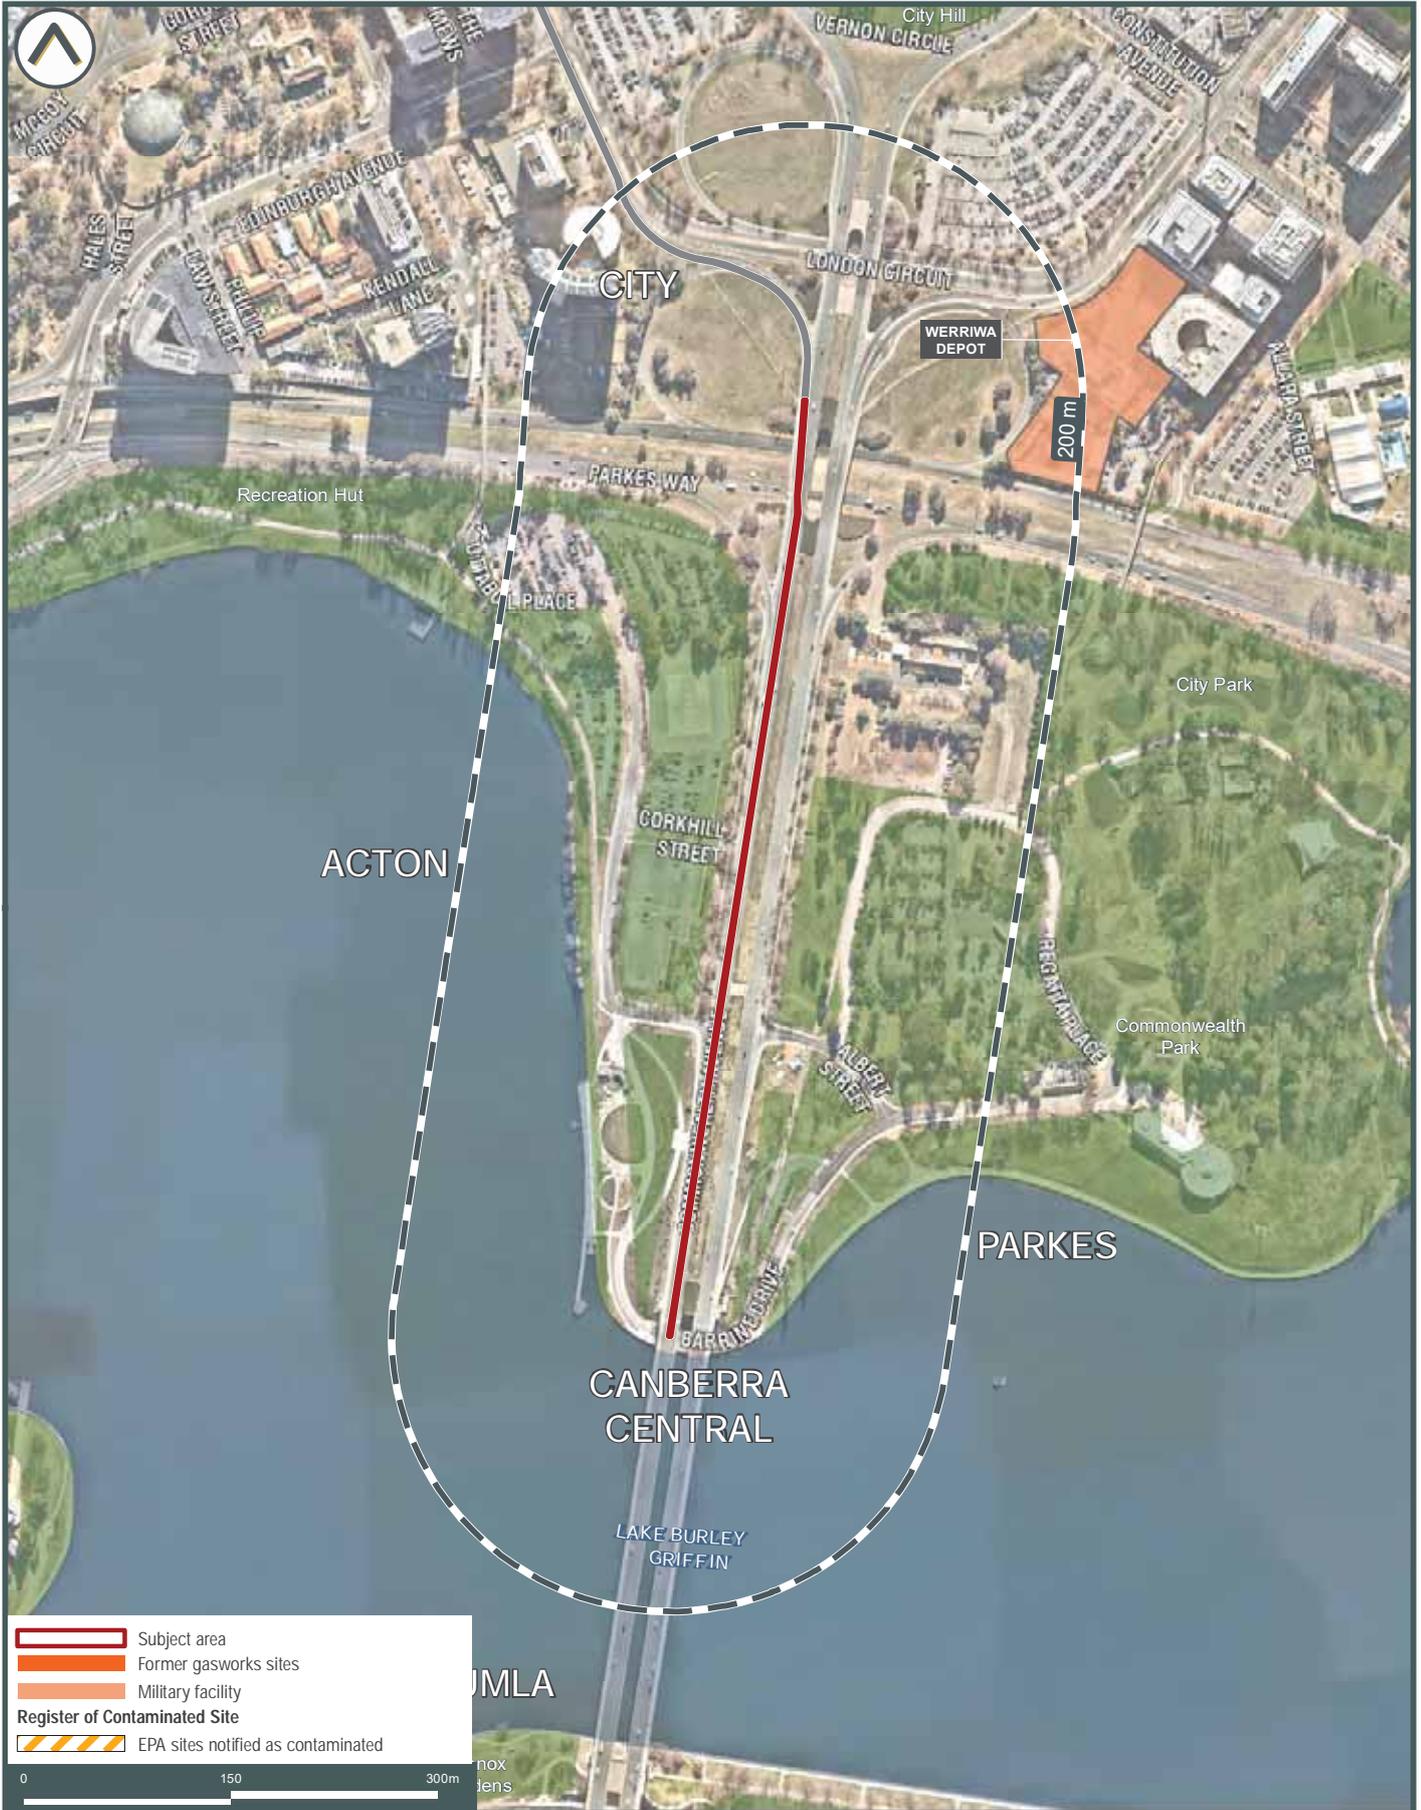
EPA RECORDS AND OTHER REGULATORY CONTAMINATION ISSUES

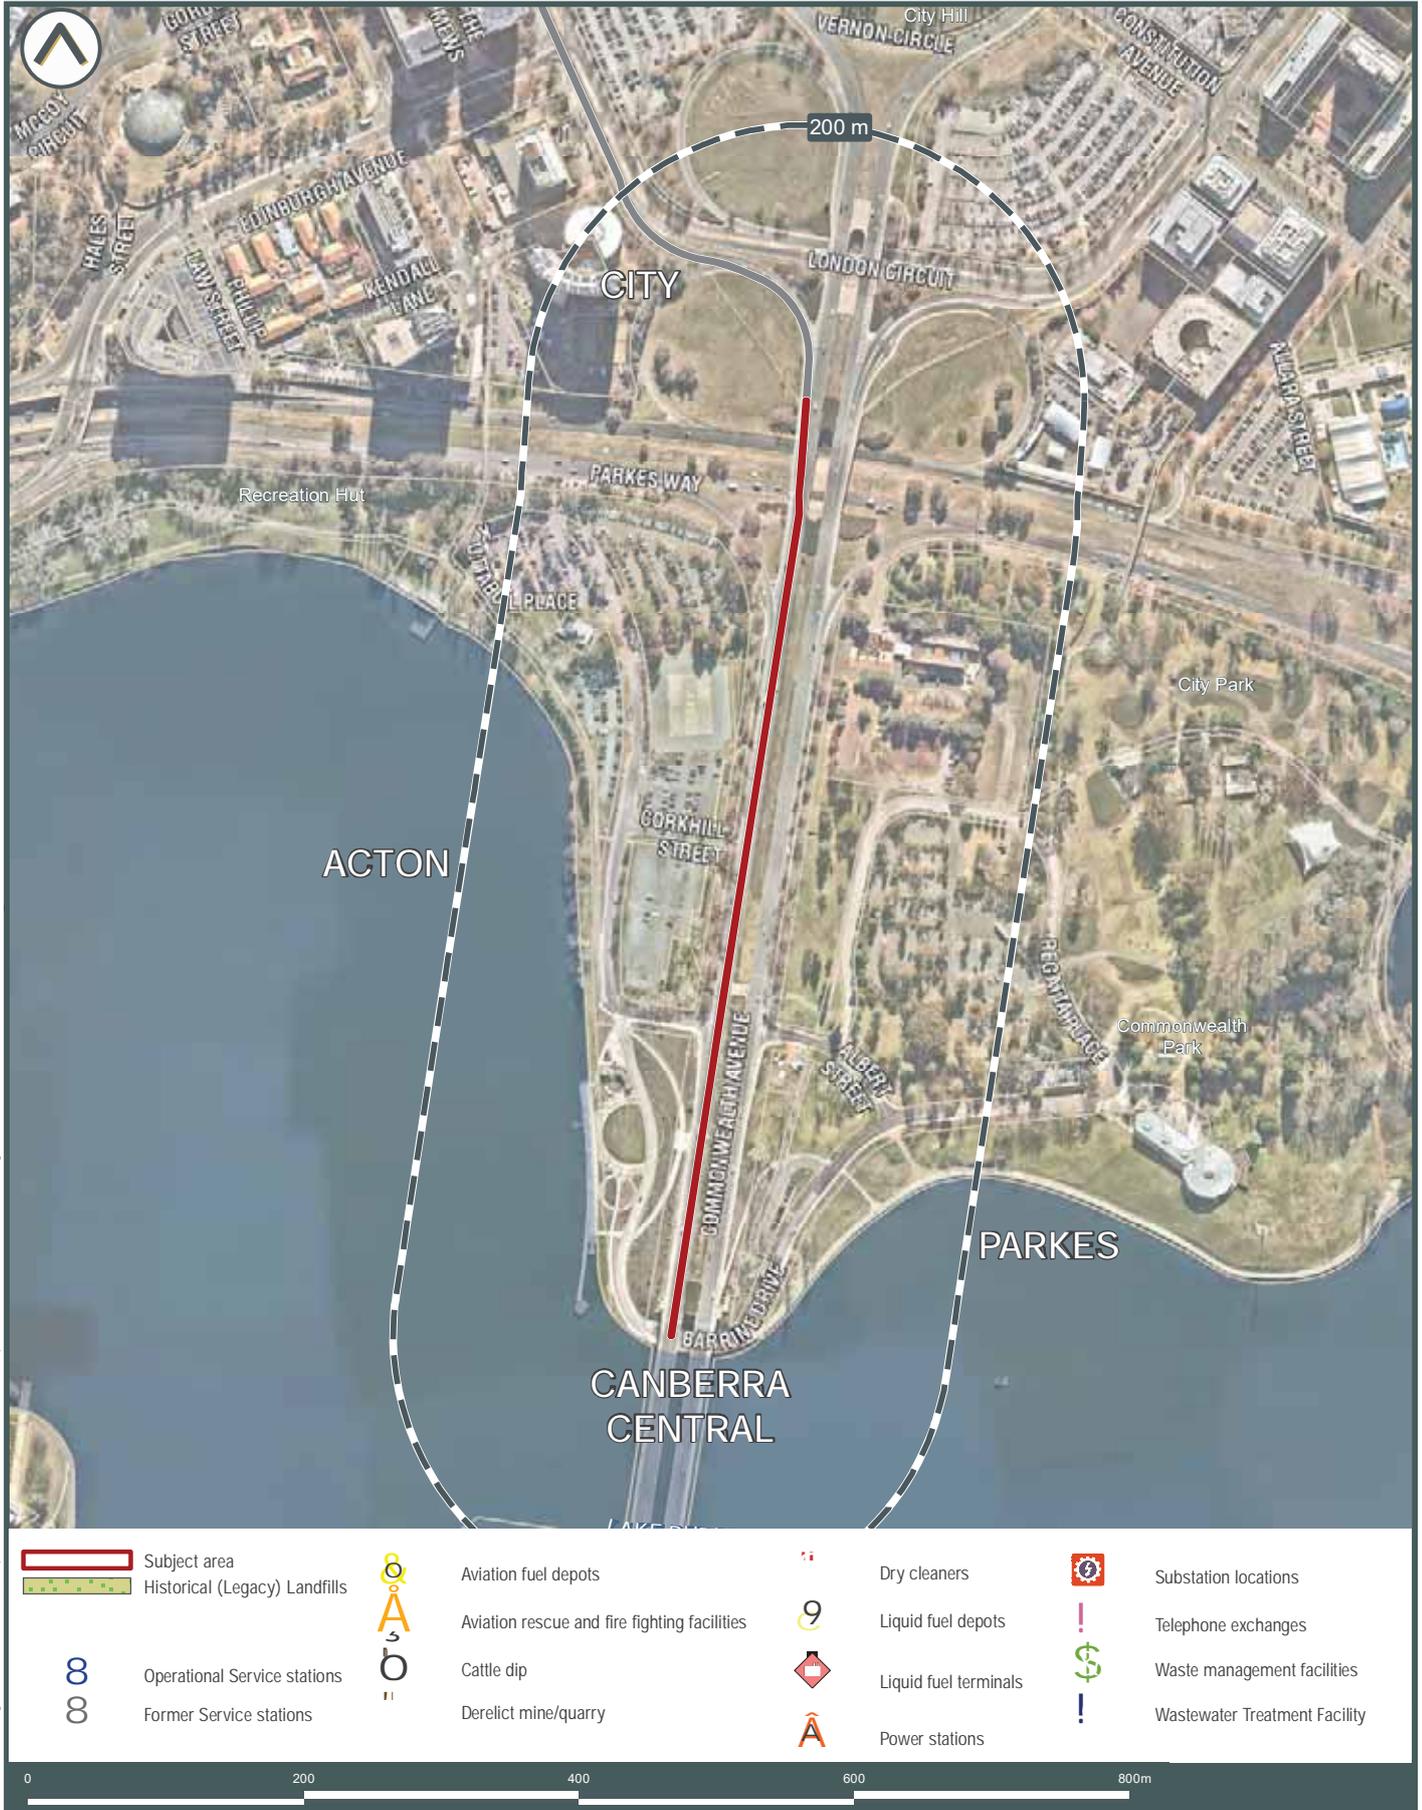
POTENTIALLY CONTAMINATING ACTIVITIES
