Appendix D—Manager and User Requirements and Aspirations

Issues Arising from Consultations and Investigations

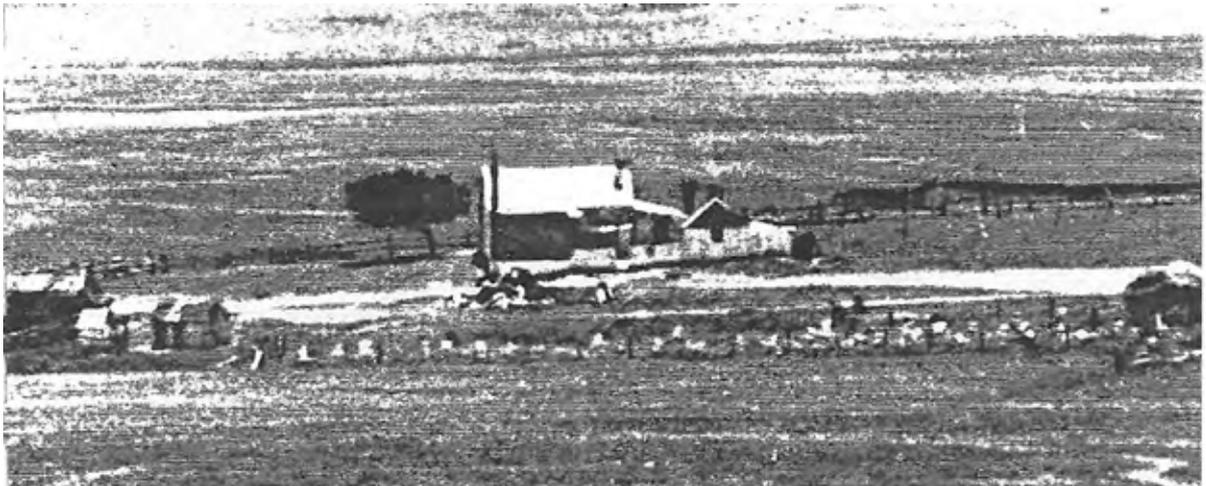
Figure D.1 Detail of 'Federal Capital Views' (detail), 1910. View north. There appears to be a skillion over the bread oven, although this does not appear to connect directly to the slab shed. Note limewash on the slabs and on foundation plinth of room 1, the current 'office'. There is also a large lean-to addition to the east of the slab shed. (Source: NLA Picture File detail of panorama photo in album 300, 1910 NLA:PIC8470/8)

The 1910 Percival survey indicates that the larger slab shed had some form of roofing structure connecting it to the side of the cottage in the vicinity of the bread oven. There is some photographic evidence from 1913 suggesting there was a roof over the bread oven, extending approximately to the line of the slab shed wall. The arrangement of roof lines suggests the two structures were not connected. Remnant limewash on the side of the cottage suggests that this area was formerly covered and used as an extension of the kitchen food preparation area.

The skillion does not appear in the 1961 Morton Herman plans, even though other structures identified for demolition were shown dotted—presumably the slab shed and roofing over the bread oven area had already been removed by that date. There are no other known references to the skillion and it may have collapsed before the 1960s; however, a 1961 photo of Blundells before work commenced shows part of the bread oven with possibly a fibro sheet covering it as part of the roofing structure support.

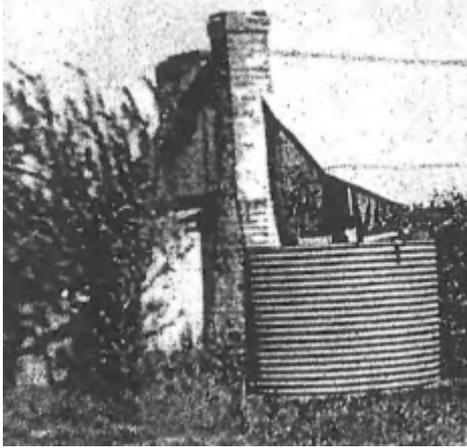
Figure D.2 Blundells/Oldfields Cottage prior to restoration in 1961, CDHS Picture file reproduced in Beth Knowles, *The Cottage in the Parliamentary Triangle*. The light colour to the bread oven wall may be a sheet of fibro over the end wall of the skillion. Compare this photo with Figure D.9 which clearly shows the brick end wall of the bread oven.

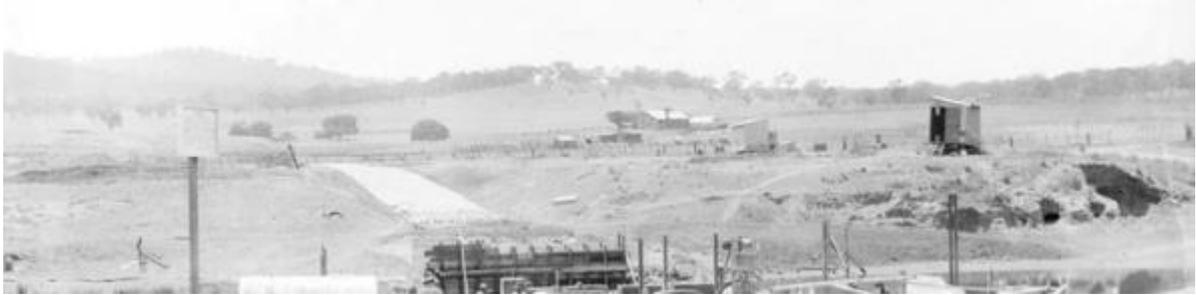
Figure D.3 Scott's Crossing 1928 showing Blundells in middle distance. The stone walls do not appear limewashed all over at this date. (Source: NAA A3560, 4970 1929 Scott's Crossing over the Molonglo River)

The historic photos seem to confirm that the cottage was not maintained regularly as a limewashed building.

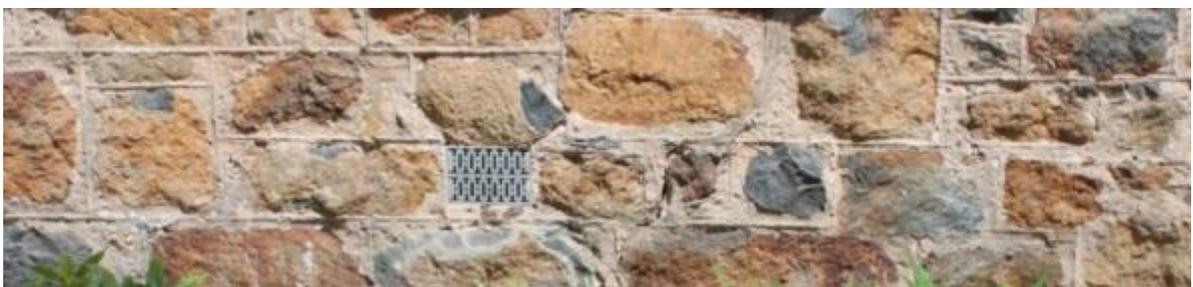
Figure D.4 Much of the aesthetic appeal of Blundells Cottage lies in the varied colours of its stones. (Source: GML 2012)

Blundells is a rubble stone building that demonstrates a rich variation of colour and character, from sandy golds, through reds to deep blue/greys. The walls have very high aesthetic value that would be lost if they were re-limewashed. It is likely that the building in its present form is valued partly for these aesthetic qualities and it is apparently a popular place as a backdrop for wedding photos. It is quite likely that many people who appreciate the building on their circuit of the lake have never actually been inside—for them its value may be aesthetic rather than historic.⁵

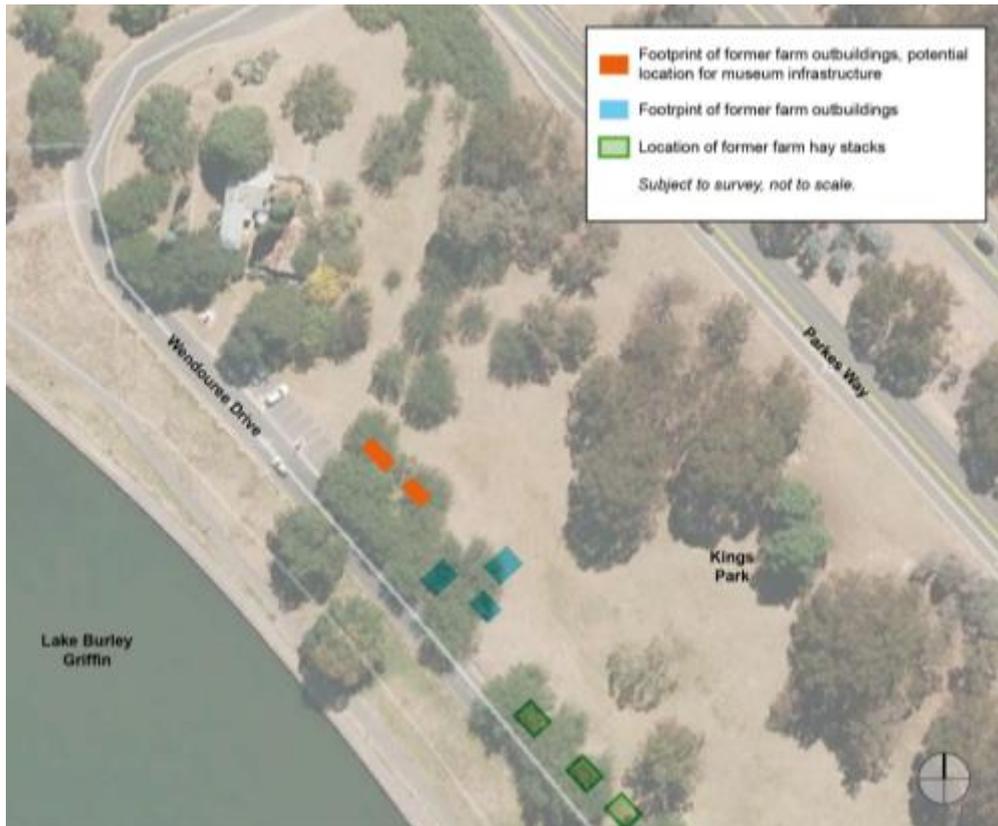
Figure D.5 Approximate possible proposed location of new service building—sufficiently distant from the cottage not to affect heritage values but sufficiently close to provide staff and visitor services close to carparking. (Source: GML edit to Google Earth base plan.)

A service building in the location of former sheds/haystacks adjacent to Wendouree Drive could provide ready access to additional facilities from the cottage without compromising its immediate setting. It could be designed in a form that referenced the historic outbuildings and haystacks (they were similar in form) and could link to the cottage with a multi-ability accessible graded pathway that could lead through the new orchard plantings. Although this location is some distance from the cottage, it can provide a fresh opportunity to interpret the cottage in an appropriate heritage curtilage, without the confusion of museum infrastructure.

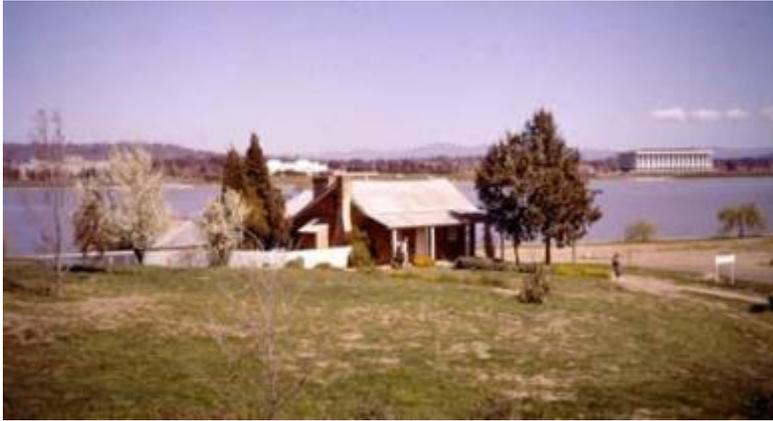
Figure D.6 Blundells Cottage 1968—a photo was taken a year or two after the site was re-landscaped. Note that the canopy of the Himalayan cypress on the right is far smaller than that today, 2013. (Source NAA A1500, K193851968)

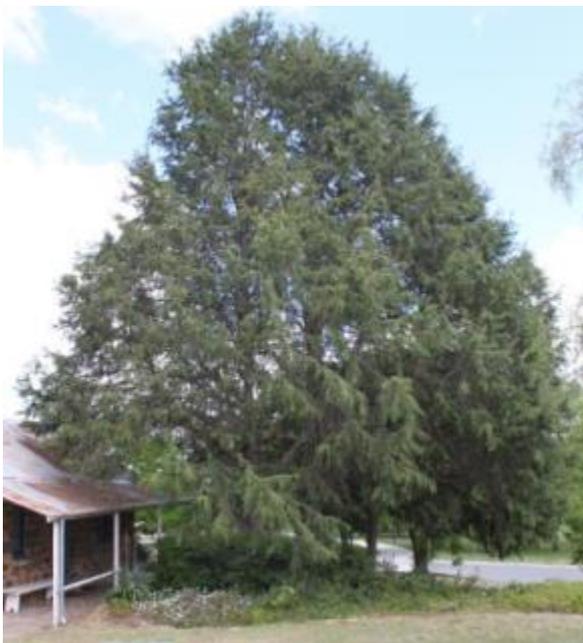
Figure D.7 The Himalayan cypress 2012. The tree closest to the cottage hangs heavily over the building. (Source GML 2012)

Of the three Himalayan cypresses located at the front of the building it is recommended that the one closest to the verandah be investigated for active management to eliminate most of the foliage overhanging the building. Periodic follow-up pruning may be necessary.

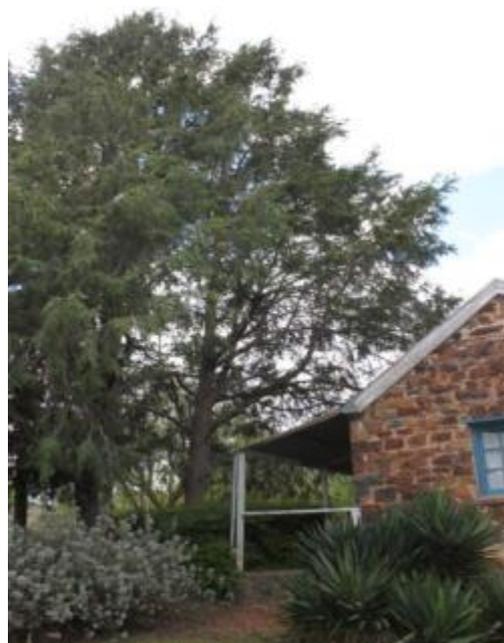
Figure D.8 Manage the Himalayan cypress closest to the building. (Source: GML 2012)

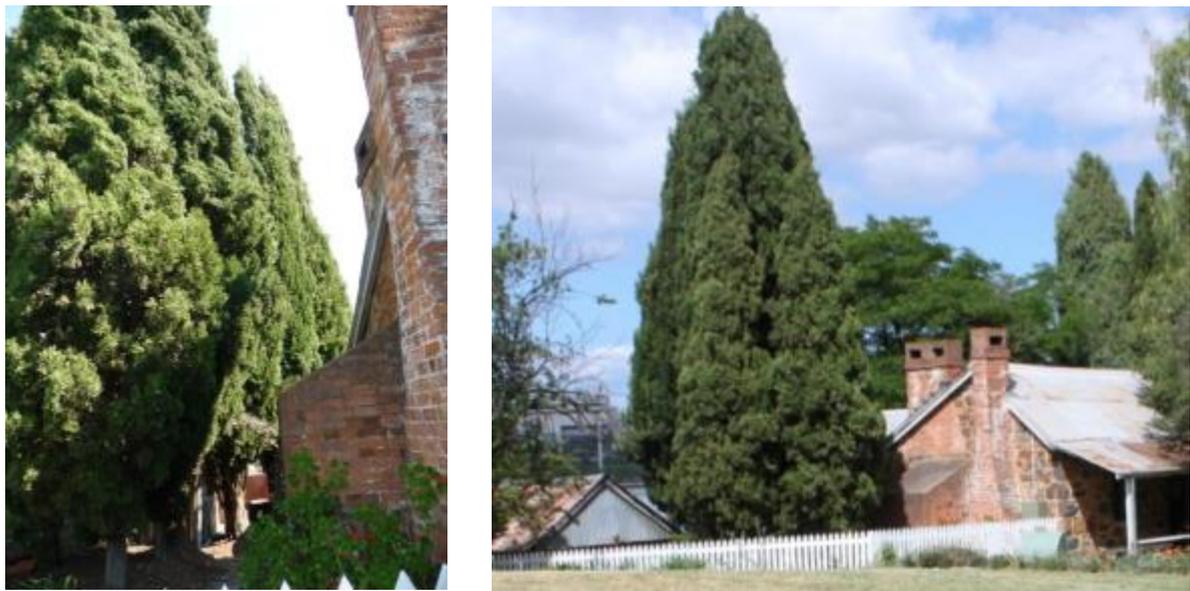
Figure D.9-D.10 Roman cypress trees between the stone cottage and the slab shed.

The Roman cypress trees between the cottage and slab shed are also problematic as they drop an enormous quantity of plant material on both buildings and the ground. This has resulted in past rotting of base plates and slabs in the shed that has necessitated expensive remedial work. These mature trees have become hazards to both significant buildings.

For the Roman cypress trees between the cottage and slab shed an assessment should evaluate the effects of planting a replacement specimen (propagated vegetatively from the existing specimens to retain the current variety and form) further from the buildings to reduce crowding and fire danger. This will enable the remaining pines to be managed by removal at a future time when the replacement tree has grown to gain some presence in the landscape.

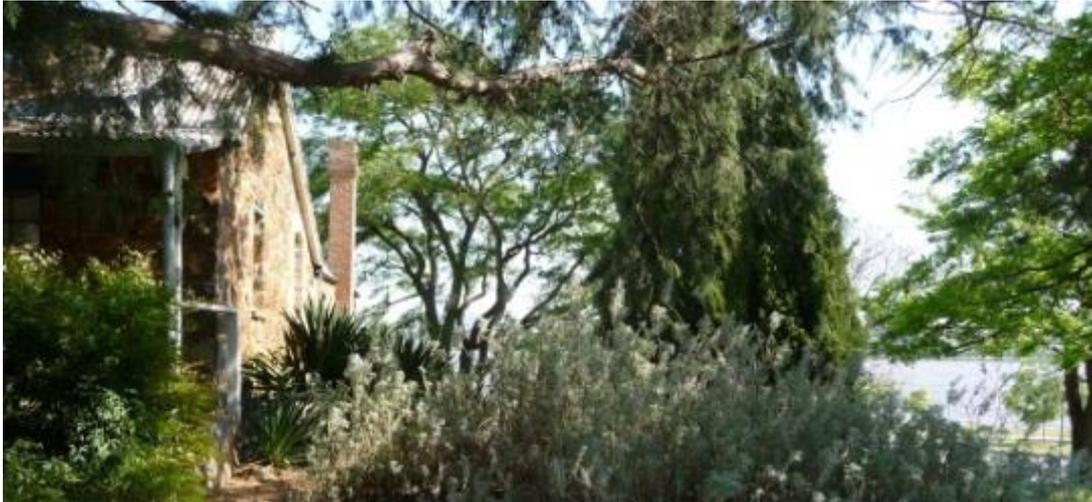
Figure D.11 Roman cypress trees at southwest of cottage obscure the view of the cottage from the Menzies Walkway along the side of the lake. (Source: GML 2012)

There are also Roman cypress to the southeast of the cottage which do not appear to be Oldfield era plantings and which obscure the view of the cottage from the lake edge approach path around from Commonwealth Park (Figure D.11 and D.12).

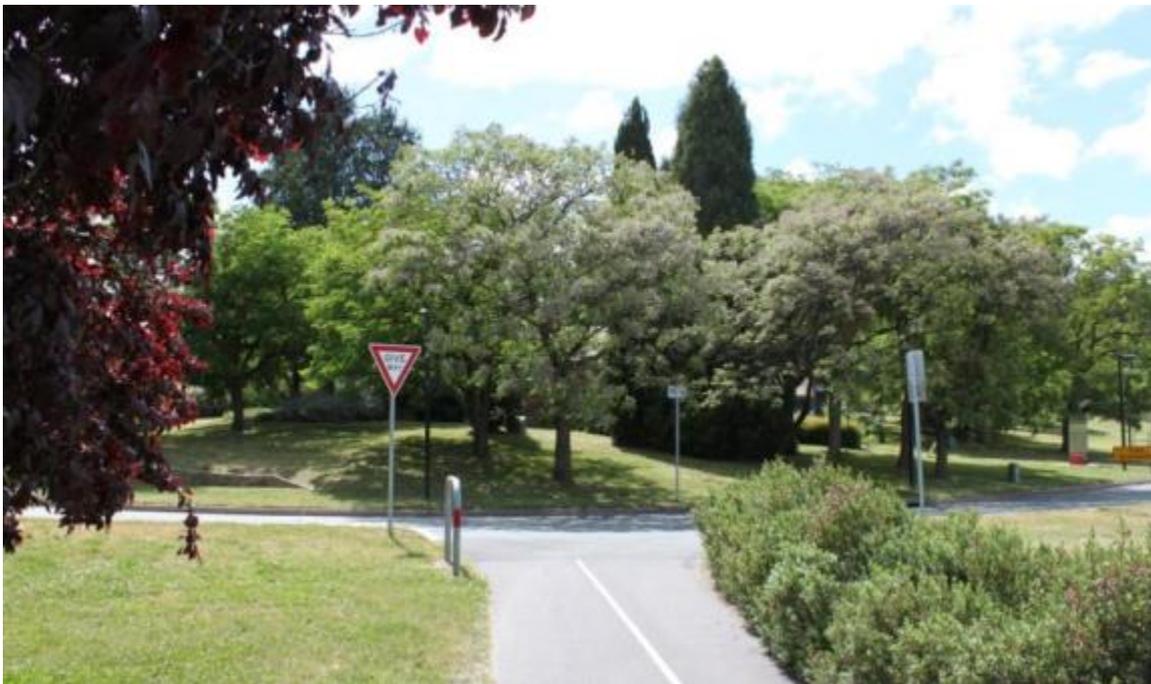
Figure D.12 View of Blundells from west approach pedestrian/cycle path arriving from Commonwealth Park. (Source: GML 2012)

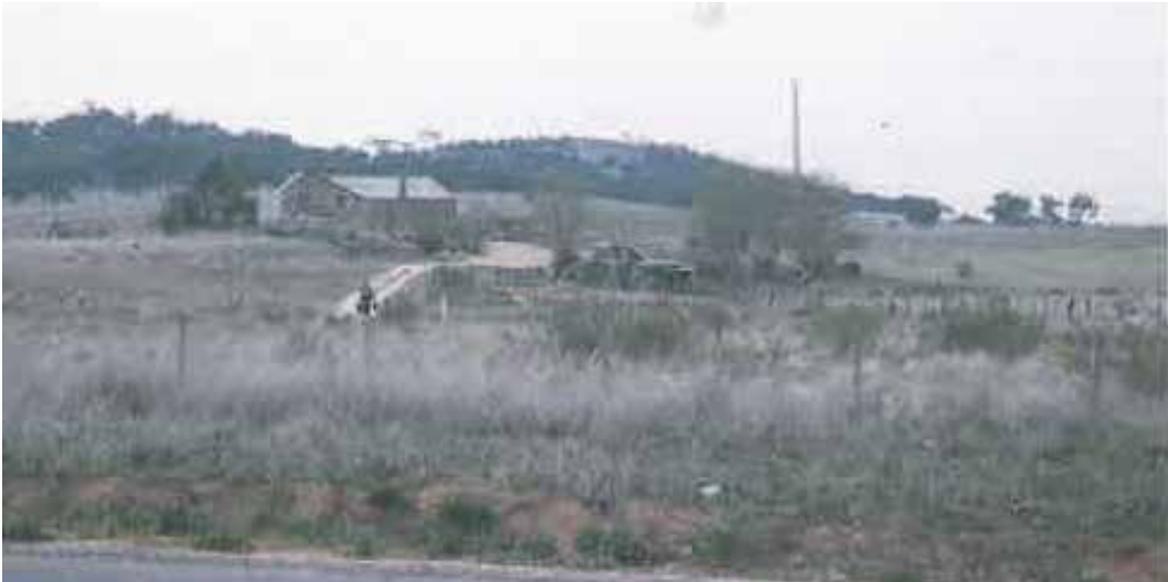
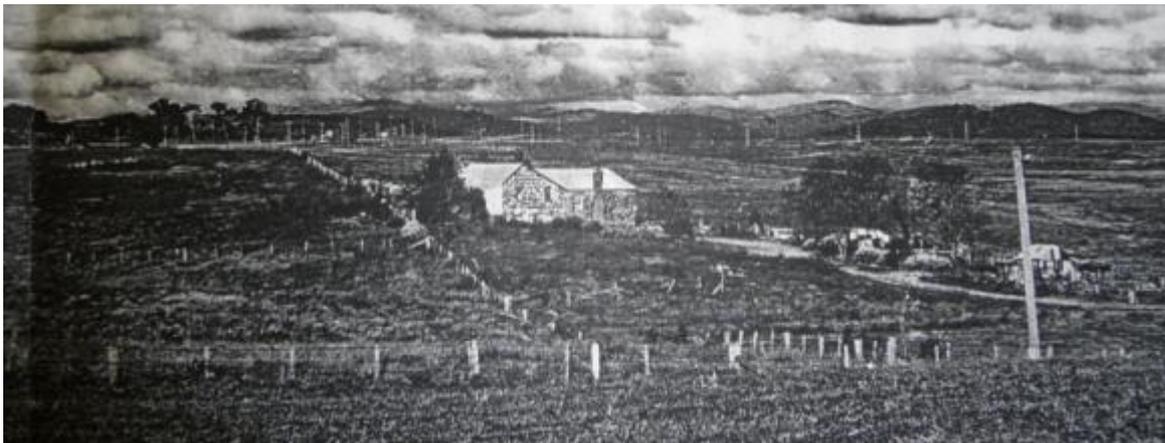
Figures D13-D.14 Historic view of Blundells from west approach 1957 showing the open landscape with few trees. Post and wire fences in existence. (Source: Photos from Beth Knowles, Canberra)

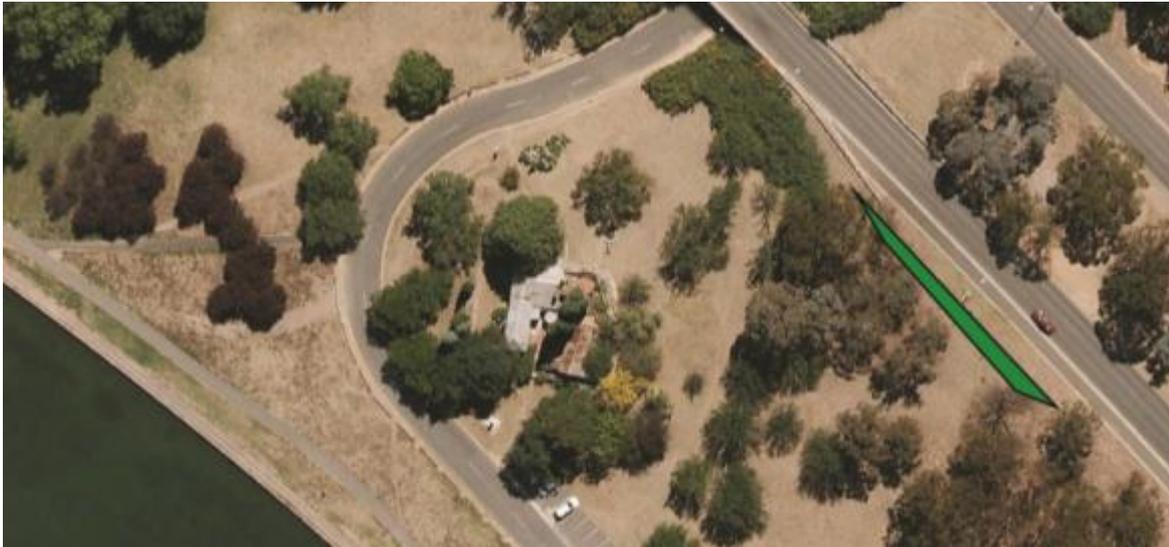
Figure D.18 Suggested position of earth berm to Parks Way shown.

One way to achieve this is to add an earthen berm (mound) in King's Park adjacent the highway and to plant dense vegetation in its proximity (Figure D.18). A heritage impact assessment would have to be undertaken to determine effects on both the heritage values of Blundells Cottage and on the heritage values of the King's Park landscape design.
