# Changi Chapel, RMC Duntroon

## Heritage Management Plan

Report prepared for the National Capital Authority

June 2013

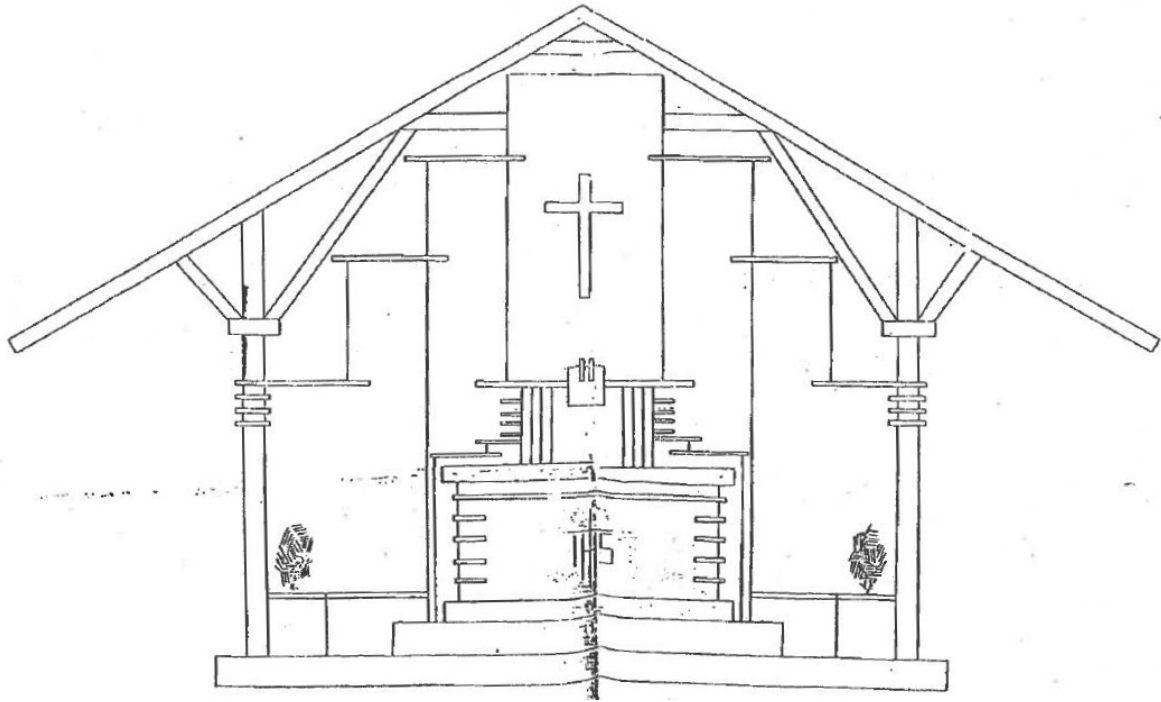
Figure 17: Drawing of Changi Chapel by MC Lee, 1946, showing internal rear wall and altar. (Source: ACS Reconstruction of Changi Chapel, March 1990, Annexure A2.5)

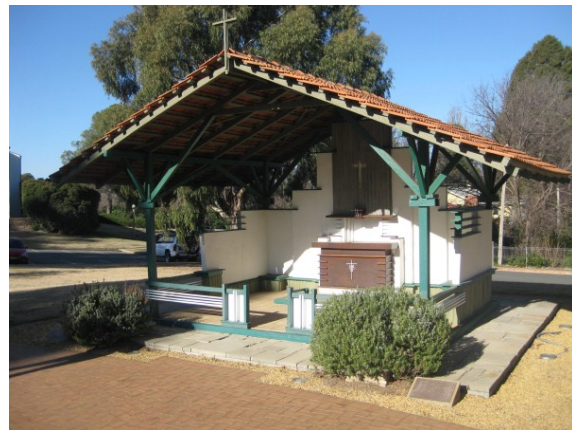
Figure 28: General view of Changi Chapel set on concrete tile base and gravel surroundings. (Source: GML, 2011)

The Chapel is unique in its design, with echoes of Art Deco styling in its features and detailing including the fine horizontal lines in the railings and altar details contrasting with the vertical altar panels, beams and gate posts (Figure 3.1, 3.26). The reconstructed Chapel building is an open timber-framed structure with a terracotta-tiled gable roof and partial walls on three sides. The whole building is set on a base of concrete pavers tiles laid in a randomly coursed pattern (an interpretation of the 'crazy' paving pattern found at Changi, Figure 2.9), surrounded by a 1200mm wide border of course gravel (Figure 3.12).

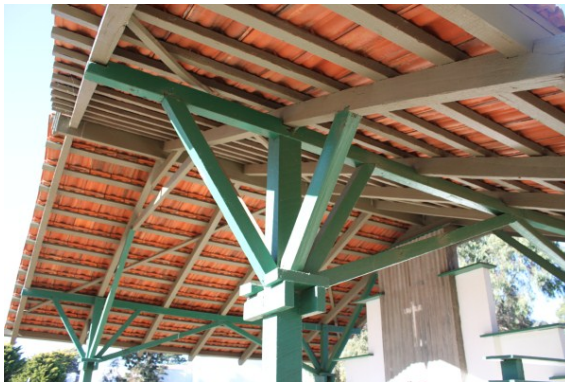
Figure 29: Timber frame construction with hardwood posts and supporting timber arms. (Source: GML, 2011)

The timber frame consists of four corner posts, each with five supporting arms branching out to support the roof beams and exposed timber rafters (Figure 3.13). The terracotta roof tiles are stamped, identifying them as Crown Brand tiles manufactured by the Malabar Tile Works at Feroke in India (Figure 3.14). A timber cross is positioned at the front on the gable of the roof (Figure 3.15). Identical replacement tiles were said to have been sourced from Saint Mary's Church at Rose Hill, Sydney and integrated with original tiles where necessary.

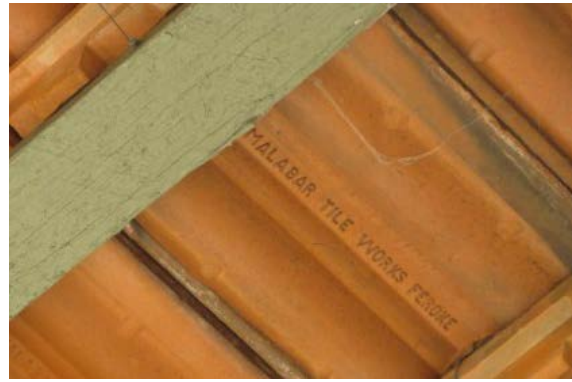
Figure 30: Roof tiles imprinted with 'Malabar Tile Works Feroke'. (Source: GML, 2011)

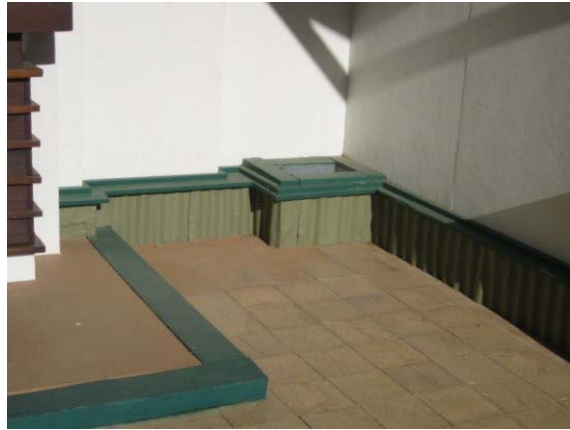
Figure 32: Wall detail showing corrugated-iron edging and planter box. (Source: GML, 2011)

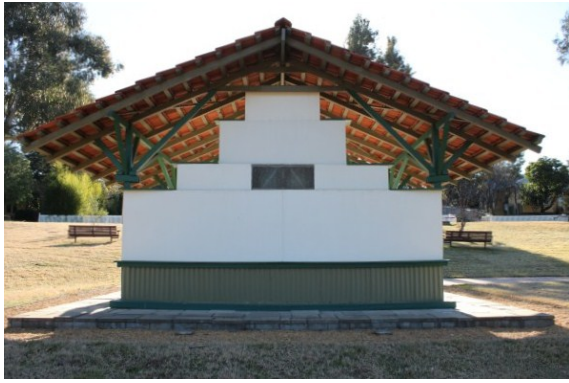
Figure 35: External rear wall of Chapel with glass panel to allow light in to the altar. (Source: GML, 2011)

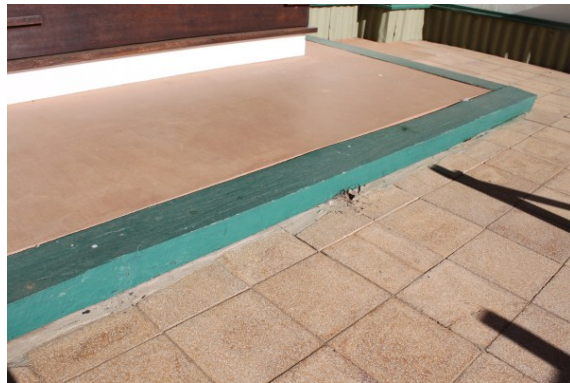
Figure 38: Raised altar platform and terracotta floor tiles. (Source: GML, 2011)

The floor is covered with speckled terracotta coloured tiles, some of which are cracked and are showing evidence of efflorescence (Figure 3.22). A low timber railing with a central gate painted green and white provides a visual enclosure for the Chapel.

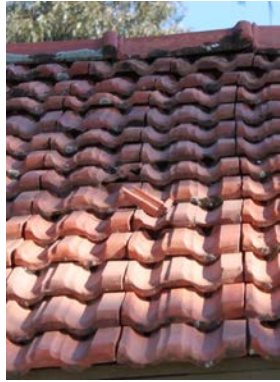
ELEMENT	CONDITIO N	IDENTIFIED ISSUE/S	RECOMMENDED WORKS	PRIORITY	TIMING	IMAGE
Roof tiles	Fair-Good	The corner of one tile on the north facing roof plane is broken, with the dislodged fragment still resting on the roof.	<ul style="list-style-type: none"> <li>- The broken tile should be replaced.</li> </ul> <p><i>NOTE: According 1989 Reconstruction Report, spare tiles were stored in the Chief Engineer’s Compound at Duntroon.</i></p> <ul style="list-style-type: none"> <li>- The broken tile and fragment should be returned to the storage area rather than being discarded.</li> </ul>	High	Immediately

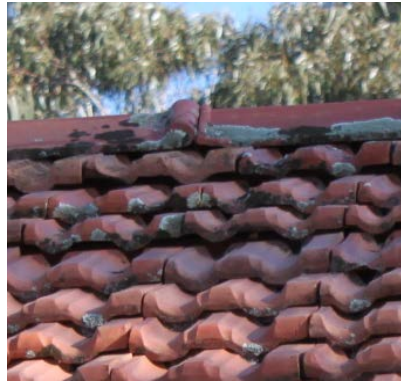
Roof tiles and ridge tiles	Fair-Good	Small amount of biological growth including lichen and algae.	<ul style="list-style-type: none"> <li>- Apply a biocide to the roof tiles to kill the lichen.</li> <li>- Once lichen is dead the tiles should be washed with a soft broom to remove biological growth. This should be done with a cherry picker to avoid damage to the tiles (CW).</li> </ul>	High	Immediately <i>At same time as tile repair</i>

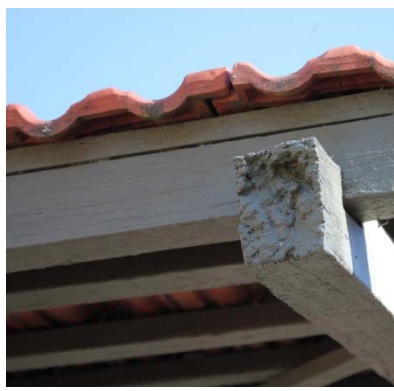
ELEMENT	CONDITIO N	IDENTIFIED ISSUE/S	RECOMMENDED WORKS	PRIORITY	TIMING	IMAGE
<b>Roof framing</b>	Good	Rafter ends have been recently restored and painted, in accordance with recommendations in the CW January 2011 report.	- Repainting should be undertaken as necessary with the original paint colours (as noted). <i>4:1 mix Cabots AC51 'Sagebrush Grey' and Cabots AC37 'Cardovian Brown'.</i>	High	As required

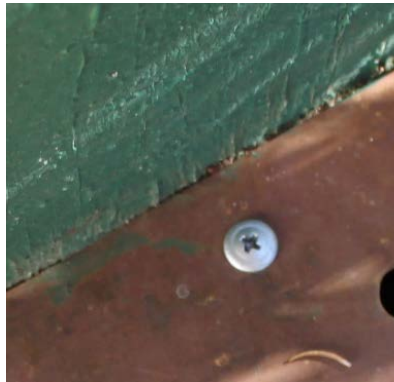
<b>Vertical posts</b>	Good	CW noted water inundation to drains at the base of posts has been resolved.  The cover plates have been re-secured using bright zinc-plated Phillips head screws, which although small are visually intrusive	- Water inundation should be closely monitored by inspection of sump holes and drains.	High	Annually (or more frequently if clogging is noted)

- Screws should be replaced with screws having a more appropriate patina, or painted to match the metal base plate.	Low	Within 5 years

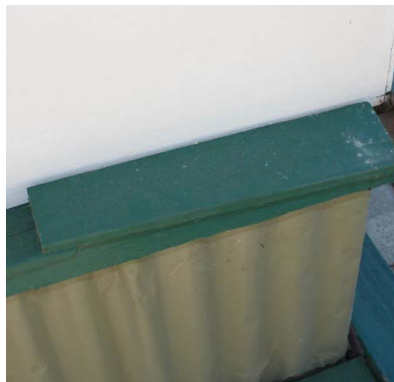
ELEMENT	CONDITIO N	IDENTIFIED ISSUE/S	RECOMMENDED WORKS	PRIORITY	TIMING	IMAGE
<b>Stud Walls</b>	Good	<p>Front edge of the two side walls leant outwards. These were stable on inspection.</p> <p>Current distance between the upper outer edges of the stud walls was measured as 5220mm.</p> <p>Minor works undertaken 2011 (CW).</p>	- A section of trim board is loose and needs to be re-attached with minimal visible impact.	High	Immediately

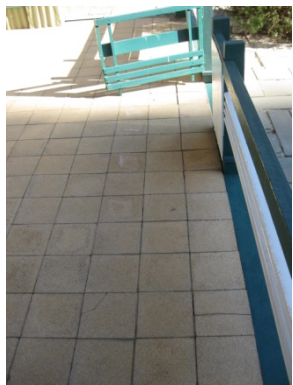
<p>- Corrugated iron to be touched up using Cabots AC51 'Sagebrush Grey'.</p> <p>- Touch up white paint with Pascal Timber 'White'.</p>	High	As required	
<b>Fence / communion rail</b>	Good	All elements were cleaned in 2011 in line with CW recommendation.	- Clean all elements regularly.	High	As required

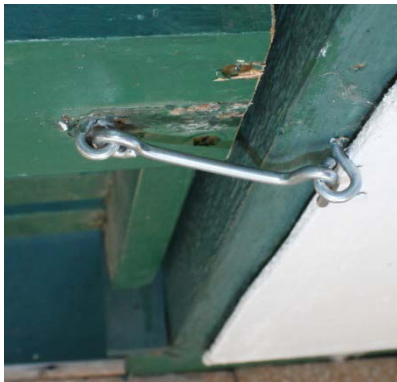
ELEMENT	CONDITION	IDENTIFIED ISSUE/S	RECOMMENDED WORKS	PRIORITY	TIMING	IMAGE
<p><b>Gate in communion rail—Latch</b></p>	<p>Fair</p>	<p>Minor repairs have been undertaken to the gate modern materials including zinc-plated catch.</p> <p><i>Note: Gate is not part of the original fabric.</i></p>	<p>- Fixings should be replaced with a sympathetic alternative.</p>	<p>Low</p>	<p>Within 5 years Simultaneously with other gate works.</p>

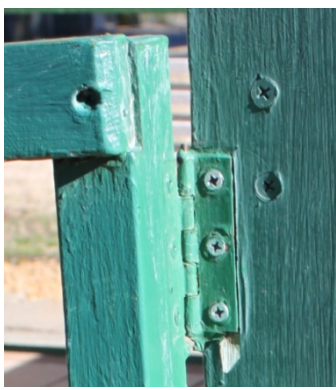
<p><b>Gate in communion rail—Screws in hinge</b></p>	<p>Fair</p>	<p>Minor repairs have been undertaken to the gate modern materials including modern Phillips head screws.</p> <p><i>Note: Gate is not part of the original fabric.</i></p>	<p>- Replace Phillips head screws with brass or steel slot head screws and apply touch-up paint in matching colour.</p>	<p>Low</p>	<p>Within 5 years Simultaneously with other gate works.</p>

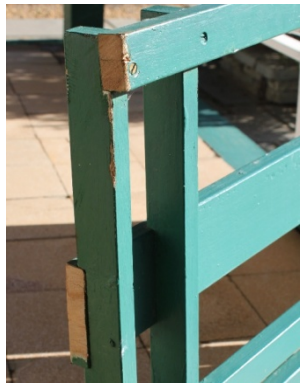
ELEMENT	CONDITIO N	IDENTIFIED ISSUE/S	RECOMMENDED WORKS	PRIORITY	TIMING	IMAGE
<b>Gate in communion rail— exposed end-grain</b>	Fair	The end grain on several sections of the gate rails and edges are unpainted. <i>Note: Gate is not part of the original fabric.</i>	<ul style="list-style-type: none"> <li>- Paint exposed timber on gate</li> <li>- Obtain colour match</li> <li>- Prime bare timber and apply two coats of paint finish having the same gloss level as existing.</li> </ul>	Low	Within 5 years Simultaneously with other gate works.

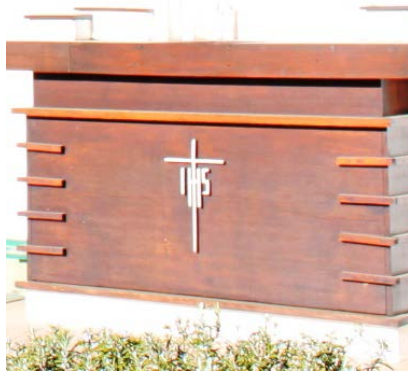
<b>Altar and Surrounds</b>	Fair	Some timber battens to the front and sides of the altar are loose. If not attended to, the battens could fall off and be lost.	<ul style="list-style-type: none"> <li>- The solution may be to firmly punch nail heads, although this may need to be reassessed more closely at time of repair.</li> <li>- Work should be carried out by appropriately qualified cabinet maker.</li> </ul>	High	Immediately

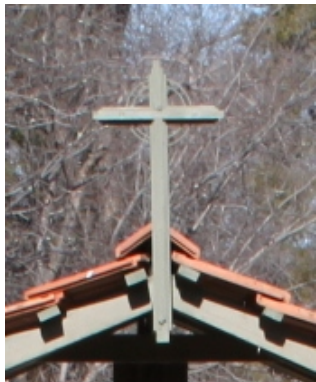
ELEMENT	CONDITIO N	IDENTIFIED ISSUE/S	RECOMMENDED WORKS	PRIORITY	TIMING	IMAGE
<b>Cross</b>	Good	Stabilised in line with CW recommendations 2011.	<ul style="list-style-type: none"> <li>- Monitor condition</li> <li>- Repaint and stabilise as required</li> </ul>	High	As required

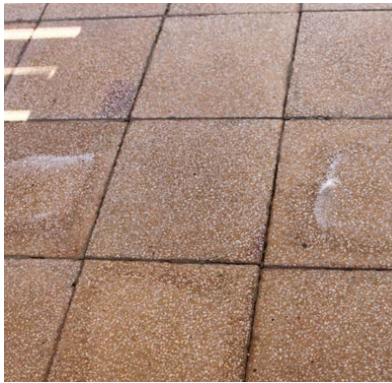
<b>Terrazzo tile floor (interior of Chapel)</b>	Fair	<p>Most of the tiles are 'drummy' when tapped and some are obviously loose.</p> <p>There is the potential for loose tiles to crack.</p> <p>Evidence of cement mortar substrate losing holding power.</p> <p>Efflorescence on tiles due to free salts leaching surface.</p> <p>Evident on three tiles.</p> <p>Water staining on the edge of most tiles.</p> <p>CW stated cause may be damp substrate from previously blocked</p>	<ul style="list-style-type: none"> <li>- Short term—lift individual tiles, consolidate the substrate and re-glue using modern waterproof adhesive.</li> <li>- Long-term—lift all tiles, remove mortar and relay the tiles on a new mortar bed.</li> <li>- Work to be undertaken by a tiling specialist.</li> <li>- Existing salts should be washed off and tiles monitored for fresh efflorescence.</li> <li>- If efflorescence returns, investigate poultice measures such as 'Cocoon'.</li> </ul>	Medium	Within 24 months

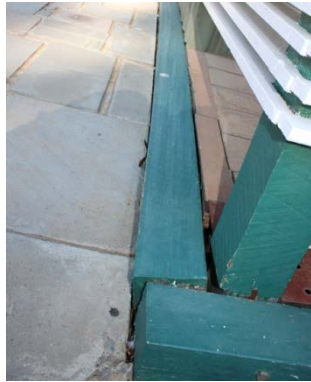
<p><b>Rotation of northern ring beam</b></p>

<b>Timber ring beams</b>	Fair	<p>The ring beam comprises four lengths of 100 x 100 m (approx) timber that encircles the Chapel and forms an edge to the tiling between the tiling and crazy paving. Its condition and species varies.</p> <p>The northern beam is hardwood that has twisted and rotated away from the chapel.</p> <p>The eastern beam is also hardwood and appears to</p>	<p>- The southern (Oregon) beam should be re-secured to the posts or otherwise restrained.</p> <p>- Currently sits below the edge of the tiles and should be raised or replaced with a more durable species.</p>	Medium	Within 24 months.

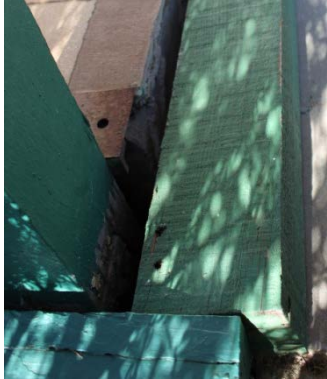
ELEMENT	CONDITIO N	IDENTIFIED ISSUE/S	RECOMMENDED WORKS	PRIORITY	TIMING	IMAGE
		<p>be stable.</p> <p>The southern beam appears to be rough sawn Oregon, and is unsecured.</p> <p>The western beam, (supporting the communion rail and gate) has been coach bolted to the northern and southern posts since the beam was last painted.</p> <p>There is timber decay to the underside at the southern end, although it appears stable at present.</p>

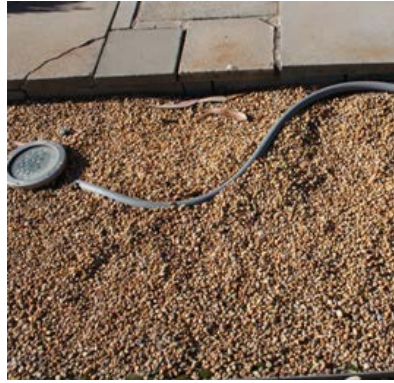
<b>Electrical services</b>	Poor	Historically there was a reflector plate behind the light bulb, this is no longer in place.	<ul style="list-style-type: none"> <li>- Fabricate a new reflector plate</li> <li>- Replace the current energy saving light bulb at the ridge beam with a traditionally shaped light bulb.</li> <li>- Reinstate ground lighting as required.</li> <li>- New ground lighting should be non-intrusive and subject to heritage advice.</li> <li>- Check electrics to ensure they are still safe and pose no risk of fire or short</li> </ul>	Medium	Within 24 months

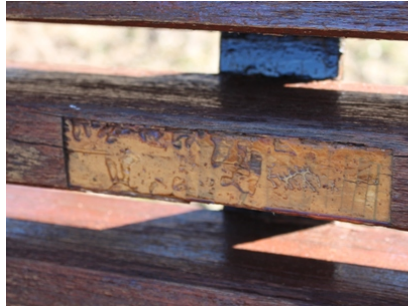
ELEMENT	CONDITIO N	IDENTIFIED ISSUE/S	RECOMMENDED WORKS	PRIORITY	TIMING	IMAGE
			circuit.			
<b>Plaques</b>	Good	A commemorative plaque on one seat is missing.	- Research text on original plaque and reinstate.	Medium	Within 24 months

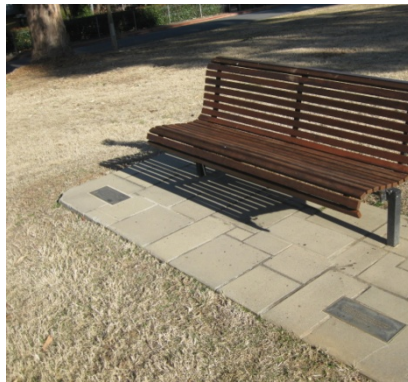
<b>Memorial benches</b>	Good	- Timber bench seats were restored and recoated in 2011.	- Monitor condition of benches and maintain as required.	High	Ongoing

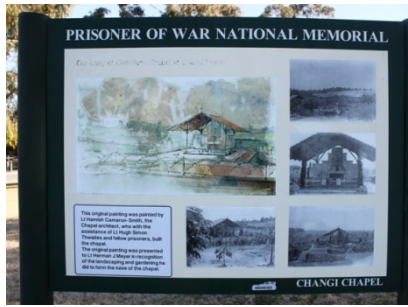
ELEMENT	CONDITIO N	IDENTIFIED ISSUE/S	RECOMMENDED WORKS	PRIORITY	TIMING	IMAGE
<b>Interpretive signage</b>	Poor-Fair	The current signage is faded and peeling.	<ul style="list-style-type: none"> <li>- Upgrade existing signage in the short term if possible.</li> <li>- Replace signage in line with an Interpretation Strategy.</li> </ul>	High	Within 24 months

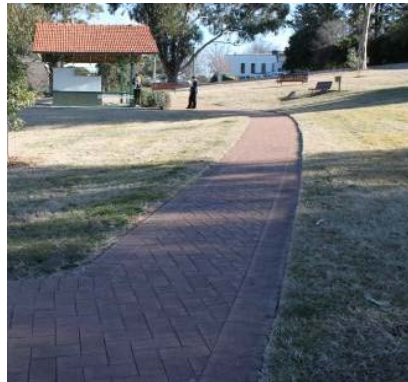
<b>Pedestrian paths</b>	Good	Current pedestrian paths do not link, and are not consistent with the historic character of Changi Chapel.	<ul style="list-style-type: none"> <li>- Investigate options to link pedestrian paths and upgrade in line with any changes to the landscape surrounding the Chapel.</li> </ul>	Medium	Within 5-10 years
