3.0 Understanding the Place—Built Elements & Archaeology

3.2 Physical Description of Blundells Cottage

To the west of the cottage a number of small huts were used for storage and a variety of home farm purposes, including an apiary for bees, while to the east another shed (described as old in 1923) was associated with the smaller paddocks used for stacking wheat and hay. Historic photographs and maps indicate that boundary fences were post and rail with slip rails in lieu of gates.⁷⁵

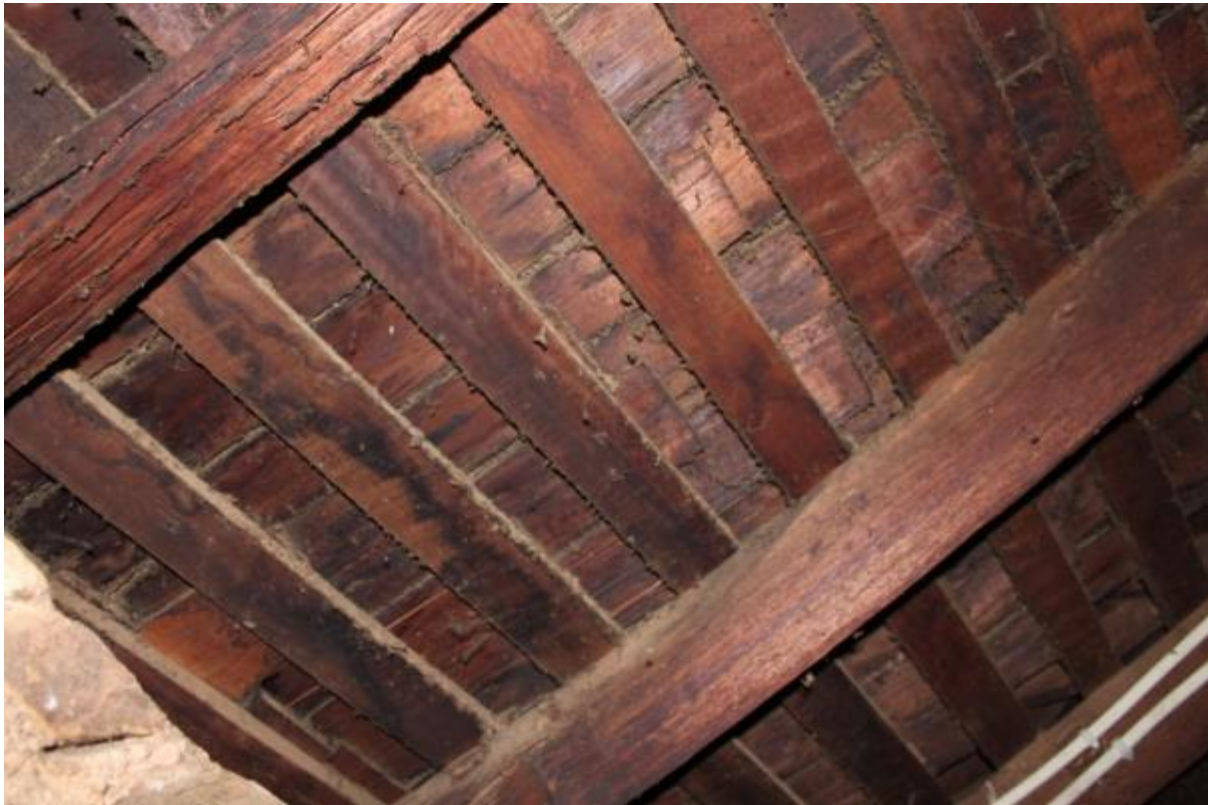
Roof—Shingles: The roof over the original part of the cottage was initially split timber shingles on pit-sawn timber battens supported in turn by split timber rafters, all of which are still in place beneath the iron (Figure 3.7). The material is most likely to have been sourced locally or regionally, although the timber has not been determined.

Figure 3.7 Underside of roof above parlour showing 1859 split rafters, sawn battens and shingles. (Source: GML 2013)

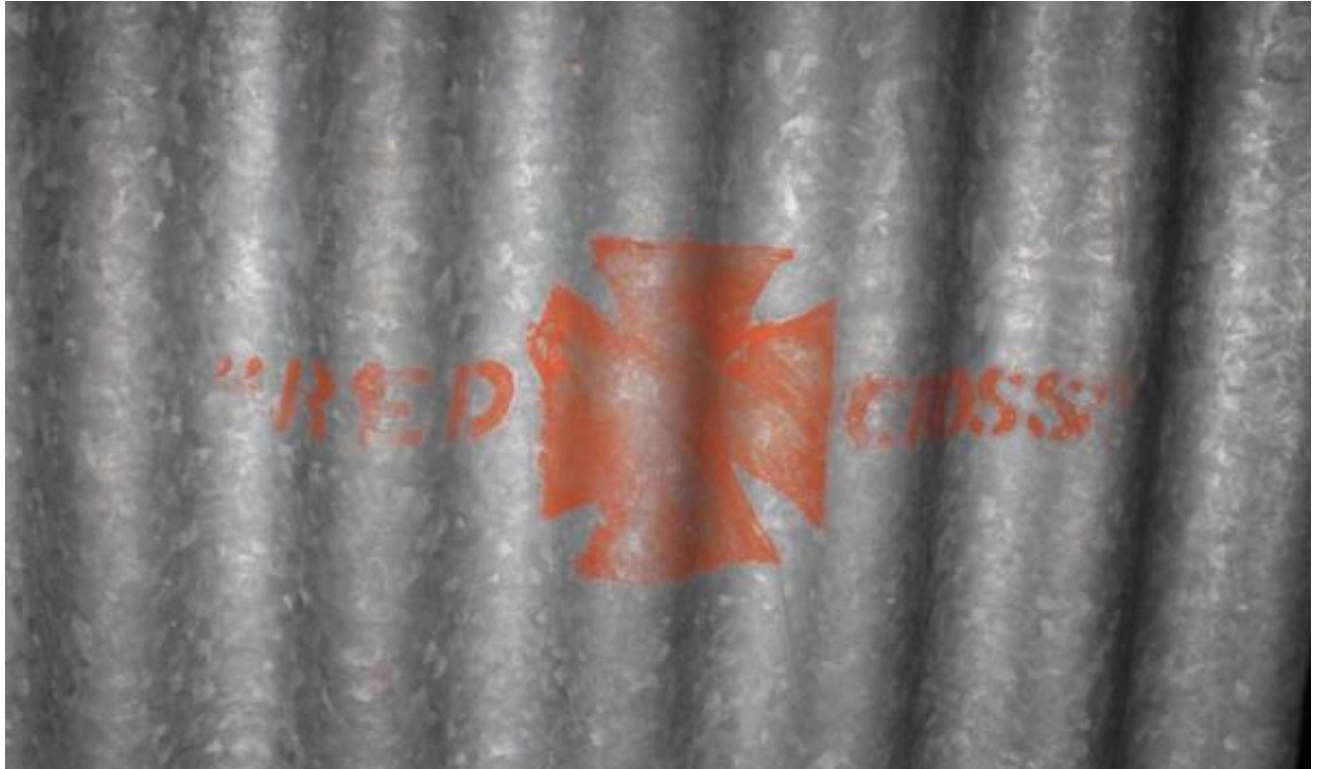
Roof—Iron: In 1888 corrugated galvanised iron was laid over the shingles. At that time corrugated iron roofing was still being imported, however, there is no brand marking on the underside of the verandah iron and the underside of the material over the shingles is not visible without removing the sheets. It is most likely that the iron on the front section of the cottage was installed when the cottage was extended in 1888 and the same iron may have been used. The iron on the rear section is branded 'Red Cross' (Figure 3.8). Miles Lewis records the Red Cross brand as dating from 1888 and described it as 'Red [Maltese cross-cum-square rosette] Cross' all in red.⁷⁹

Figure 3.8 Red Cross marking on underside of roof iron above the office. (Source: GML 2013)

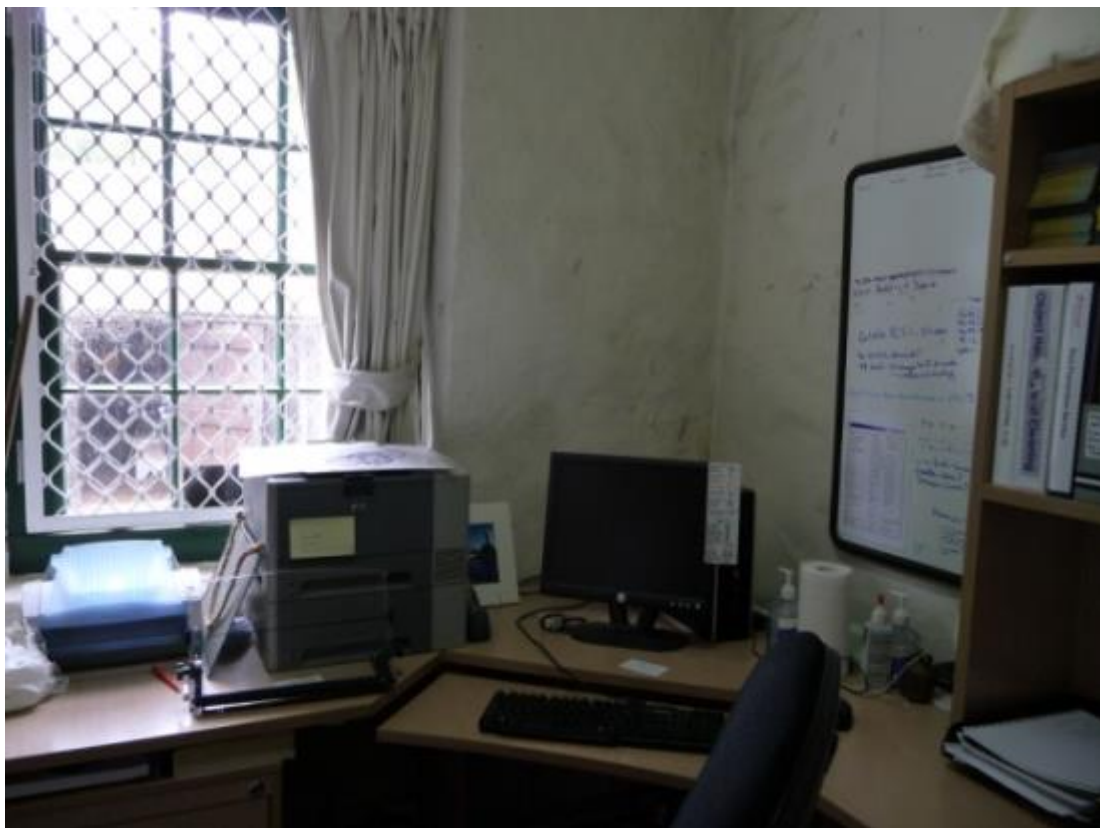
Room Number 1

Figure 3.19 Room 1. (Source: GML: 2013)

Room Element	Date	Form/Fabric Earlier Treatments	Condition	Significance of Element	Tolerance for Change Ranking
Ceiling	1963	Fibrous plaster sheets with milled quad timber cornice. Sisalkraft	Good	The ceiling rafters and fibrous plaster ceiling was installed in 1963. Sympathetic—Low.	High.
Floor	1888	Butt jointed hardwood flooring (150 x 50) with hardwood subfloor. Carpet in 2013. Plain brown linoleum in 1970 and relaid 1979, and patterned linoleum earlier. ⁸⁷	Good. Subfloor not inspected but feels firm.	2013 Carpet—Low. Earlier linoleum—Moderate. Hardwood flooring—High.	Carpet—High. Linoleum—Moderate. Hardwood flooring—Moderate.
Wall	1888	Crudely rendered with subsequent coats of limewash. Current treatment is white limewash. Freeman refers to presence of earlier layers of limewash. The pale beige evident in 1994 may have been applied in 1963. Note the two major wall cracks had been repaired in 1963 requiring the addition of 'compo mortar'. ⁸⁸	Good	Wall render—Moderate. Pre 1994 limewash—Moderate.	High. High.

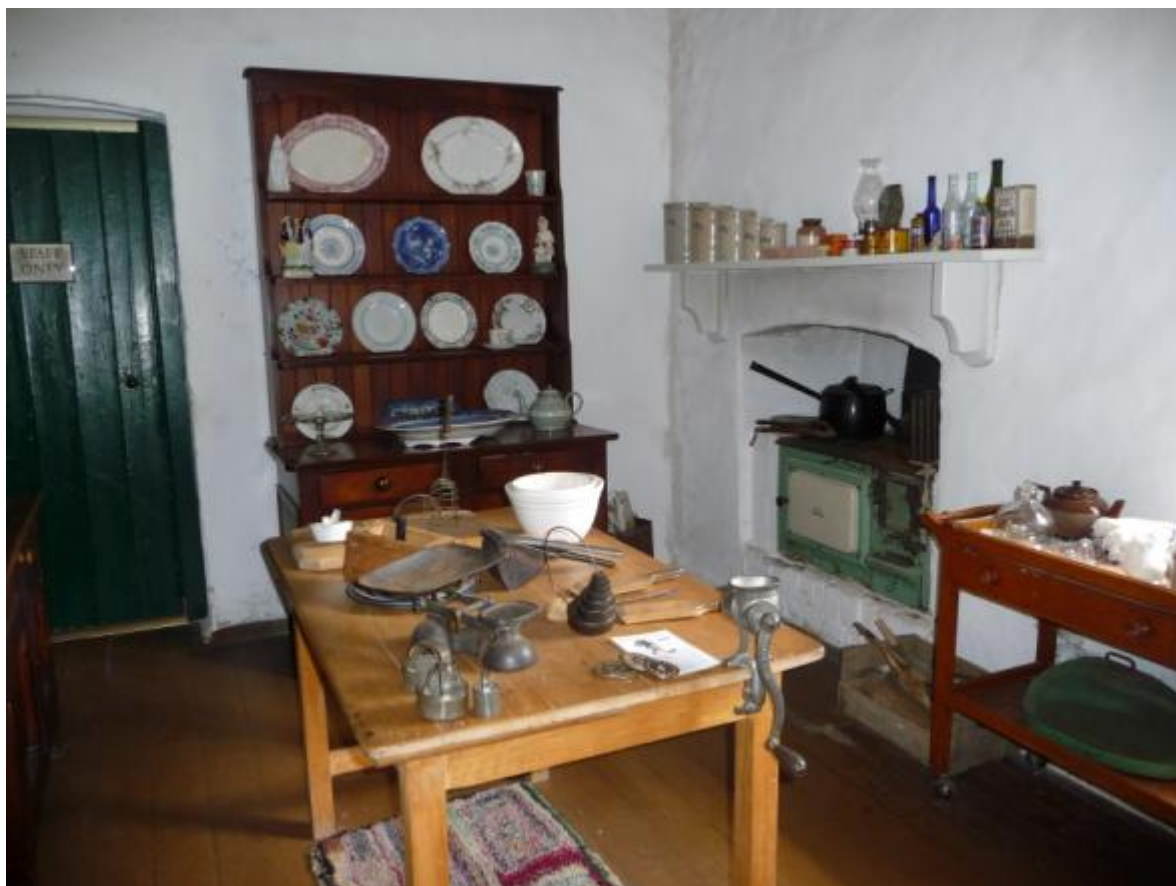
Room Number 2

Figure 3.20 Room 2. (Source: GML: 2013)

Room Element	Date	Form/Fabric Earlier Treatments	Condition	Significance of Element	Tolerance for Change Ranking
Ceiling	1964	Fibrous plaster as per Room 1. Sisalkraft	Good.	Low.	High.
Floor	1888	Butt jointed hardwood flooring (150 x 50) with hardwood subfloor. Linoleum in 2013. Plain brown linoleum in 1970 and relaid 1979, and patterned linoleum earlier. ⁸⁹ There is a small piece of earlier linoleum in the threshold between Room 2 and the porch.	Fair, although it is being impressed by the irregularities of the boards below.	Moderate.	Moderate.
Wall	E S & W:	Stone walls with rough render finish	Extensive penetrating	Original stonework: High.	Low. Moderate.

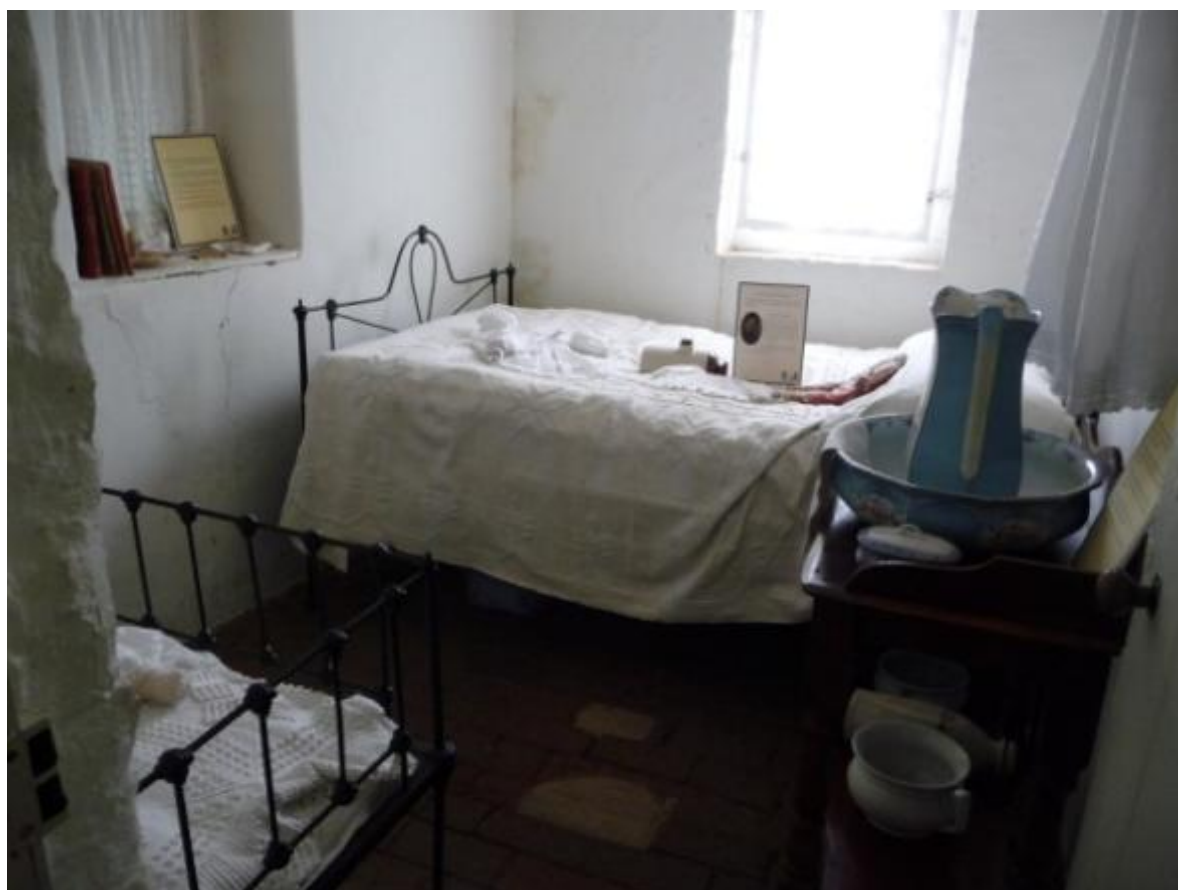
Figure 3.21 Room 3. (Source: GML 2013)

Room Element	Date	Form/Fabric Earlier Treatments	Condition	Significance of Element	Tolerance for Change Ranking
Ceiling	Post 1994	Hessian, a sympathetic modern introduction.	Good	Sympathetic but not original—Low.	High.
	1977	Recycled lining boards installed.	Good	Moderate.	Moderate.
	Pre 1960	Fibro sheeting was installed probably before 1960.	Cox report records tar paper which is not visible.	Late addition to fabric of cottage—Low.	Asbestos content—High.
Floor	1859	Sand stock brick laid in stretcher bond. Worn bricks repaired with cementitious mortar. Painted red.	Good	Original fabric—High.	Low. Can be repainted after investigation of original colour.
Wall	1859	Random rubble rendered and limewashed. A horizontal timber board (100 x 50mm) is fixed to the wall. The render above the	Good	Stone wall is original fabric—High. Hessian wall extension from ceiling is sympathetic introduced fabric—Low.	Hessian wall—High. Stone walls—Low.

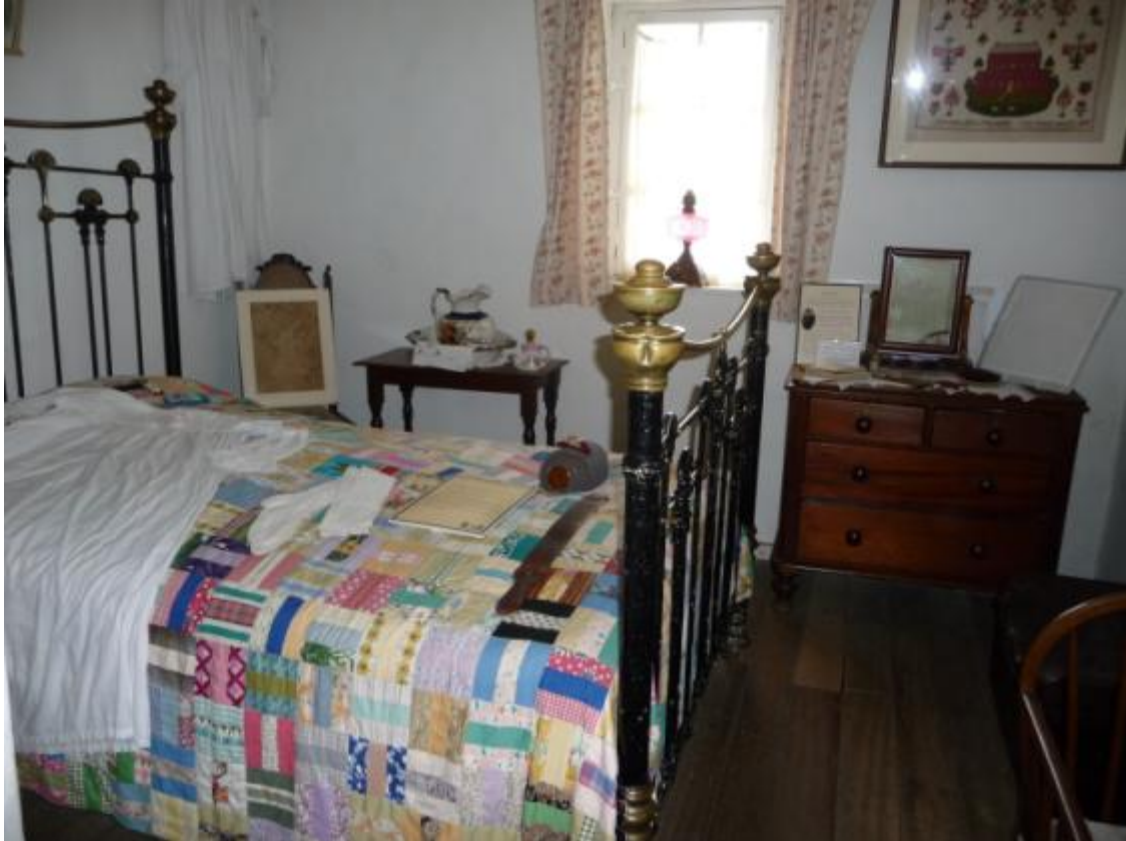
Room Number 4

Figure 3.22 Room 4. (Source: GML 2013)

Room Element	Date	Form/Fabric Earlier Treatments	Condition	Significance of Element	Tolerance for Change Ranking
Ceiling	1977 Pre 1960 1859	Lining boards. Asbestos sheeting. Lath and plaster. The rafters were sawn, and the walls above were never rendered or limewashed, suggesting an early intention to have a ceiling over the bedroom.	Good In situ No longer extant, however, evidence can be seen on ceiling rafters adjacent to the manhole	Even though introduced, the boards have some importance as sympathetic material recycled from an old homestead in Murrumbateman—Moderate. Sheeting is fabric from the occupancy phase, but the material is not rare and contains asbestos—Low. The rafters are highly significant—High.	Lining boards—Low. Sheeting—High due to the asbestos content. Rafters—Low.
Floor	1859	150 x 25 butt jointed hardwood.	Subfloor space is	The originality of the floor is unclear, although it	The floors have already been

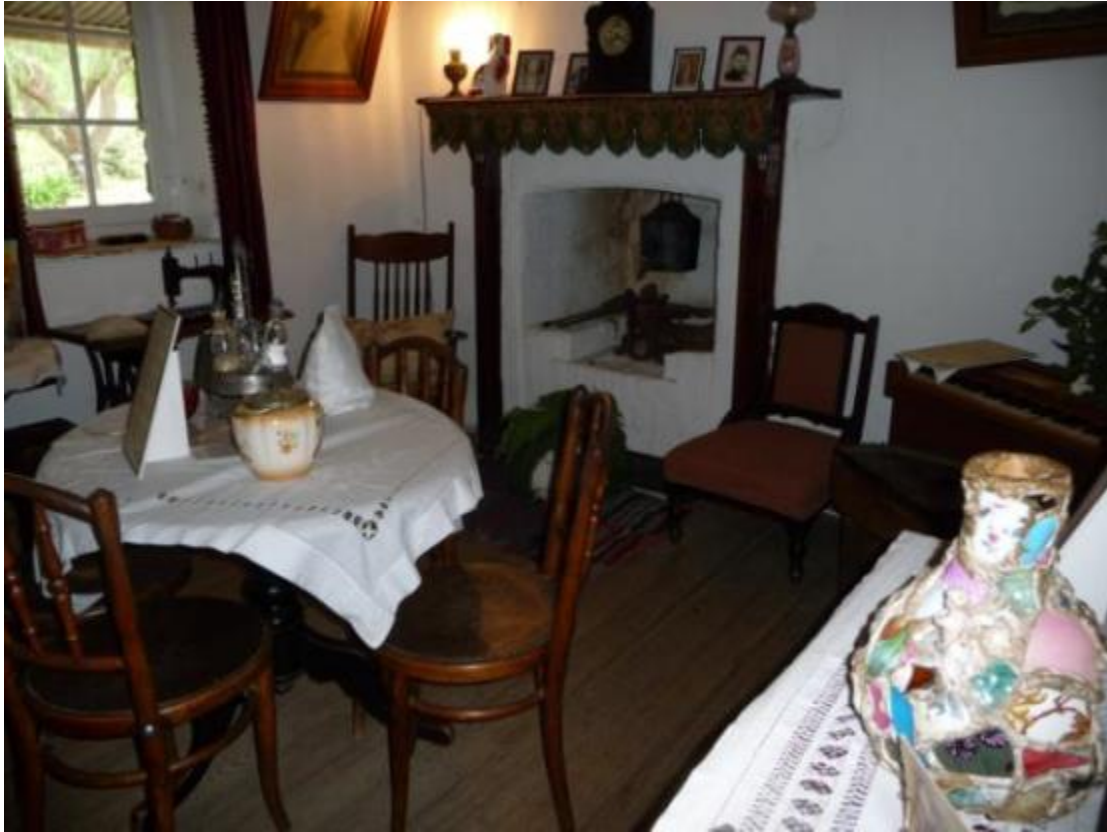
Figure 3.24 Room 6. (Source: GML 2013)

Room Element	Date	Form/Fabric Earlier Treatments	Condition	Significance of Element	Tolerance for Change Ranking
Ceiling	1977	<p>Painted lining boards under sheet (presumably asbestos).</p> <p>Initially there was no ceiling. The limewashed wall render extended through to the underside of the shingles and a hessian barrier hung above the dividing wall between Rooms 6 and 5.</p> <p>Probably in the early to mid twentieth century an asbestos sheet ceiling was added to the underside of the existing ceiling joists. Boards were added in 1977.</p>	Fair	<p>Lining boards and asbestos sheet—Low.</p> <p>Original ceiling joists and hessian—High.</p>	<p>Lining boards and asbestos sheet—High.</p> <p>Original ceiling joists and hessian—Low.</p>
Floor	1888 at least	150 x 25 butt jointed hardwood. Freeman notes the flooring is on joists resting on	Sound	The timber flooring could date from before 1888 and is significant as being from the residential occupancy	Incremental repairs—Moderate.

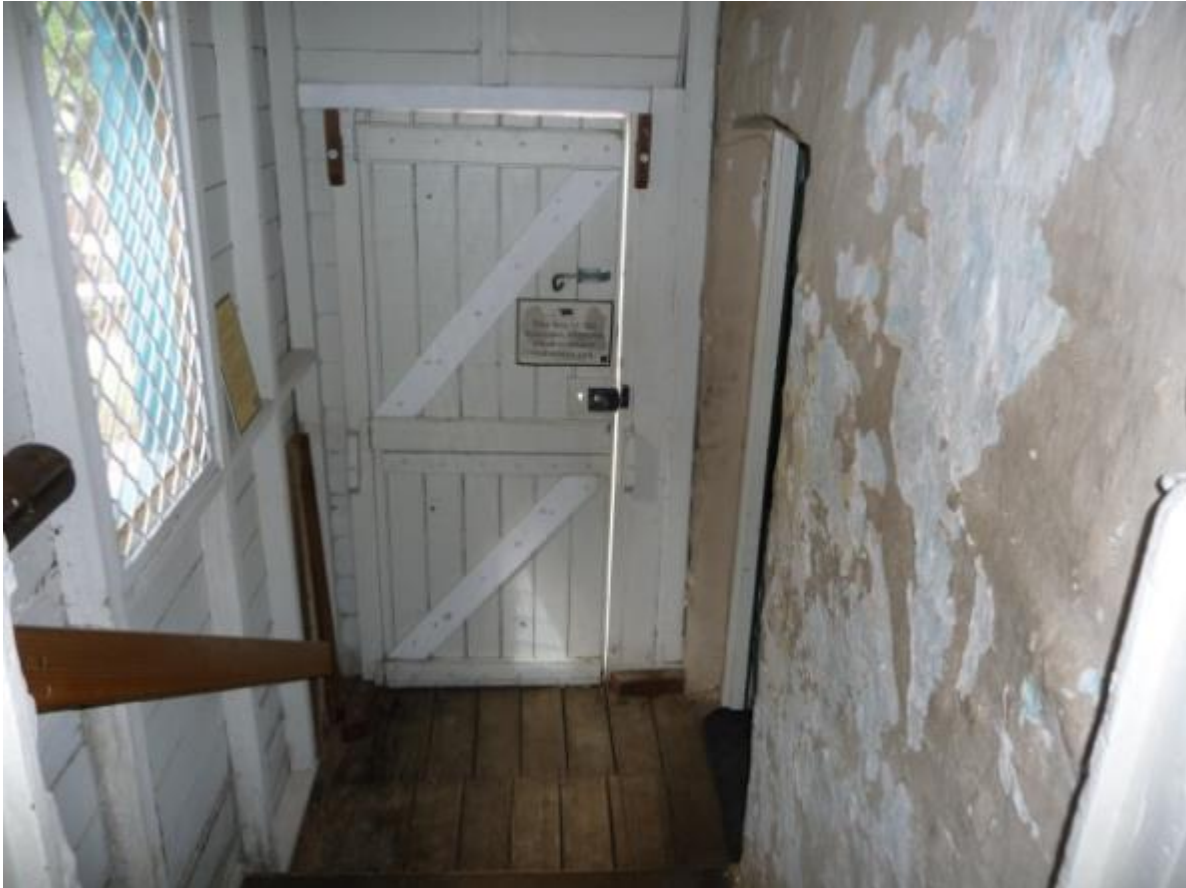
Room Element	Date	Form/Fabric Earlier Treatments	Condition	Significance of Element	Tolerance for Change Ranking
Ceiling	Post 1994	Hessian Lining boards probably installed in 1977. Historic ceiling not known.	Stains evident at northern end.	Low	High
Floor	Post 1888	Timber stairs with linoleum covering. Butt jointed 125 x 25 timber boards on landing. Linoleum appears to predate 1960. Weathered ends of landing boards previously replaced.	The ends of the replaced boards are weathered again and may need to be repaired or replaced.	The short lengths of flooring are fairly standard for the time and not especially significant—Moderate. The linoleum on stairs appears to predated 1960—Moderate.	Floor boards—Moderate. Linoleum on stairs—Moderate.
Wall	Wall: 1888 Board : 1963	Rendered and painted stone wall. Inside face of painted weatherboards on a timber stud frame The rendered wall retains an excellent sequence of colour schemes. White paint to timberwork probably from 1963. Original treatments not known. Porch post-dates to c1888. Clad in fibro pre-1960 (possibly in the 1930s) and replaced with current weatherboards in 1963.	Loose plaster in top right corner of rendered wall. Water stains on inside of boards.	The sequence of paint treatments on the stone wall—High. Timber frame/weatherboards—Low.	Rendered wall—Low. Timber frame—Moderate. Weatherboards and white paint—High.

Window	Post 1964	Fixed glass with security screen to the inside. The window was present in 1994.	Sound	Introduced window—Low. Security screen—Intrusive.	High
Door	Post 1964	Ledged and braced with vertical timber board panelling	Appears to be sound.	The door is sympathetic but not individually significant—Low.	High

Figure 3.25 Porch. (Source: GML 2013)

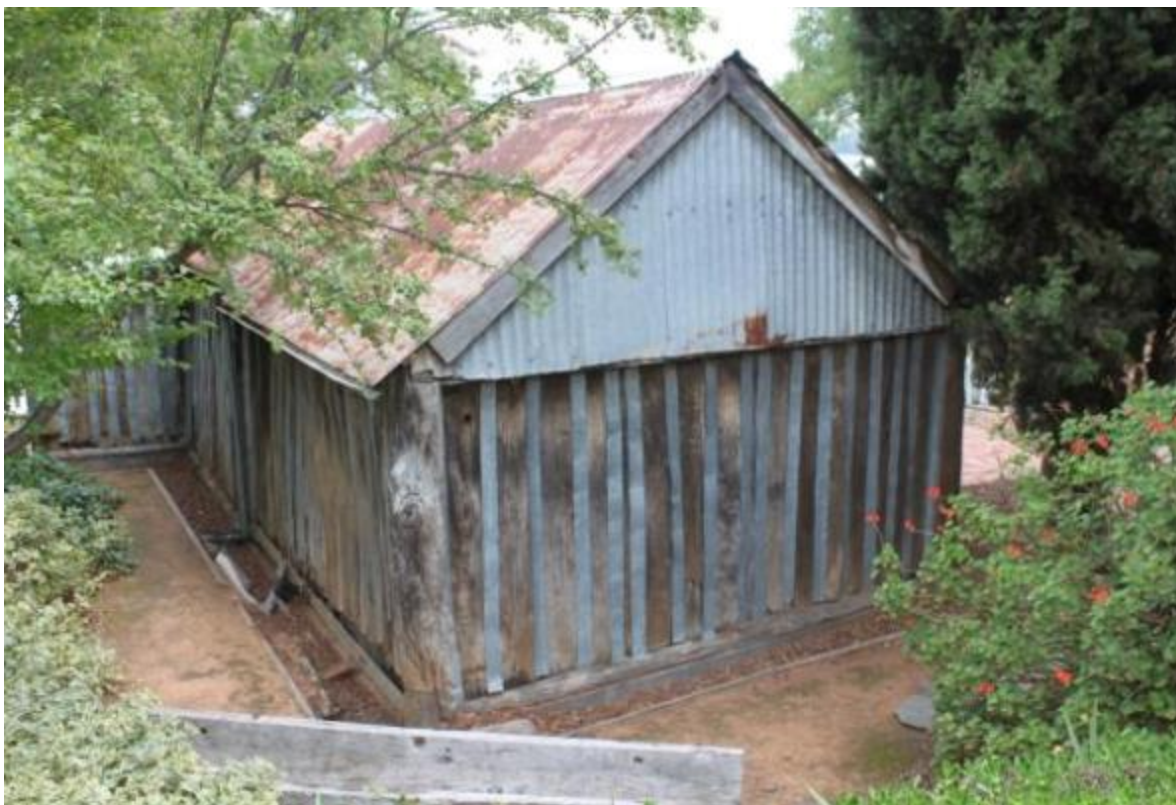
Slab Shed North Elevation

Figure 3.26. North elevation of Slab Shed. (Source: GML 2013)

Room Element	Date	Form/Fabric Earlier Treatments	Condition	Significance of Element	Tolerance for Change Ranking
Roof	Circa 1888	No maker's mark visible on iron but likely to have been reroofed at similar time to main cottage. Corrugated galvanised iron with steep roof pitch (approximately 40 degrees). Plain timber barge boards probably from 1963.	Extensive rusting to the surface.	As original fabric the iron has a high level of importance and includes the location of former flue pipes etc—High.	The iron should be retained for as long as possible—Moderate.
Wall		Vertical slabs between base and top plates with galvanised iron cover strips. Bush posts at corners. Corrugated galvanised iron to gable. The iron appears to be original and has not been painted. Evidence suggests a chimney fireplace on this wall—served	Sound	Gable iron, corner posts and top plate—High. Introduced slabs—Moderate. Base plate Low Galvanised cover strips—Low (but any replacement should follow advice above) and policy 6.2.2.	Low for significant items. Slabs, and base plate—High. Cover strips—Moderate

Room Element	Date	Form/Fabric Earlier Treatments	Condition	Significance of Element	Tolerance for Change Ranking
		<p>former kitchen/dining block. Traces of mortar on the lower edge of gable iron may be all that remains.</p> <p>The north wall was reconstructed in 1967, although it is assumed this was the slabs only. The attached skillion outhouse is on the RHS.</p>

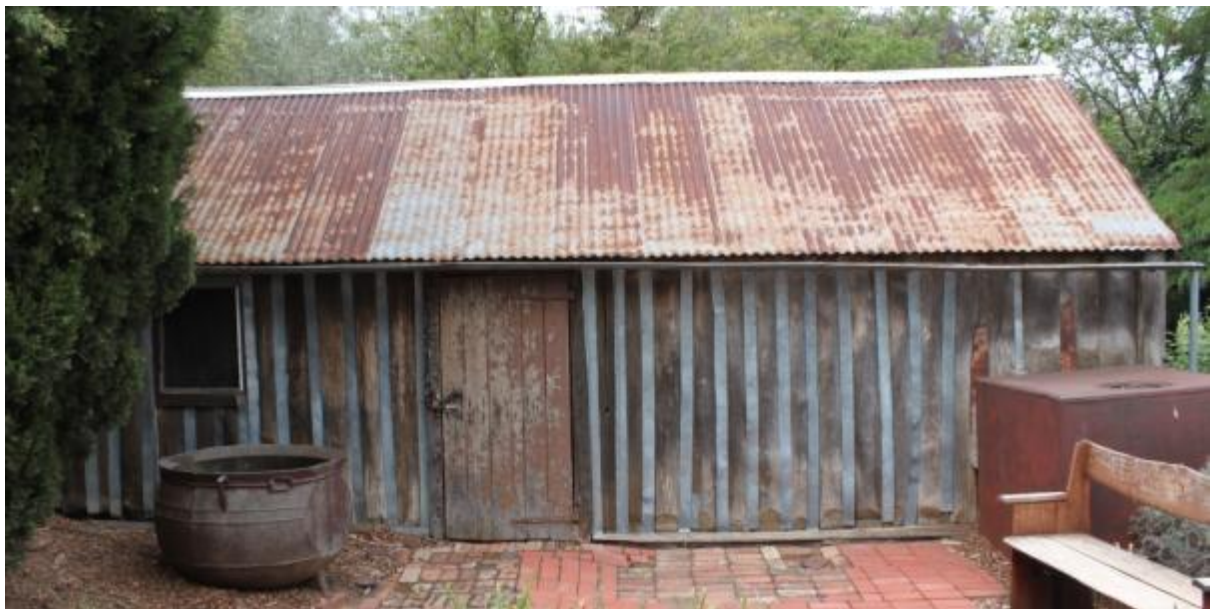
Slab Shed West Elevation

Figure 3.27 Slab Shed West elevation. (Source: GML 2013)

Room Element	Date	Form/Fabric Earlier Treatments	Condition	Significance of Element	Tolerance for Change Ranking
Roof	c1888	<p>Corrugated galvanised iron with recent rolled ridge cap.</p> <p>Existing iron appears to be the original material.</p> <p>No changes to this elevation.</p>	Rusted	High	Moderate
Wall	c1888	<p>Vertical slabs between top and bottom places, with galvanised cover strips.</p>	Good	It is assumed that these slabs are original to their location in this building—High.	Moderate

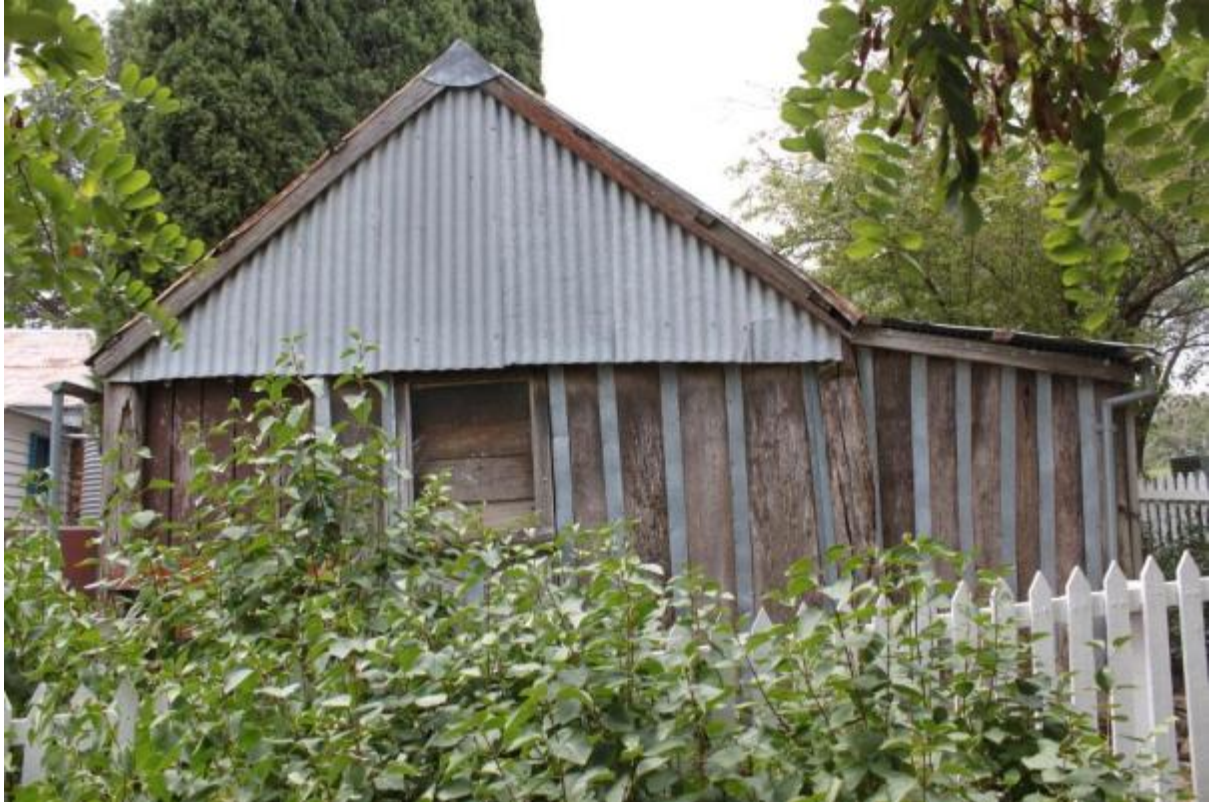
Slab Shed South Elevation

Figure 3.28 Slab Shed South elevation. (Source: GML 2013)

Room Element	Date	Form/Fabric Earlier Treatments	Condition	Significance of Element	Tolerance for Change Ranking
Wall	c1888	<p>Post and beam construction with vertical slabs.</p> <p>Decayed base plate, base of posts replaced in 1998, and soil retained away from wall.</p> <p>Previously limewashed.</p> <p>Cover strips introduced in 1967.</p> <p>Not clear how many slabs have been replaced, if any.</p> <p>The attached skillion outhouse on the eastern wall replaced former buggy shed.</p>	Good	High	Moderate
Window		<p>Single pane sash evident in 1910 photo.</p> <p>This sash may be a replacement.</p>	Good	<p>Sash—Moderate.</p> <p>A window in this location—High.</p>	<p>Sash could be replaced as necessary—Moderate.</p>

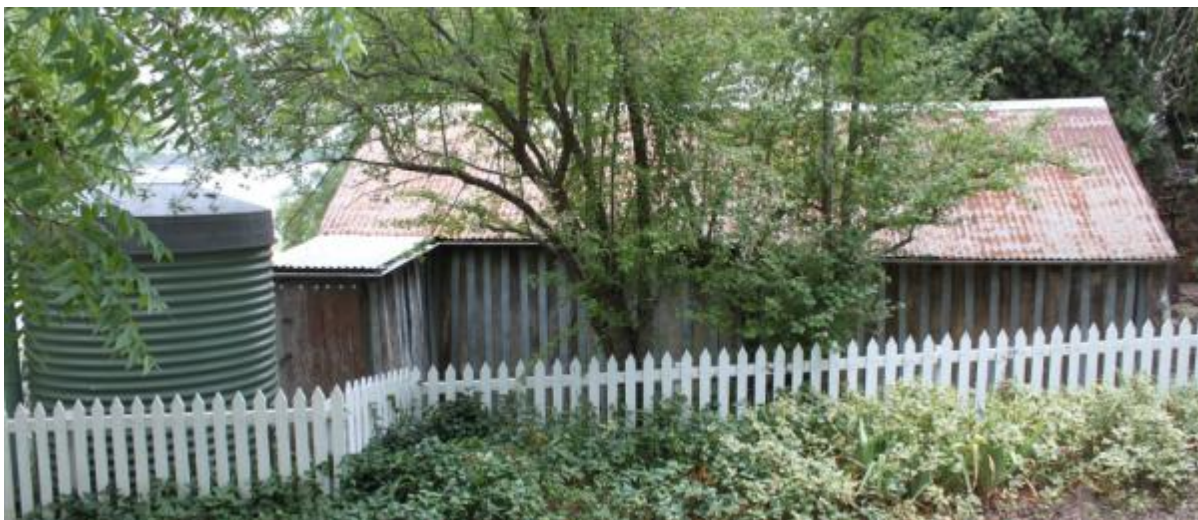
Figure 3.29 Slab Shed East elevation. (Source: GML 2013)

The slab shed at one time had a small buggy shed with skillion roof attached to its eastern elevation. See Figure 4.11 for a historic photograph.

Room Element	Date	Form/Fabric Earlier Treatments	Condition	Significance of Element	Tolerance for Change Ranking
Roof	c1888	A skillion-roofed buggy shed or lean-to located on this side was removed c1964. Evidence remaining in the fabric includes slightly shorter roof sheets and rebates for former rafters in the existing top plate.	Rusted	High	The iron should be retained for as long as possible—Moderate.
Wall	c1888	Timber slab wall with introduced cover strips. Limewashed. A skillion buggy shed on the eastern side was removed c1963 and replaced with a small skillion outhouse WC constructed c1964. Possible replacement of some slabs.	Good. Some repair to base plates in 1998.	Some slabs may have been introduced, but generally accorded high importance.	Moderate

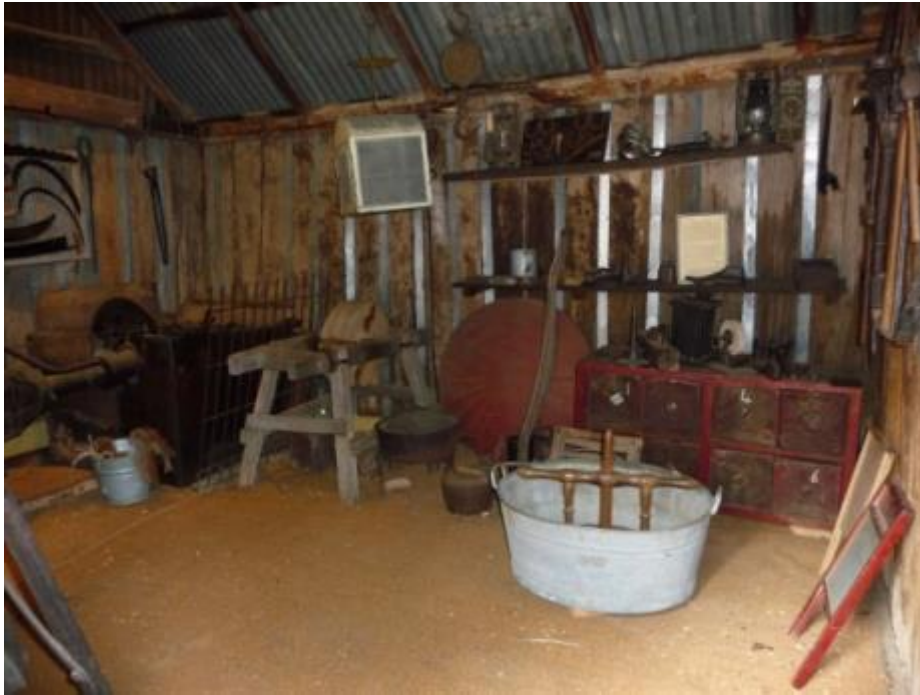
Figure 3.30 Interior of main room in Slab shed. (Source: GML 2013)

The slab shed is divided into two. The slabs have been covered internally with newspapers applied in the 1960s by the CDHS. There is no ceiling and the floor is coir matting over rammed earth and concrete. There is a newly inserted hopper window with no glass to the southern side of the shed in Room 8. The two rooms are separated by a slab wall.

Room Element	Date	Form/Fabric Earlier Treatments	Condition	Significance of Element	Tolerance for Change Ranking
Ceiling		There is no ceiling in 2013—the underside of the iron is visible. It is not known what, if any, ceilings were present historically.	—	—	—
Roof Frame	c1888	Lightweight bush round rafters supported on machined top plates. Sawn battens at about 900 centres. Frame appears to be original.	Good	All the original framing is considered to be significant—High.	Low

Room Element	Date	Form/Fabric Earlier Treatments	Condition	Significance of Element	Tolerance for Change Ranking
Floor		A mix of cement reinforced earth in the centre with concrete topping to the perimeters. It is possible that the floor was rammed earth initially then topped with cement that is breaking down in the more highly trafficked areas.	Unstable	Fabric—Moderate. Possible low archaeological potential.	Moderate

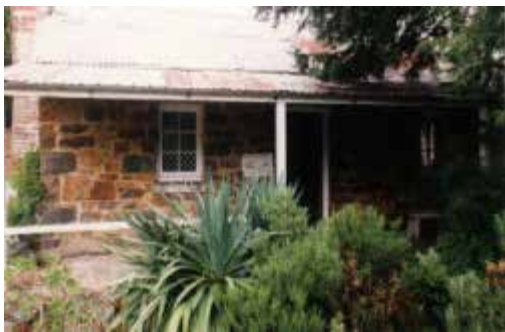
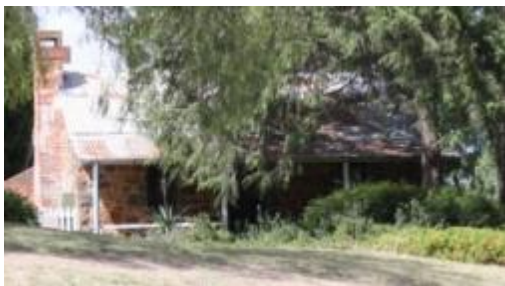
Building Element	Changes to Fabric	Image
North elevation	<p>The window's paint colour changed from white to teal blue.</p> <p>1994 CMP—the CMP notes that 'the chimneys have never been flashed'.</p> <p>More of the tree overhangs the building.</p>

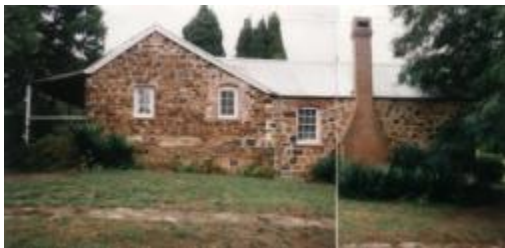
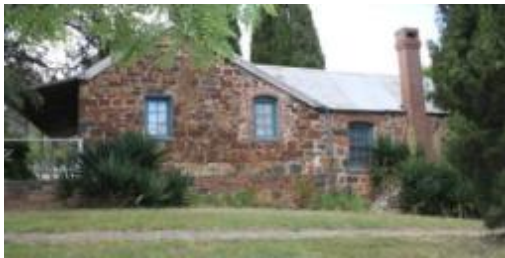
<p>2012</p>
West wall	<p>1994 CMP—the random rubble wall was in fairly good condition, although there was some breakdown of pointing between the stones, particularly on the older section of wall 'most of the pointing from the earlier work has weathered off'.</p> <p>2012—the window frames had been painted blue/grey, there had been an increase in the breakdown of mortar, and possibly even some of the stone, particularly around the downpipe.</p> <p>Note that the yuccas have grown considerably.</p>

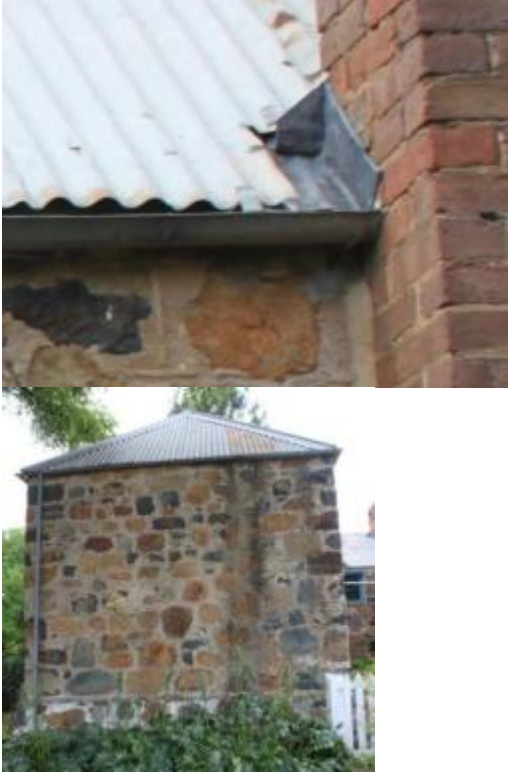
Building Element	Changes to Fabric	Image
<p>South wall</p>	<p>There has been very little change to the south wall, other than slightly increased loss of limewash on the lower plinth, and increased staining or algal growth in the vicinity of the repaired crack. The wall was underpinned in the 1960s and has remained stable.</p> <p>The sash on the south wall of room 5 has been painted grey/blue.</p>

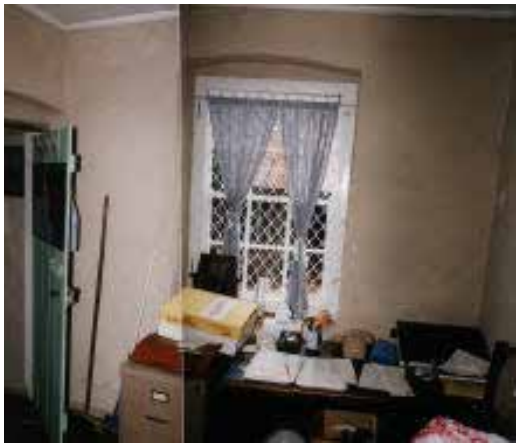
Cottage Interior		
Room 1 Office	<p>1994—the walls were painted acrylic light brown in 1994 and the floor was plain brown linoleum over butt jointed hardwood.</p> <p>2012—the walls are now limewashed to full white and carpet has been laid.</p>

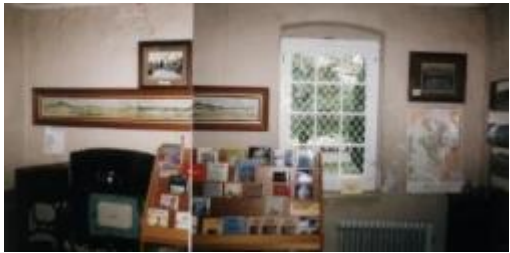
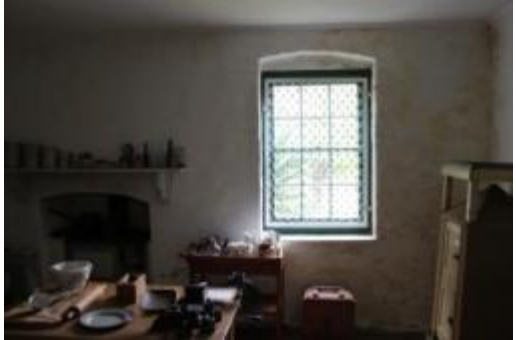
<p>1994</p>
Room 2 Kitchen	<p>1994 CMP—the CMP notes that there has been leaking above the fireplace and at the wall junction with the original four-roomed cottage structure but that both leaks had been repaired and only staining remained.</p> <p>2012—the leaking above the fireplace has stabilised, although damp continues to penetrate at the junction of the west wall with the original four-roomed cottage.</p> <p>1994—beige paint has been replaced with white limewash and internal sashes have been painted green.</p>

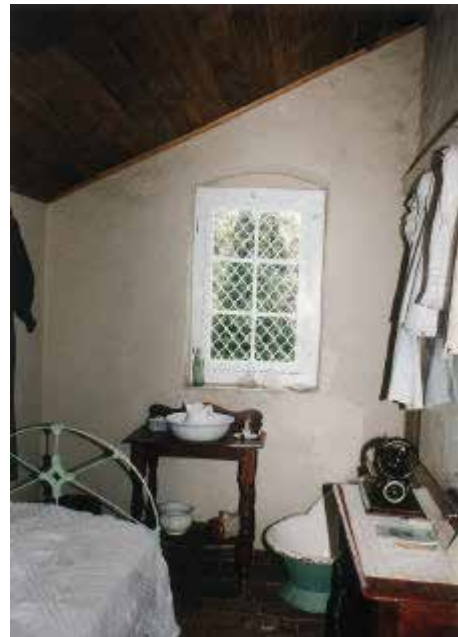
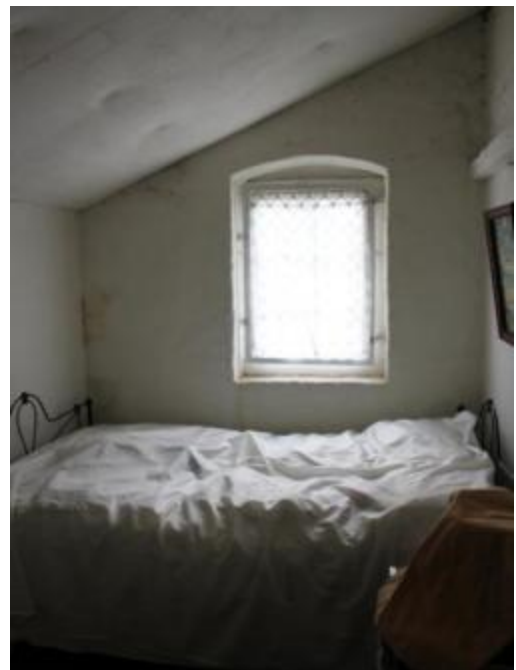
1994—the walls were painted with acrylic paint and the ceiling comprised fibro sheeting and recycled lining boards. The walls were pale green.

2012—the ceiling has been covered with hessian and has been limewashed. The window sash remains white. The walls have been painted white.

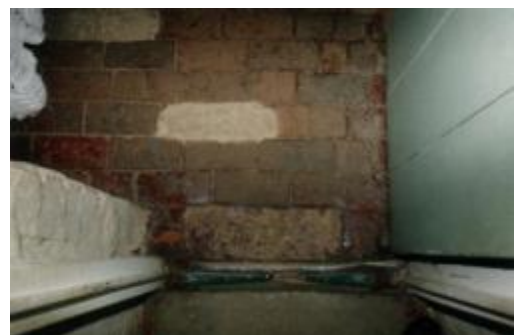
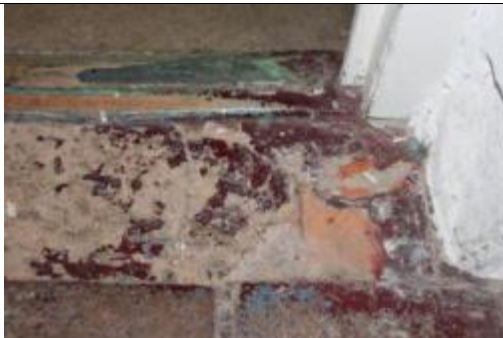
Threshold and floor in 1994.

<p>In 2012 the door threshold continued to retain much of its intriguing detail.</p>
Room 4 Front bedroom	<p>1994—the walls were painted with beige acrylic paint, however by 2012 it is white and appears to have been limewashed. There has been minimal other change.</p>

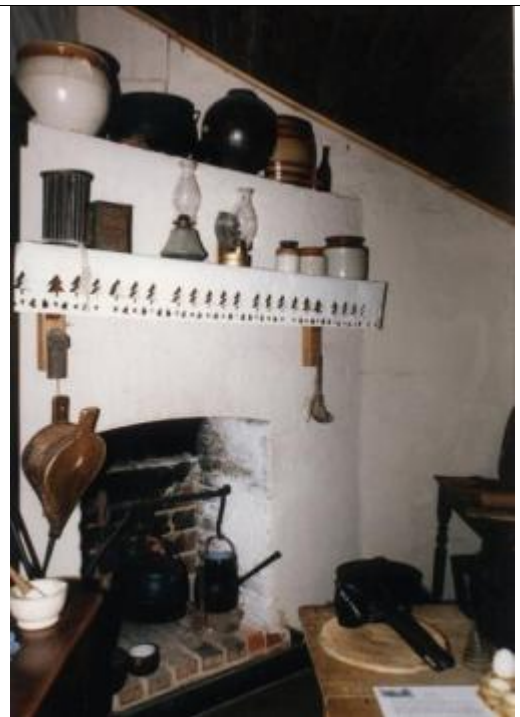
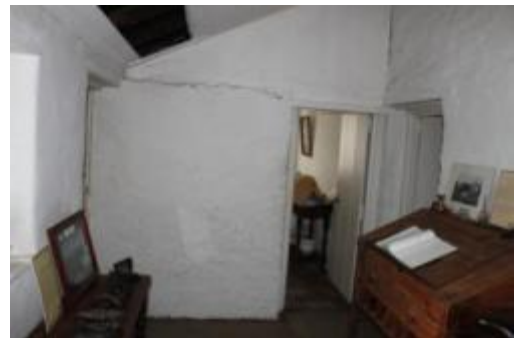
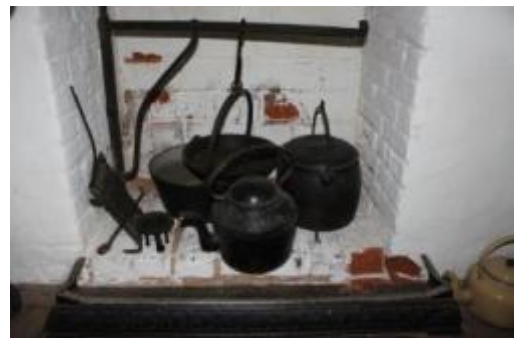
<p>2012</p>
Room 5 Former kitchen	<p>The major change in room 5 has been to the ceiling.</p> <p>1994—the ceiling was recycled lining boards.</p> <p>2012—the ceiling is now limewashed hessian, a strip of which has been removed to reveal the underside of the shingles above. It is not obvious if the former fibro and lining board ceiling was removed before the hessian was installed.</p> <p>Also in 2012, the fireplace has been fully limewashed.</p>

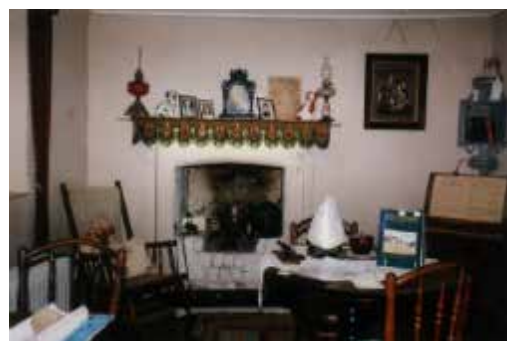
The walls and fireplace have been limewashed and the sample of earlier wall paper has been enlarged to show more of the pattern. Otherwise there appears to have been no change to the fabric.

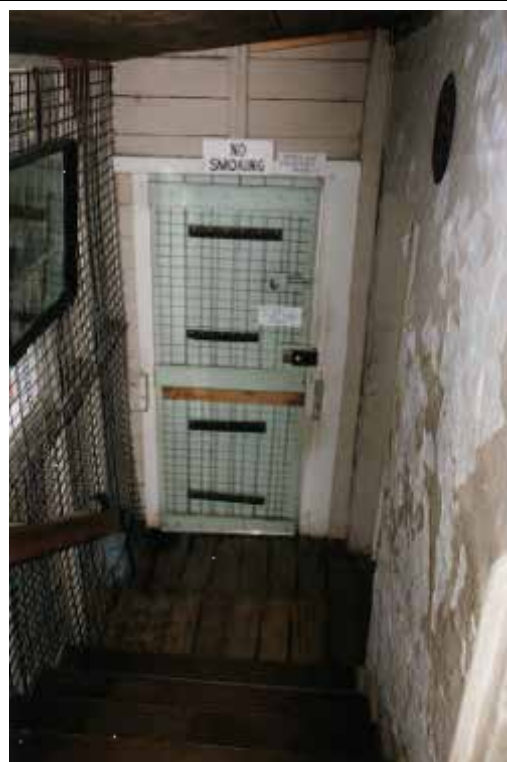
The most substantial change has been the removal of security mesh on the eastern wall, and repainting of the timber walls. The door has been painted from pale green to white and its security bars modified. The masonry wall, with its mottled collection of past paint finishes, has been left as evidence of former treatments. The ceiling has been covered with hessian that has been limewashed.

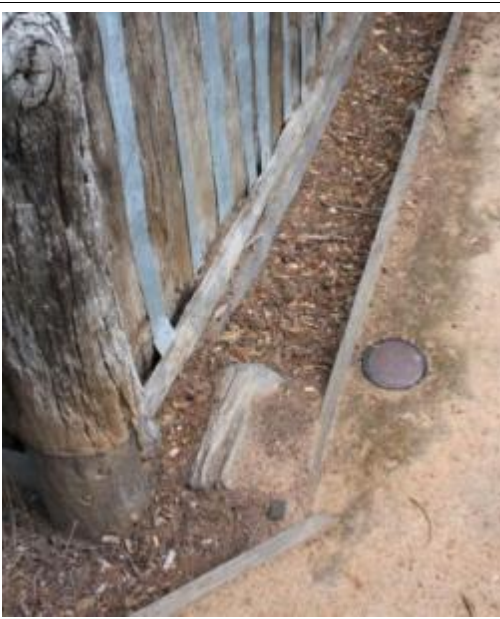
<p>Slab shed</p>	<p>The major modification since 1994 has been repair to base plates at the northern end and excavation of soil in the same area.</p> <p>The base of posts has been removed and a new base spliced on, and a soil retaining strip introduced about 450mm from the slab wall.</p> <p>Internally, the structure remains much as it had, although public access to the southern room is limited.</p>

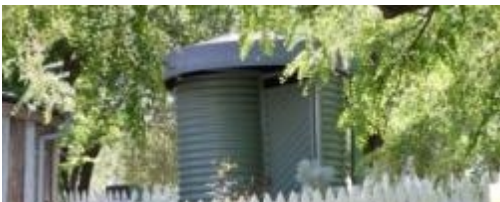
<p>2012</p>
<p>Modern WC</p>	<p>This modern composting toilet has been introduced since 1994 to provide services for staff and some visitors. It is not connected to a sewerage system. A former WC was located in the adjacent section of the slab building, but is no longer used.</p>

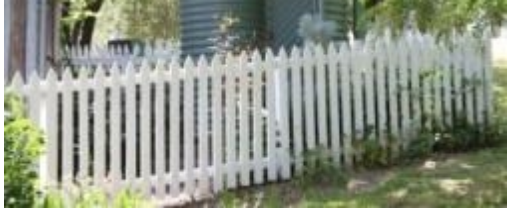
Fence	The picket fence is understood to have been a reconstruction of the previous picket fence that was introduced after 1960 by the CDHS, ie it is a new version of an introduction which was based on conjecture not evidence.
