**Blundells Cottage**  
**Heritage Management Plan**

Report prepared for the National Capital Authority

May 2014

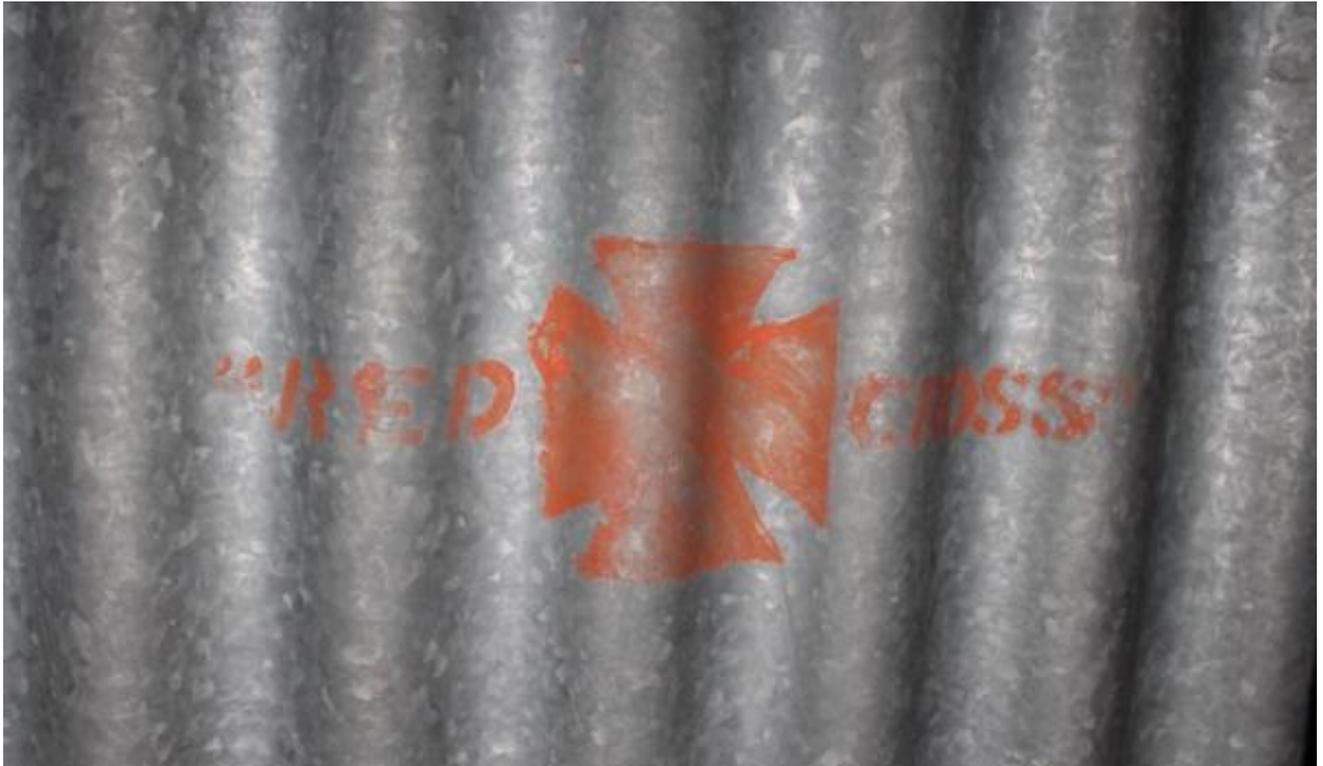
**Figure 3.8** Red Cross marking on underside of roof iron above the office. (Source: GML 2013)

**The roof over the 1888 extension** is corrugated galvanised iron screwed to a sawn hardwood roof frame. The iron bears the mark 'Red Cross' which is dated to 1888 and therefore likely to be the material initially installed on this section of roof (refer to Figure 3.8 above). The roof pitch is close to 45 degrees and the southern roof plane is hipped, unlike the 1859 roof which is gabled. The ridge is capped with a rolled galvanised ridge cap. Gutters are 'half-round' profile, similar to that used on the front verandah and the one central down pipe is also in galvanised iron. The condition of roof iron varies with some more recent sheets intermixed with the earlier ones. Some have substantially more pronounced rust. Repair work undertaken circa 2011 included new lead flashing to the chimney and additional roof screws using hand cut lead sheet.

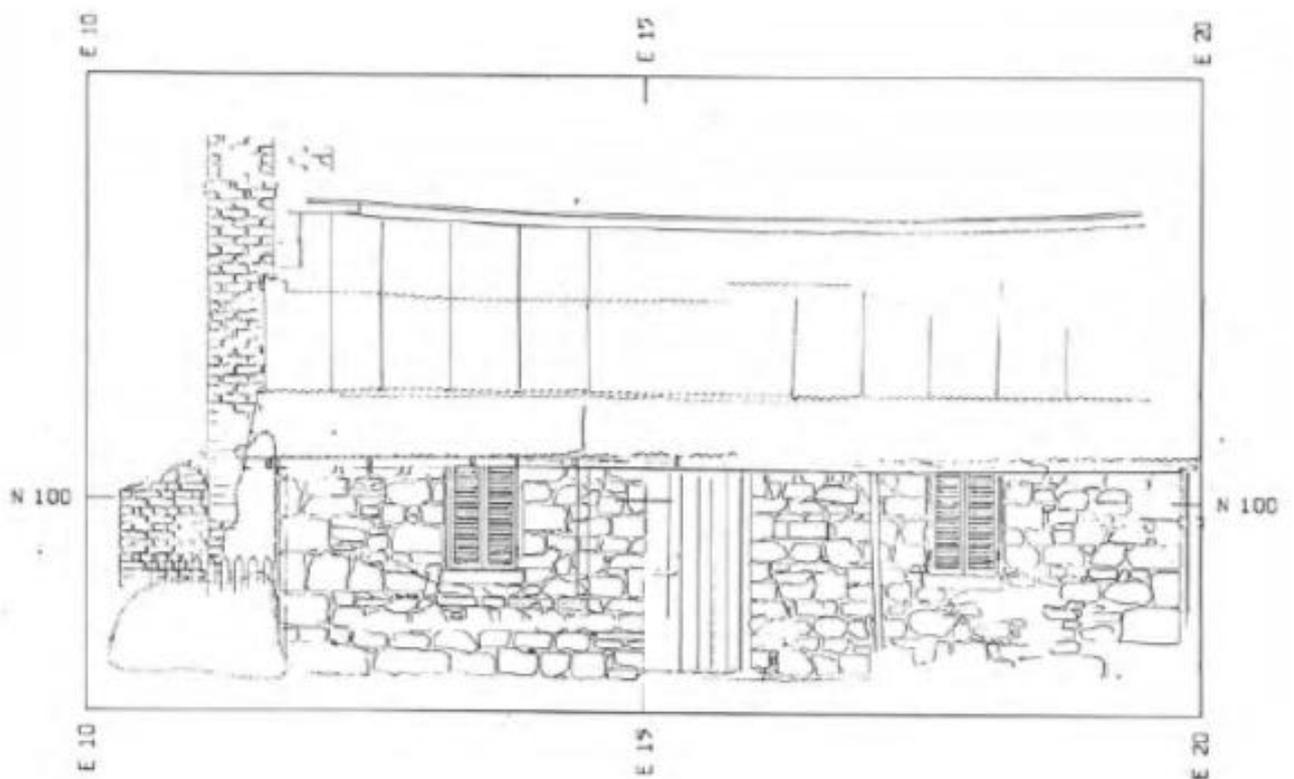
The roof form over the 1859 part of the house is a gable roof, unlike the rear addition, which is hipped. The ridge line has a distinct dip in its centre (apparent in the photogrammetric drawings (Figure 3.9)). A prop was inserted under the ridge in 1991 to prevent any further subsidence.

**Figure 3.9** North elevation drawing showing dip in ridge line. (Source: Australian Survey Office 1984)

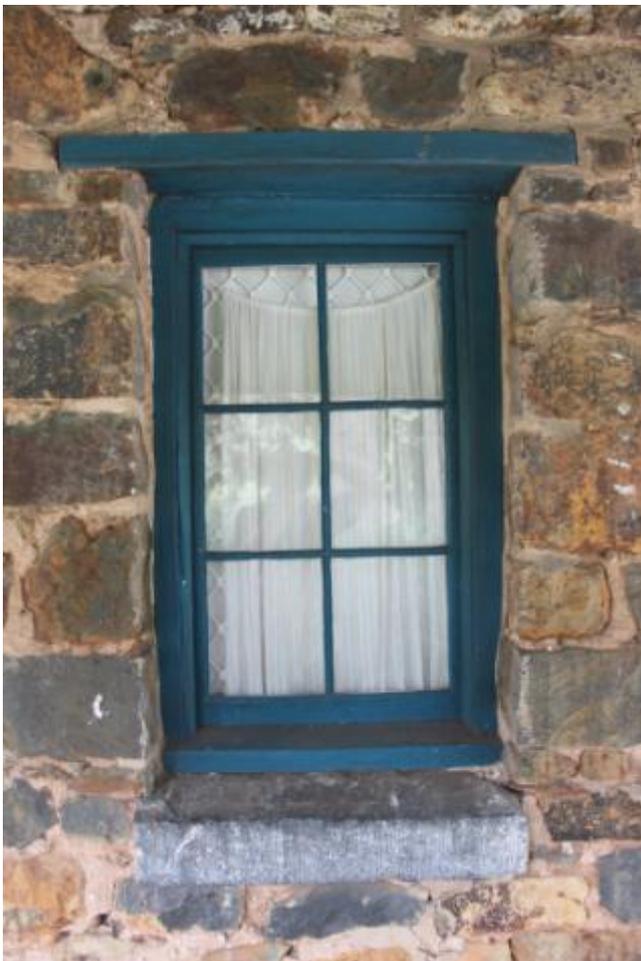
**Figure 3.11.** Front verandah window with timber lintel, hardwood frame, six-pane sash and shaped stone sill. (Source: GML: 2013)

Six-pane timber framed sashes in hardwood timber frames—all painted in a modern paint of 'teal blue' colour. See Table 3.1. The left hand (eastern) sash contains finely machined glazing bars and is presumed to be original (Figure 3.11). The right hand (west) sash, however, lacks the finesse of the former and is obviously more recent. In 1989 several sashes were destroyed during a break-in and in 1991 new window sashes were installed in the parlour, main bedroom and office. Both sashes in the front elevation have side hinges and open inwards.

Condition	Significance of Elements	Tolerance for change
Condition of windows is very good	Both window frames are highly significant as original fabric—High. The eastern sash is also assumed to be 1858—High. The western sash is significant in terms of form but not in fabric—Moderate.	Frames—Low. East sash—Low. West sash—Moderate.

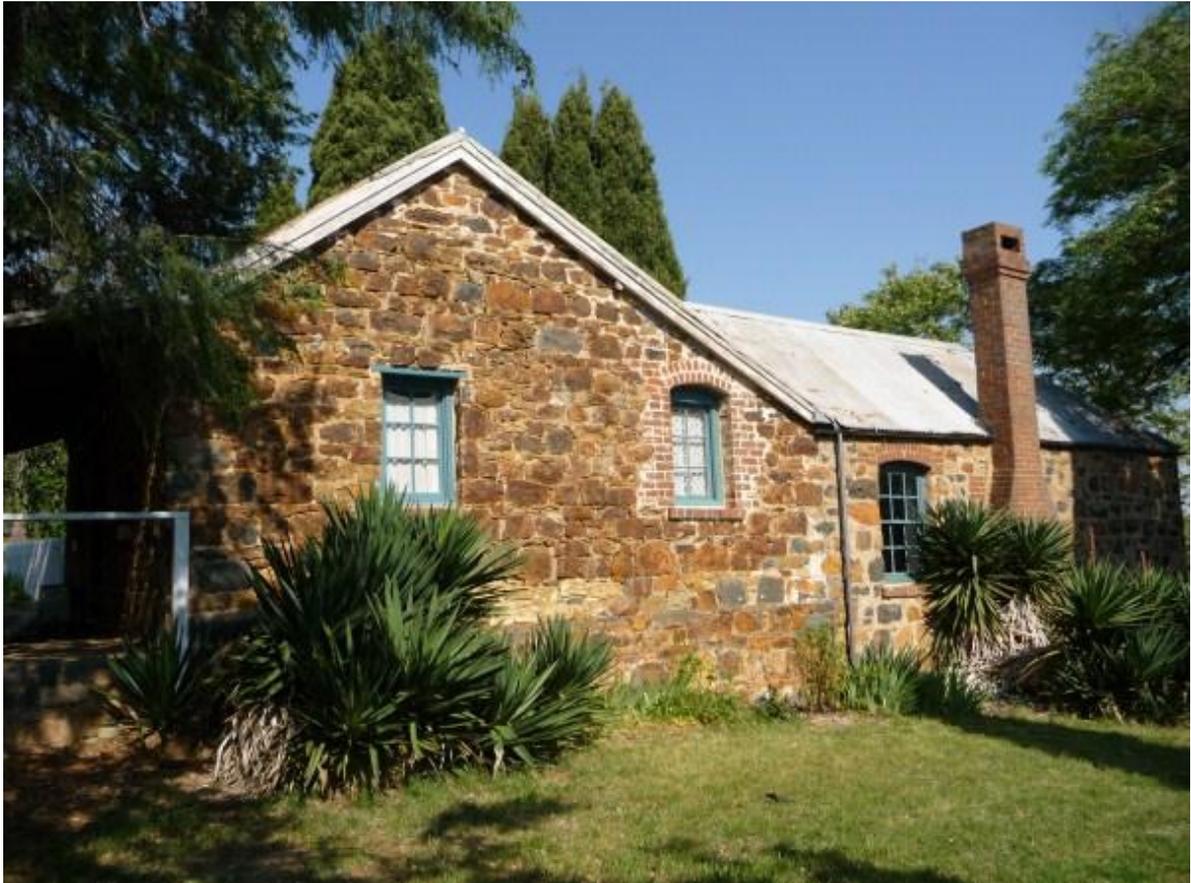
**Figure 3.12.** West elevation of Blundells Cottage. (Source: GML 2012)

<b>Condition</b>	<b>Significance of Elements</b>	<b>Tolerance for Change</b>
Fundamentally the overall wall is sound, however, the extent of erosion on joints in the 1859 wall is considerable and warrants attention (Figure 3.12). The 1888 wall had subsided at its southwest corner and was underpinned in 1963. Herman’s drawings Nos 4 and 5 (1961) include the instruction to ‘underpin wall’. A crack is evident in the wall extending from the ground to the top plate approximately 900mm from the southern corner (Figure 3.13).	The stone walls are highly significant, as is the surviving evidence of the mortar and pointing joints that were done at the time of construction—High.	Repointing is acceptable providing it follows best practice Burra Charter procedure. Refer to the scope of works for further details—Moderate.

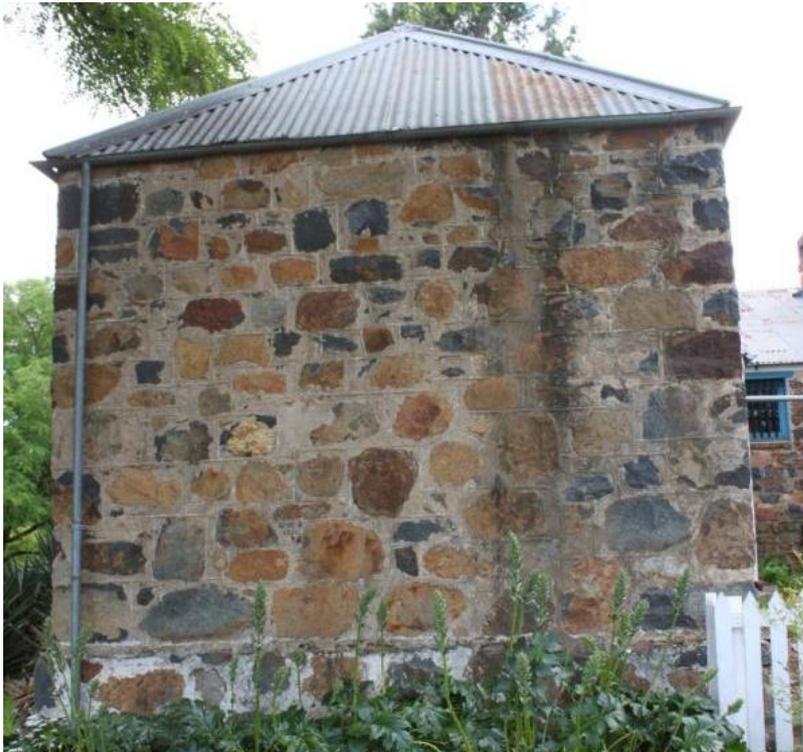
**Figure 3.15** South elevation of 1888 extension showing hipped end to the roof. (Source: GML 2013)

The rear of the 1888 extension (Figure 3.15) continues the same stone wall construction as the adjacent walls from this phase of the building. The wall is constructed on a slightly proud footing, stonework is exposed and pointing is raised.

The most significant change was the underpinning of the wall and repair of the crack about 900mm from the right hand edge during the restorations by the NCDC undertaken by Morton Herman. Herman commented that one of the main faults was ‘somewhat severe settlement at the southwest corner’.<sup>84</sup> The underpinning repair work appears to have been very successful with no further opening of this crack. Otherwise the integrity appears high.

<b>Condition</b>	<b>Significance of Elements</b>	<b>Tolerance for Change</b>
Good	Original fabric—High.	The wall has very high integrity—Low.

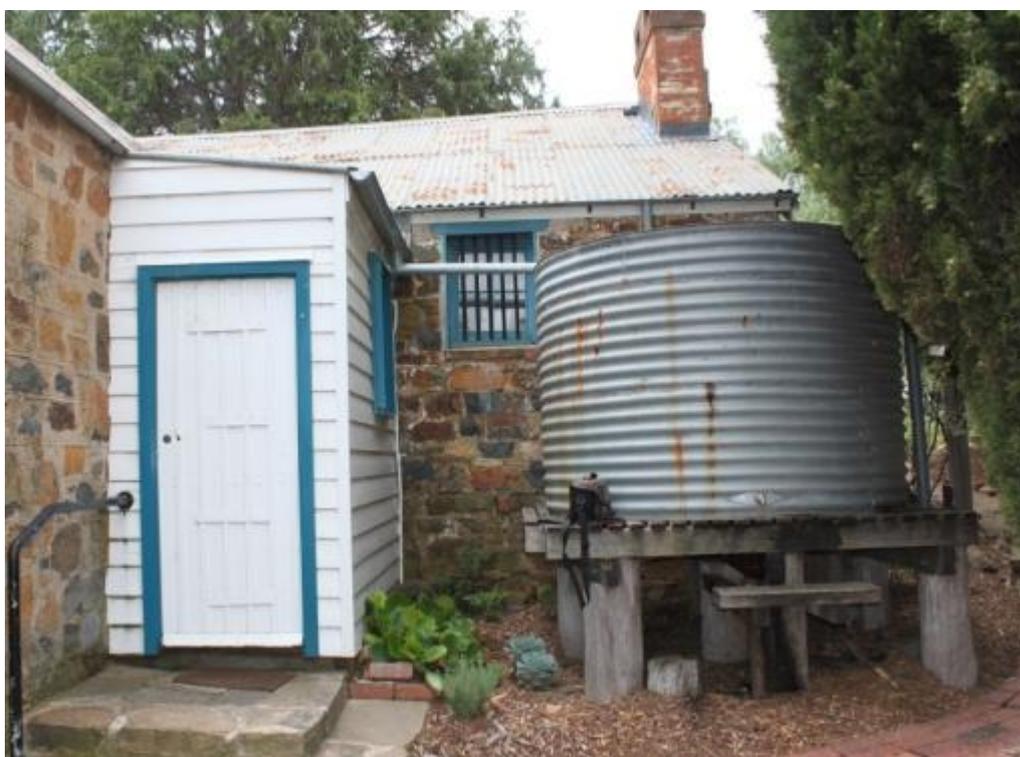
**Figure 3.16.** South elevation of 1859 section partly obscured by more recent porch and tank. (Source: GML 2013)

**Wall:** The 1859 wall visible behind the tank (Figure 3.16) is not as neatly finished as the 1888 wall on the left of the image. Much of the surface pointing has eroded although there are numerous traces of limewash remaining. The timber plate at the top of the wall appears to date to 1963.

Condition	Significance of Elements	Tolerance for Change
Moderate. Surface pointing eroded.	Original 1859 fabric apart from timber plate at top of wall.	Low for wall and mortar. High for replacement timber plate.

The tank-stand and tank were built in 1992 and replaced a former tank-stand and tank that dated from 1963 that had in turn replaced two smaller tanks, one square and one round (noted in Morton Herman's report). The 1992 galvanised iron tank is now leaking badly (Figure 3.16).

Condition	Significance of Elements	Tolerance for Change
Tank—poor condition. The iron has rusted through and the tank needs to be replaced in full.	From the period of occupation and may be the original tank from the north of the cottage relocated in the early 1960s.	Moderate. The fabric is decayed and must be replaced for the tank function to continue. The form and materials of the tank should be replicated for a replacement.

and presumably dates to the same time (post 1963). The window in the porch wall is a relatively recent fixed sash (Figure 3.16).

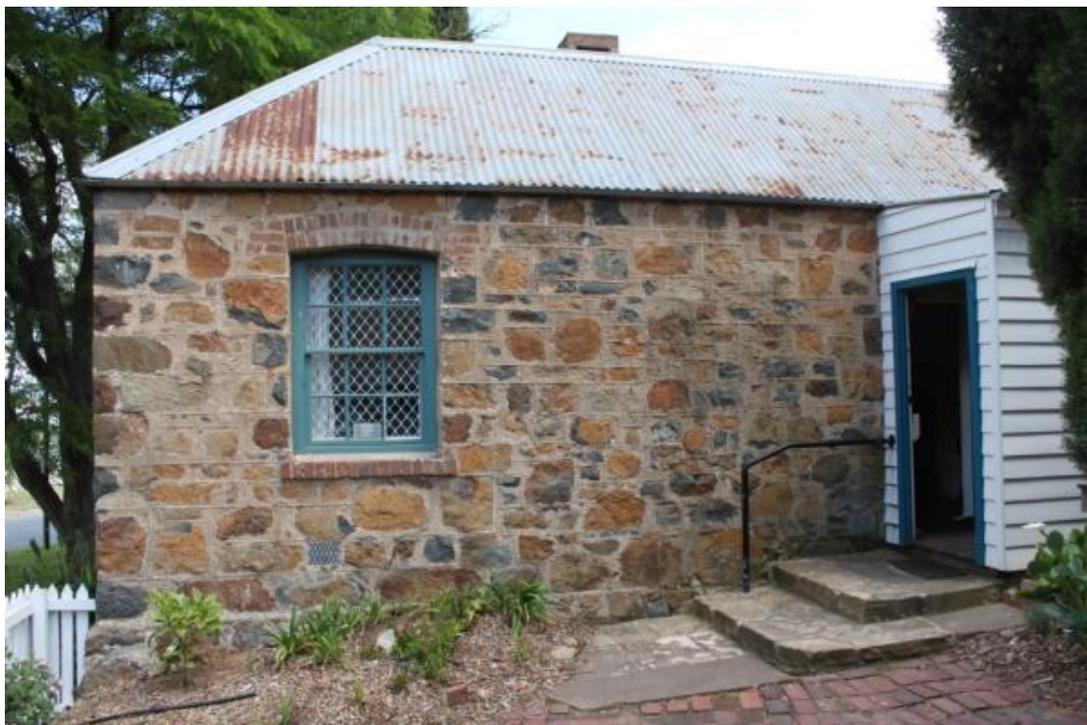
Figure 3.17 East elevation of 1888 extension. (Source: GML 2013)

**Roof:** This section of the cottage has a hipped corrugated galvanised iron roof with rolled ridge capping dating from 1888. There is light rusting across all sheets with heavy rust on one sheet in particular. At its northern end, the roof drains into a valley and onto the porch skillion roof. The remainder of the roof drains onto a half round gutter that is similar to those elsewhere on the building.

Condition	Significance of Elements	Tolerance for Change
Corrugated iron—Moderate Some rusting.	1888 fabric—High.	Moderate. Avoid change unless roof iron and fixings are failing.
Guttering—Poor.	Introduced 1960s fabric.	High. Inadequate for function and

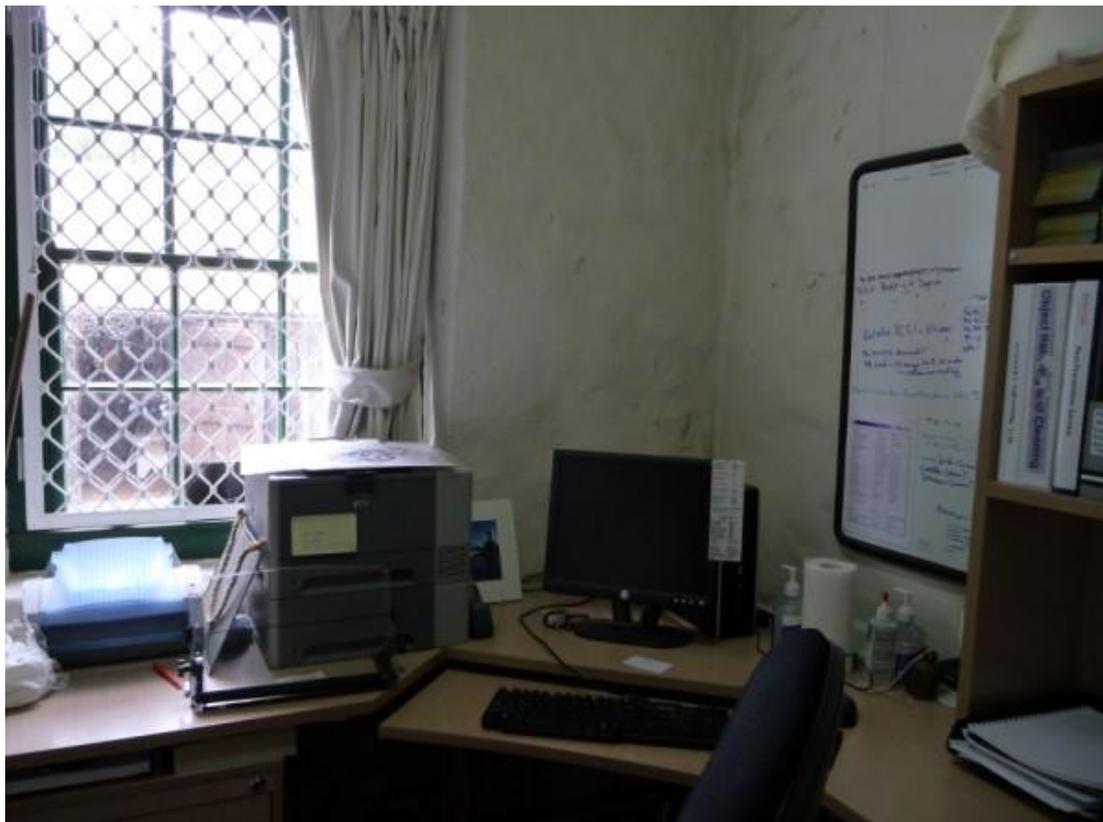
**Figure 3.19** Room 1. (Source: GML: 2013)

This room is part of the 1888/90 extension. It is currently (2013) used as an office. The walls have been rendered with the irregularities of the underlying stonework showing through and limewashed several times with a variety of colour schemes. A fibrous plaster ceiling is present and replaces the tar paper ceilings noted in the Herman report of 1961. Room 1 has one window facing east and is accessed from Room 2.

Room Element	Date	Form/Fabric Earlier Treatments	Condition	Significance of Element	Tolerance for Change Ranking
Ceiling	1963	Fibrous plaster sheets with milled quad timber cornice. Sisalkraft	Good	The ceiling rafters and fibrous plaster ceiling was installed in 1963. Sympathetic—Low.	High.
Floor	1888	Butt jointed hardwood flooring (150 x 50) with hardwood subfloor. Carpet in 2013. Plain brown linoleum in 1970 and relaid 1979, and patterned linoleum earlier. <sup>87</sup>	Good. Subfloor not inspected but feels firm.	2013 Carpet—Low. Earlier linoleum—Moderate. Hardwood flooring—High.	Carpet—High. Linoleum—Moderate. Hardwood flooring—Moderate.
Wall	1888	Crudely rendered with subsequent coats of limewash. Current treatment is white limewash. Freeman refers to presence of earlier layers of limewash. The pale beige evident in 1994 may have been applied in 1963. Note the two major wall cracks had been repaired in 1963 requiring the addition of 'compo mortar'. <sup>88</sup>	Good	Wall render—Moderate. Pre 1994 limewash—Moderate.	High. High.

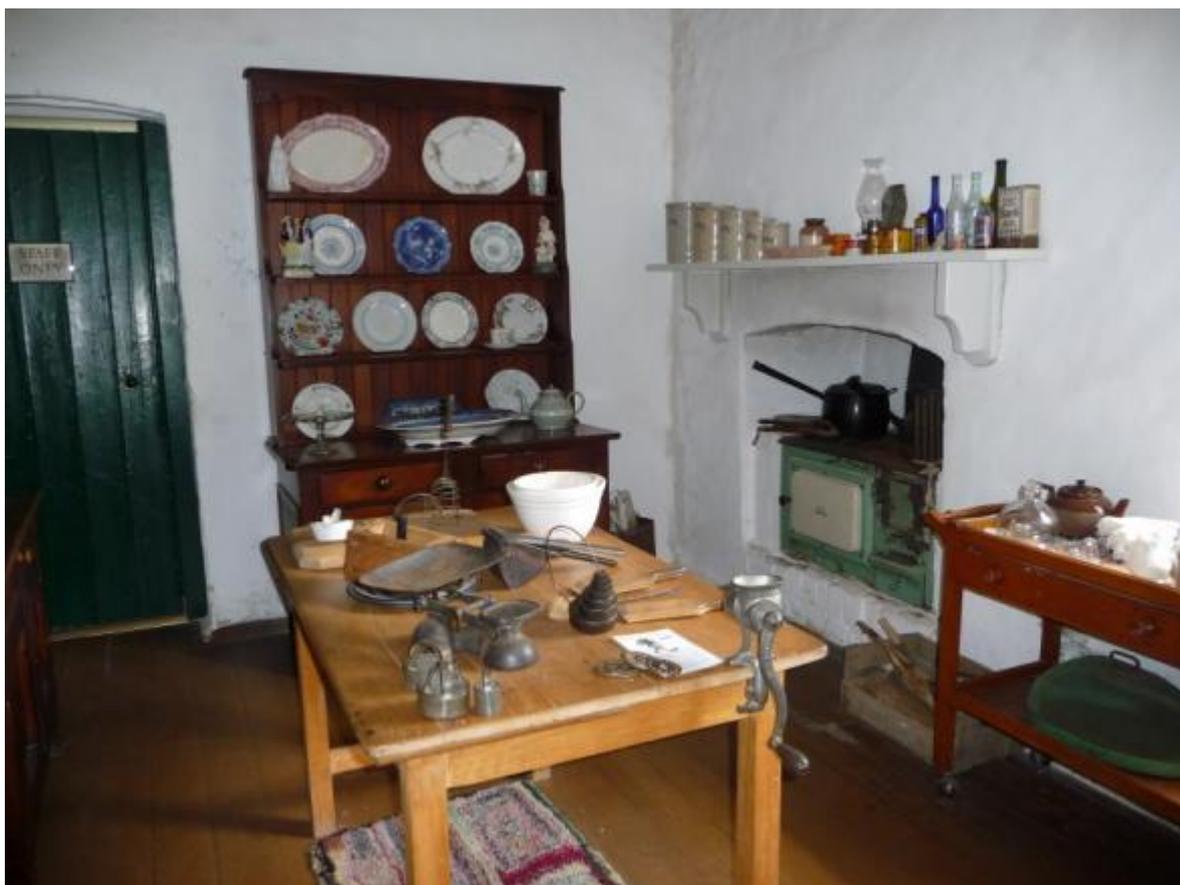
Figure 3.20 Room 2. (Source: GML: 2013)

This room is part of the 1888/90 extension to accommodate the growing Blundell family. It was later used as self-contained accommodation for lodgers. It is currently (2013) used as display space concentrating on cooking technology. The walls are rendered and limewashed. The ceiling is fibrous plaster which replaced former ceilings of hessian and then tar paper (present in 1961). The floor is hardwood with linoleum covering. There is an open fireplace now occupied by a fuel stove probably installed in the late 1930s for tenants to rent Rooms 1 and 2, with a mantelpiece above. The room has one tall window facing west and a door leading to the porch way at the bottom of the internal stairs. An internal window looks into the room from Room 3.

Room Element	Date	Form/Fabric Earlier Treatments	Condition	Significance of Element	Tolerance for Change Ranking
Ceiling	1964	Fibrous plaster as per Room 1. Sisalkraft	Good.	Low.	High.
Floor	1888	Butt jointed hardwood flooring (150 x 50) with hardwood subfloor. Linoleum in 2013. Plain brown linoleum in 1970 and relaid 1979, and patterned linoleum earlier. <sup>89</sup> There is a small piece of earlier linoleum in the threshold between Room 2 and the porch.	Fair, although it is being impressed by the irregularities of the boards below.	Moderate.	Moderate.
Wall	E S & W:	Stone walls with rough render finish	Extensive penetrating	Original stonework: High.	Low. Moderate.

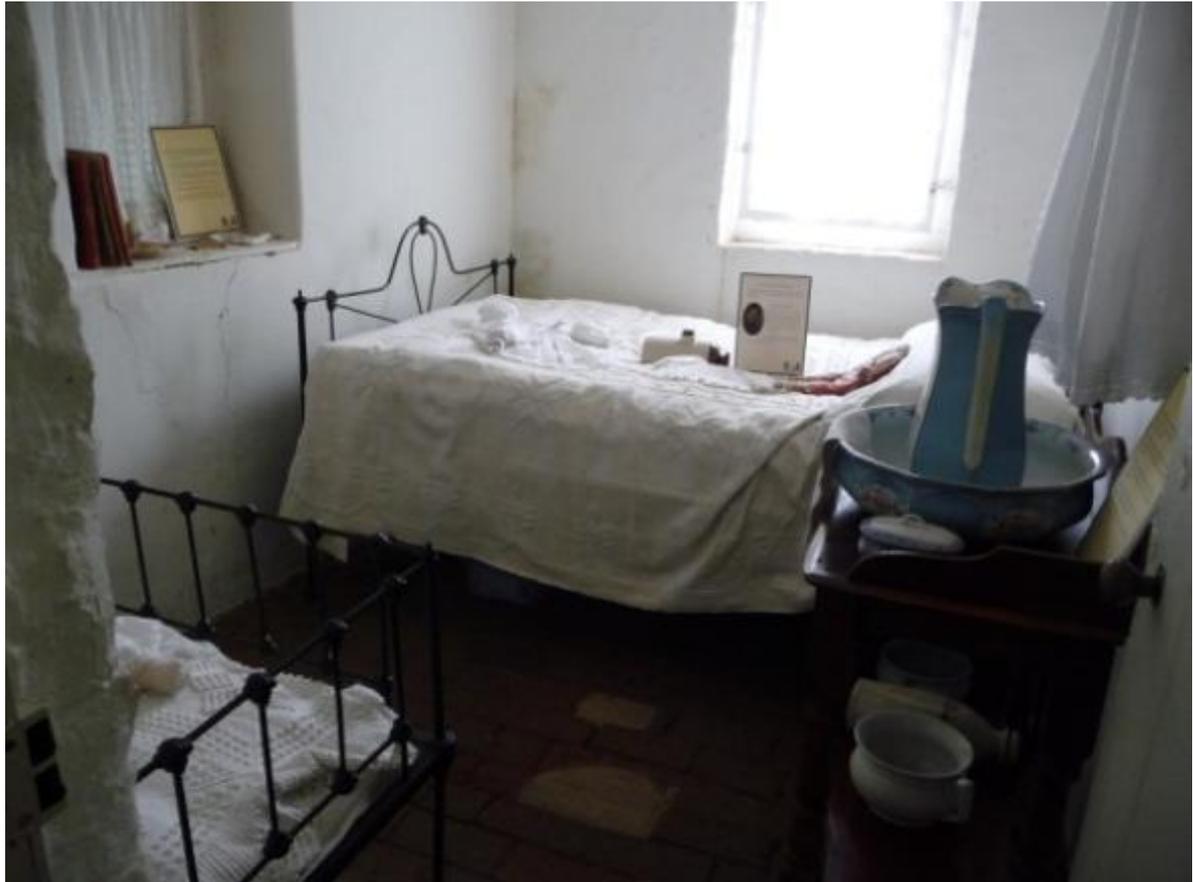
Figure 3.21 Room 3. (Source: GML 2013)

Room Element	Date	Form/Fabric Earlier Treatments	Condition	Significance of Element	Tolerance for Change Ranking
Ceiling	Post 1994	Hessian, a sympathetic modern introduction.	Good	Sympathetic but not original—Low.	High.
	1977	Recycled lining boards installed.	Good	Moderate.	Moderate.
	Pre 1960	Fibro sheeting was installed probably before 1960.	Cox report records tar paper which is not visible.	Late addition to fabric of cottage—Low.	Asbestos content—High.
Floor	1859	Sand stock brick laid in stretcher bond. Worn bricks repaired with cementitious mortar. Painted red.	Good	Original fabric—High.	Low. Can be repainted after investigation of original colour.
Wall	1859	Random rubble rendered and limewashed. A horizontal timber board (100 x 50mm) is fixed to the wall. The render above the	Good	Stone wall is original fabric—High. Hessian wall extension from ceiling is sympathetic introduced fabric—Low.	Hessian wall—High. Stone walls—Low.

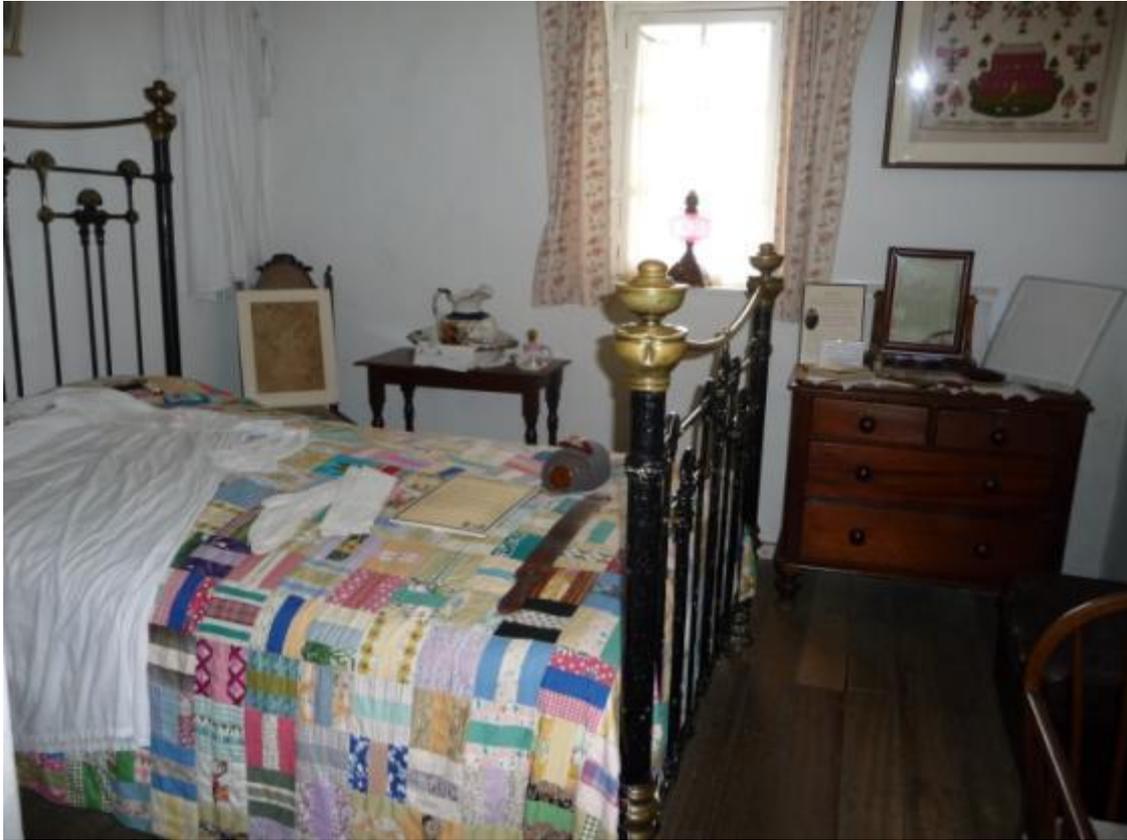
Figure 3.22 Room 4. (Source: GML 2013)

This room is part of the original four-roomed cottage and is currently (2013) set up as a main bedroom. It has one door to Room 6 and a window facing west. The walls are limewashed and the floors are re-laid hardwood. The ceiling is timber.

Room Element	Date	Form/Fabric Earlier Treatments	Condition	Significance of Element	Tolerance for Change Ranking
Ceiling	1977 Pre 1960 1859	Lining boards. Asbestos sheeting.  Lath and plaster. The rafters were sawn, and the walls above were never rendered or limewashed, suggesting an early intention to have a ceiling over the bedroom.	Good In situ  No longer extant, however, evidence can be seen on ceiling rafters adjacent to the manhole	Even though introduced, the boards have some importance as sympathetic material recycled from an old homestead in Murrumbateman—Moderate.  Sheeting is fabric from the occupancy phase, but the material is not rare and contains asbestos—Low.  The rafters are highly significant—High.	Lining boards—Low. Sheeting—High due to the asbestos content. Rafters—Low.
Floor	1859	150 x 25 butt jointed hardwood.	Subfloor space is	The originality of the floor is unclear, although it	The floors have already been

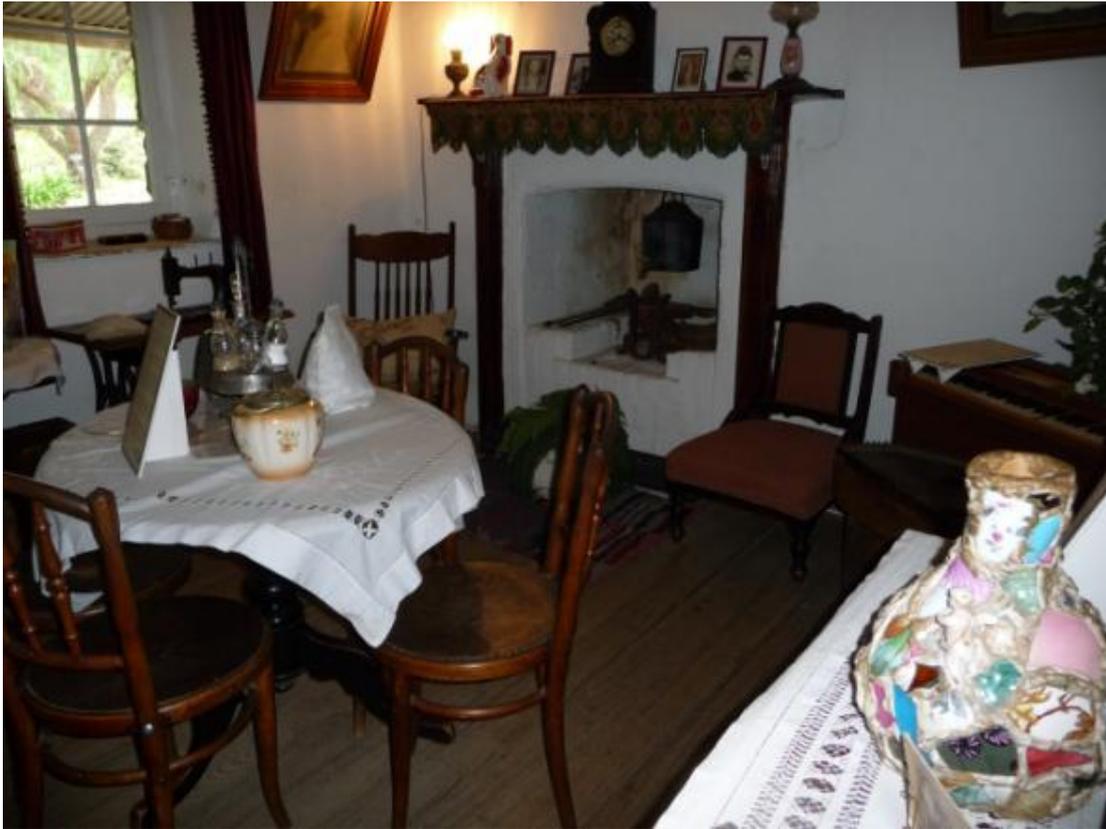
Figure 3.24 Room 6. (Source: GML 2013)

Room Element	Date	Form/Fabric Earlier Treatments	Condition	Significance of Element	Tolerance for Change Ranking
Ceiling	1977	<p>Painted lining boards under sheet (presumably asbestos).</p> <p>Initially there was no ceiling. The limewashed wall render extended through to the underside of the shingles and a hessian barrier hung above the dividing wall between Rooms 6 and 5.</p> <p>Probably in the early to mid twentieth century an asbestos sheet ceiling was added to the underside of the existing ceiling joists. Boards were added in 1977.</p>	Fair	<p>Lining boards and asbestos sheet—Low.</p> <p>Original ceiling joists and hessian—High.</p>	<p>Lining boards and asbestos sheet—High.</p> <p>Original ceiling joists and hessian—Low.</p>
Floor	1888 at least	150 x 25 butt jointed hardwood. Freeman notes the flooring is on joists resting on	Sound	The timber flooring could date from before 1888 and is significant as being from the residential occupancy	Incremental repairs—Moderate.

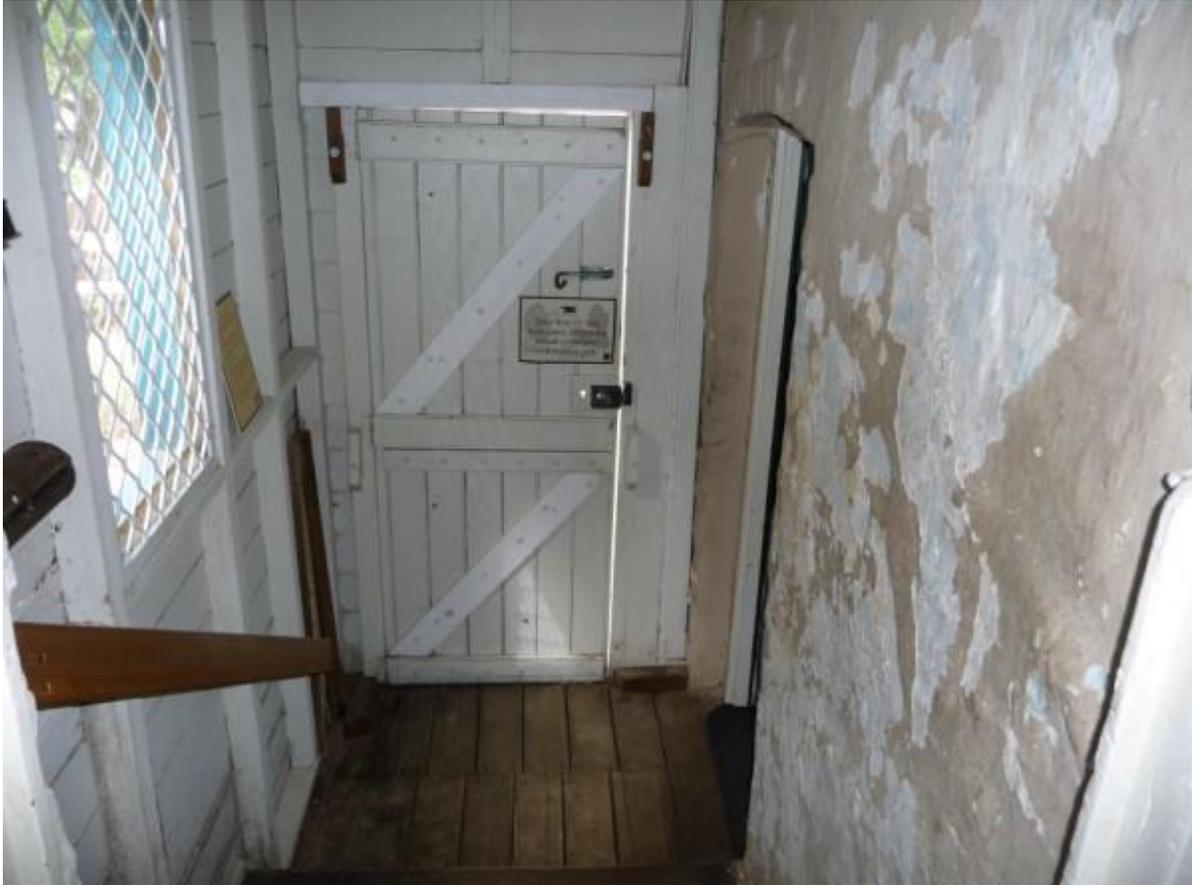
**Figure 3.25** Porch. (Source: GML 2013)

Room Element	Date	Form/Fabric Earlier Treatments	Condition	Significance of Element	Tolerance for Change Ranking
Ceiling	Post 1994	Hessian Lining boards probably installed in 1977. Historic ceiling not known.	Stains evident at northern end.	Low	High
Floor	Post 1888	Timber stairs with linoleum covering. Butt jointed 125 x 25 timber boards on landing. Linoleum appears to predate 1960. Weathered ends of landing boards previously replaced.	The ends of the replaced boards are weathered again and may need to be repaired or replaced.	The short lengths of flooring are fairly standard for the time and not especially significant—Moderate.  The linoleum on stairs appears to predate 1960—Moderate.	Floor boards—Moderate.  Linoleum on stairs—Moderate.
Wall	Wall: 1888 Board : 1963	Rendered and painted stone wall. Inside face of painted weatherboards on a timber stud frame The rendered wall retains an excellent sequence of colour schemes. White paint to timberwork probably from 1963. Original treatments not known. Porch post-dates to c1888. Clad in fibro pre-1960 (possibly in the 1930s) and replaced with current weatherboards in 1963.	Loose plaster in top right corner of rendered wall. Water stains on inside of boards.	The sequence of paint treatments on the stone wall—High. Timber frame/weatherboards—Low.	Rendered wall—Low. Timber frame—Moderate. Weatherboards and white paint—High.

Window	Post 1964	Fixed glass with security screen to the inside. The window was present in 1994.	Sound	Introduced window—Low. Security screen—Intrusive.	High
Door	Post 1964	Ledged and braced with vertical timber board panelling	Appears to be sound.	The door is sympathetic but not individually significant—Low.	High

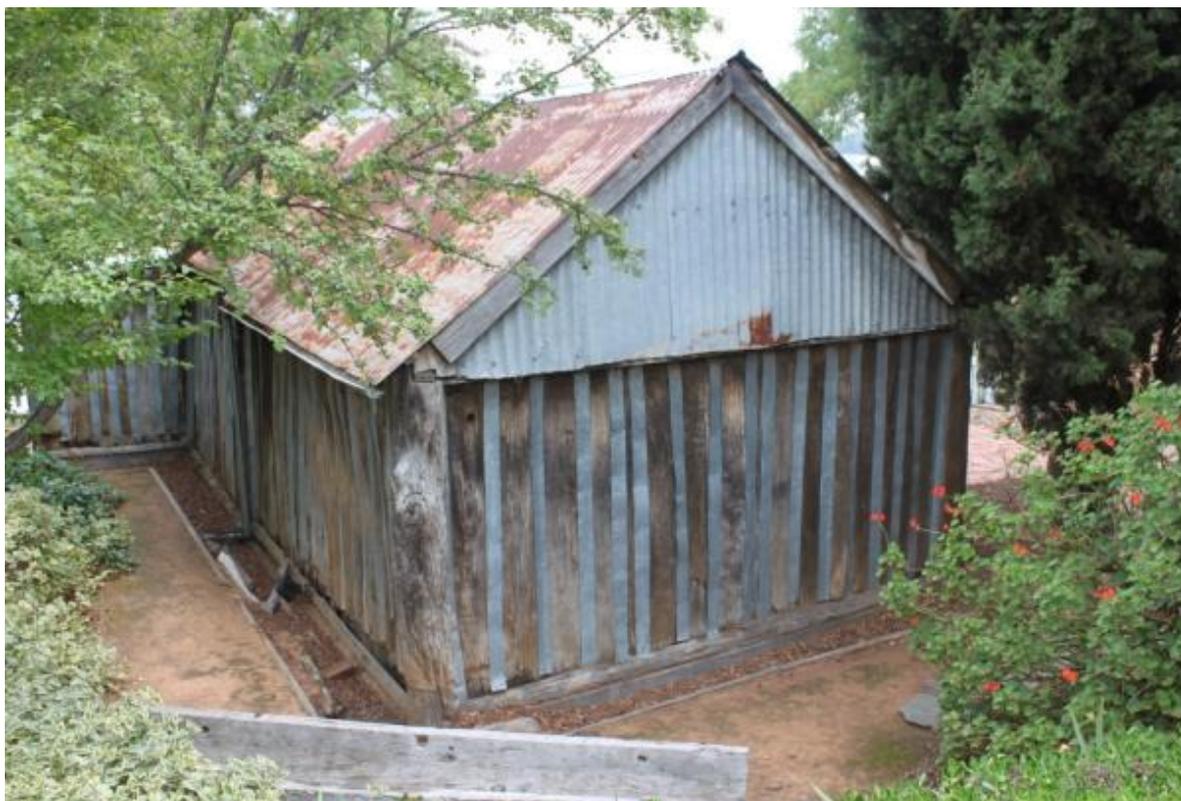
Figure 3.26. North elevation of Slab Shed. (Source: GML 2013)

Room Element	Date	Form/Fabric Earlier Treatments	Condition	Significance of Element	Tolerance for Change Ranking
Roof	Circa 1888	No maker's mark visible on iron but likely to have been reroofed at similar time to main cottage. Corrugated galvanised iron with steep roof pitch (approximately 40 degrees). Plain timber barge boards probably from 1963.	Extensive rusting to the surface.	As original fabric the iron has a high level of importance and includes the location of former flue pipes etc—High.	The iron should be retained for as long as possible—Moderate.
Wall		Vertical slabs between base and top plates with galvanised iron cover strips. Bush posts at corners. Corrugated galvanised iron to gable. The iron appears to be original and has not been painted. Evidence suggests a chimney fireplace on this wall—served	Sound	Gable iron, corner posts and top plate—High. Introduced slabs—Moderate. Base plate Low Galvanised cover strips—Low (but any replacement should follow advice above) and policy 6.2.2.	Low for significant items. Slabs, and base plate—High. Cover strips—Moderate

Room Element	Date	Form/Fabric Earlier Treatments	Condition	Significance of Element	Tolerance for Change Ranking
		former kitchen/dining block. Traces of mortar on the lower edge of gable iron may be all that remains.  The north wall was reconstructed in 1967, although it is assumed this was the slabs only. The attached skillion outhouse is on the RHS.

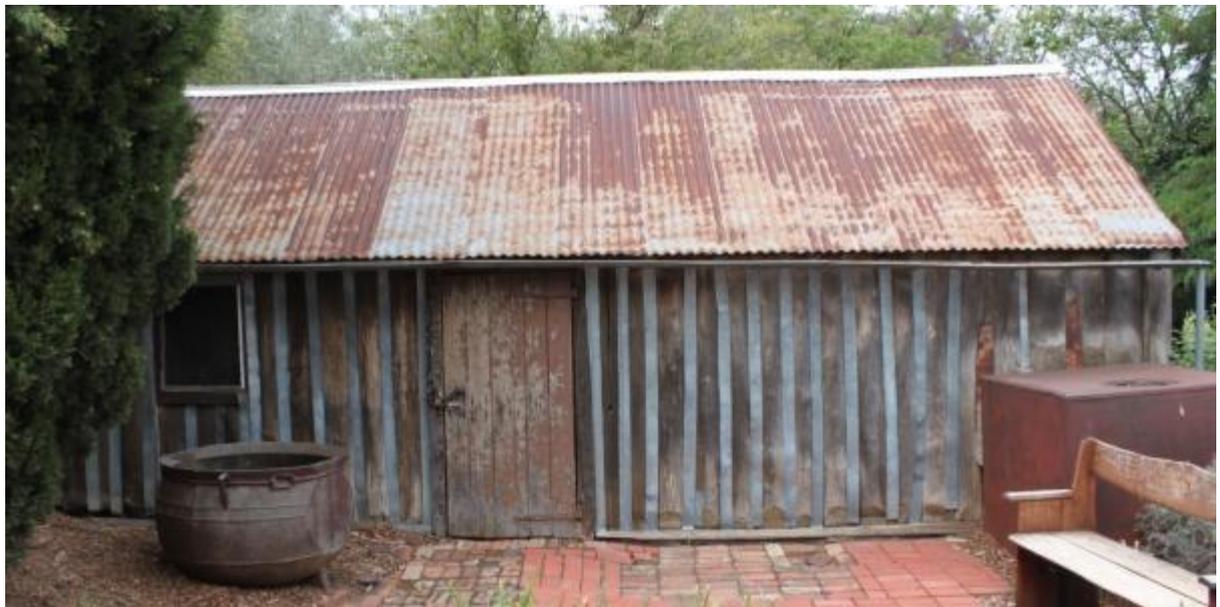
Figure 3.27 Slab Shed West elevation. (Source: GML 2013)

Room Element	Date	Form/Fabric Earlier Treatments	Condition	Significance of Element	Tolerance for Change Ranking
Roof	c1888	Corrugated galvanised iron with recent rolled ridge cap.  Existing iron appears to be the original material.  No changes to this elevation.	Rusted	High	Moderate
Wall	c1888	Vertical slabs between top and bottom places, with galvanised cover strips.	Good	It is assumed that these slabs are original to their location in this building—High.	Moderate

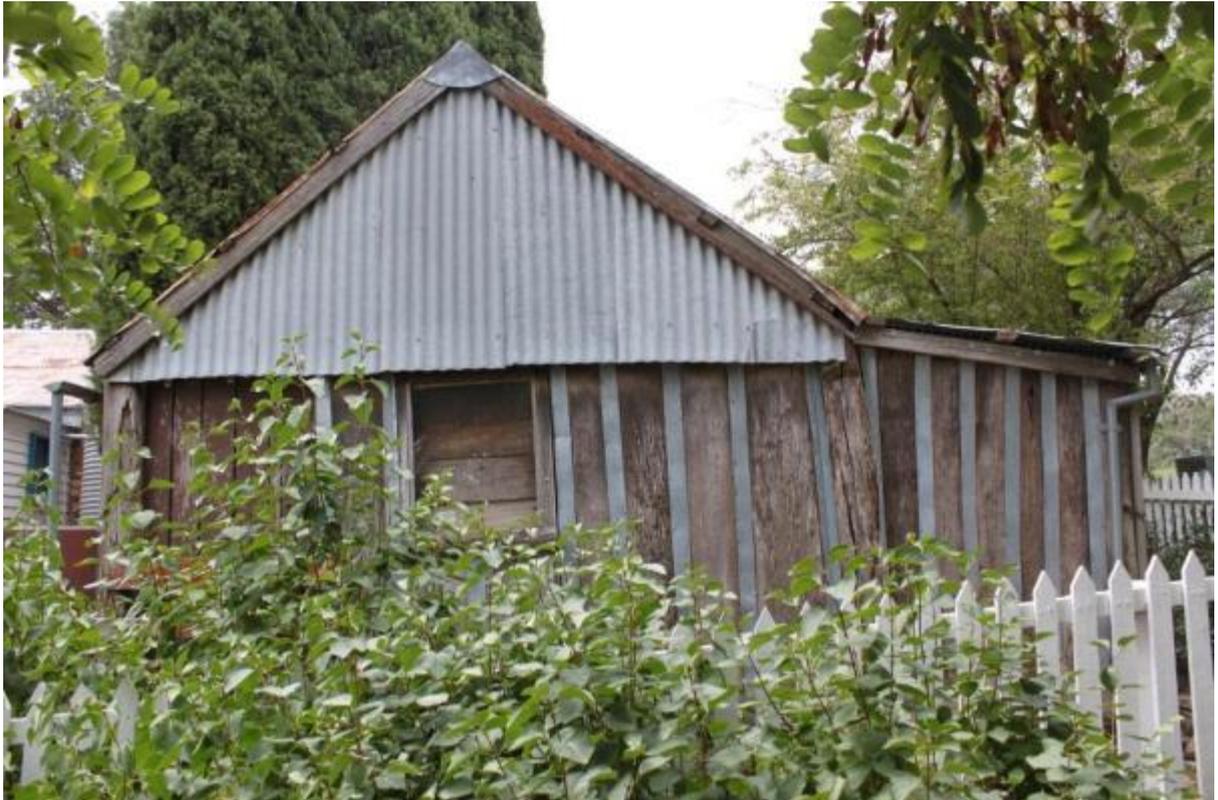
**Figure 3.28** Slab Shed South elevation. (Source: GML 2013)

Room Element	Date	Form/Fabric Earlier Treatments	Condition	Significance of Element	Tolerance for Change Ranking
Wall	c1888	<p>Post and beam construction with vertical slabs.</p> <p>Decayed base plate, base of posts replaced in 1998, and soil retained away from wall.</p> <p>Previously limewashed.</p> <p>Cover strips introduced in 1967.</p> <p>Not clear how many slabs have been replaced, if any.</p> <p>The attached skillion outhouse on the eastern wall replaced former buggy shed.</p>	Good	High	Moderate
Window		<p>Single pane sash evident in 1910 photo.</p> <p>This sash may be a replacement.</p>	Good	<p>Sash—Moderate.</p> <p>A window in this location—High.</p>	<p>Sash could be replaced as necessary—Moderate.</p>

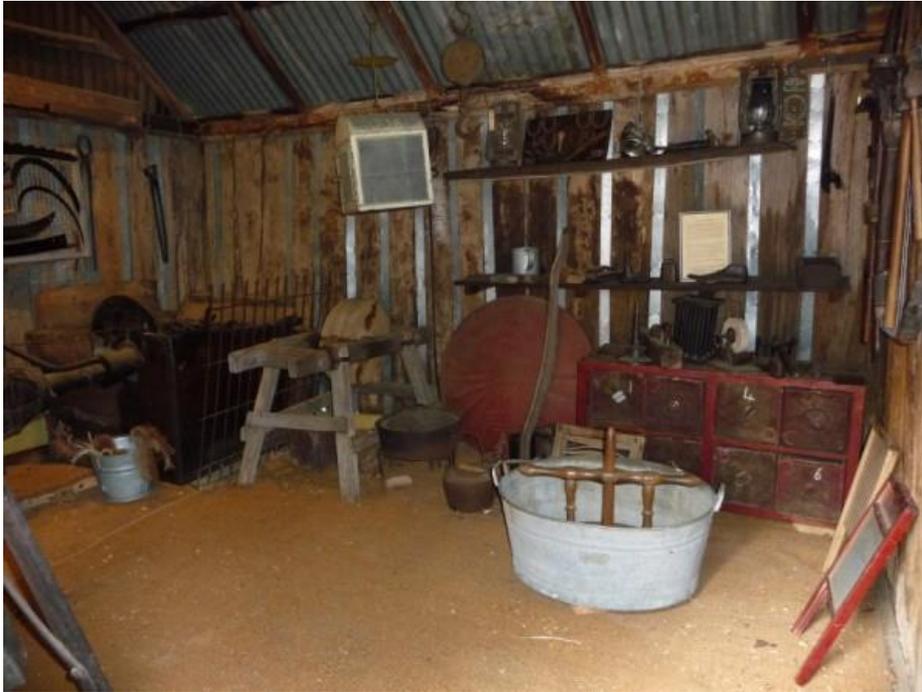
**Figure 3.30** Interior of main room in Slab shed. (Source: GML 2013)

Room Element	Date	Form/Fabric Earlier Treatments	Condition	Significance of Element	Tolerance for Change Ranking
Ceiling		There is no ceiling in 2013—the underside of the iron is visible. It is not known what, if any, ceilings were present historically.	—	—	—
Roof Frame	c1888	Lightweight bush round rafters supported on machined top plates. Sawn battens at about 900 centres. Frame appears to be original.	Good	All the original framing is considered to be significant—High.	Low

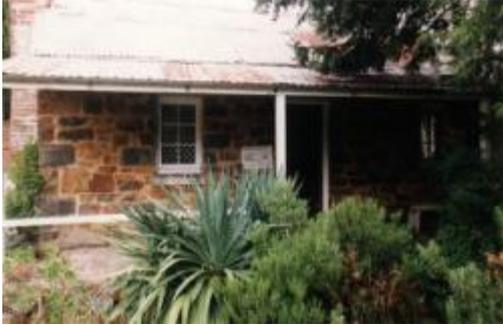
<p>1994</p>

Building Element	Changes to Fabric	Image
<p><b>North elevation</b></p>	<p>The window's paint colour changed from white to teal blue.</p> <p>1994 CMP—the CMP notes that 'the chimneys have never been flashed'.</p> <p>More of the tree overhangs the building.</p>

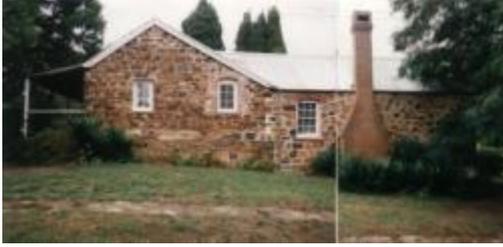
<p>1994</p>

<p>2012</p>
<p><b>West wall</b></p>	<p>1994 CMP—the random rubble wall was in fairly good condition, although there was some breakdown of pointing between the stones, particularly on the older section of wall 'most of the pointing from the earlier work has weathered off'.</p> <p>2012—the window frames had been painted blue/grey, there had been an increase in the breakdown of mortar, and possibly even some of the stone, particularly around the downpipe. Note that the yuccas have grown considerably.</p>

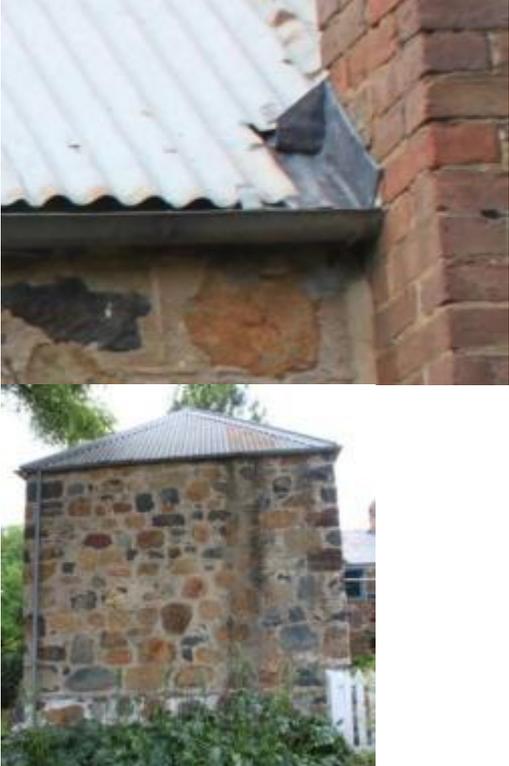
Building Element	Changes to Fabric	Image
<p><b>South wall</b></p>	<p>There has been very little change to the south wall, other than slightly increased loss of limewash on the lower plinth, and increased staining or algal growth in the vicinity of the repaired crack. The wall was underpinned in the 1960s and has remained stable.</p> <p>The sash on the south wall of room 5 has been painted grey/blue.</p>

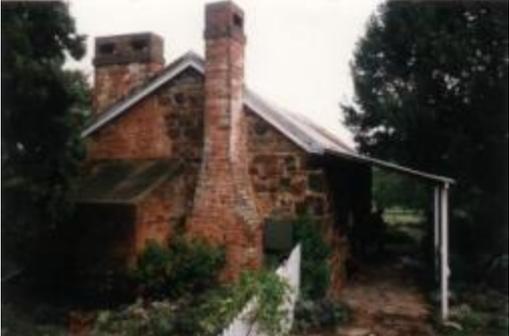
<p><b>Porch</b></p>	<p>There is no substantial change other than introduction of roof flashing.</p>	
<p><b>East elevation</b></p>	<p>There has been little change other than minor loss of limewash, and possible acceleration of fretting in mortar and bricks in the exterior of the lounge room chimney.</p>

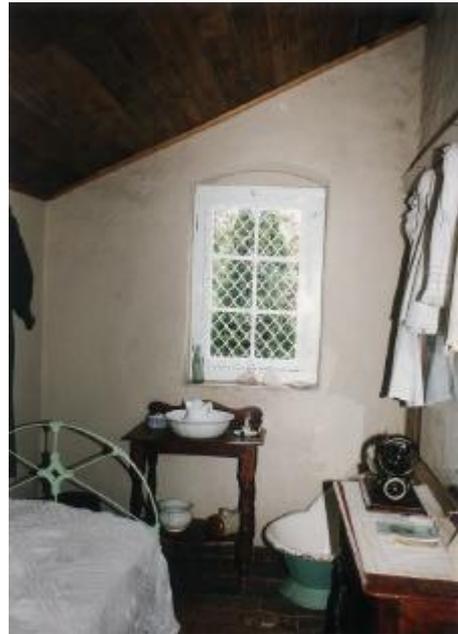
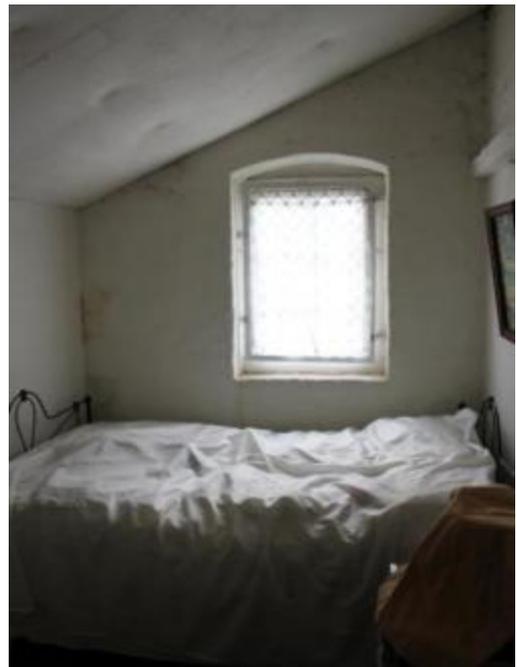
1994—the walls were painted with acrylic paint and the ceiling comprised fibro sheeting and recycled lining boards. The walls were pale green.

2012—the ceiling has been covered with hessian and has been limewashed. The window sash remains white. The walls have been painted white.

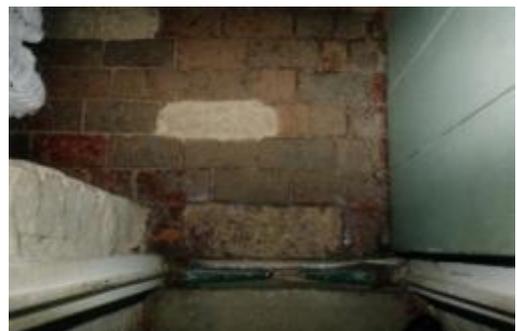
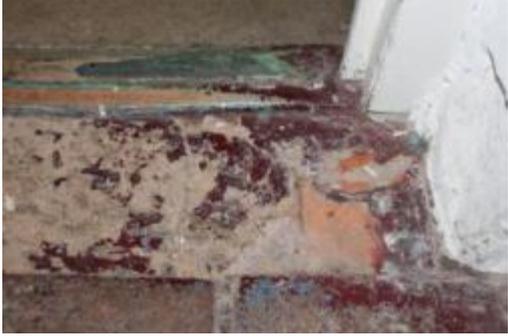
Threshold and floor in 1994.

<p>In 2012 the door threshold continued to retain much of its intriguing detail.</p>
<p><b>Room 4 Front bedroom</b></p>	<p>1994—the walls were painted with beige acrylic paint, however by 2012 it is white and appears to have been limewashed. There has been minimal other change.</p>
