**Blundells Cottage**  
**Heritage Management Plan**

Report prepared for the National Capital Authority

May 2014

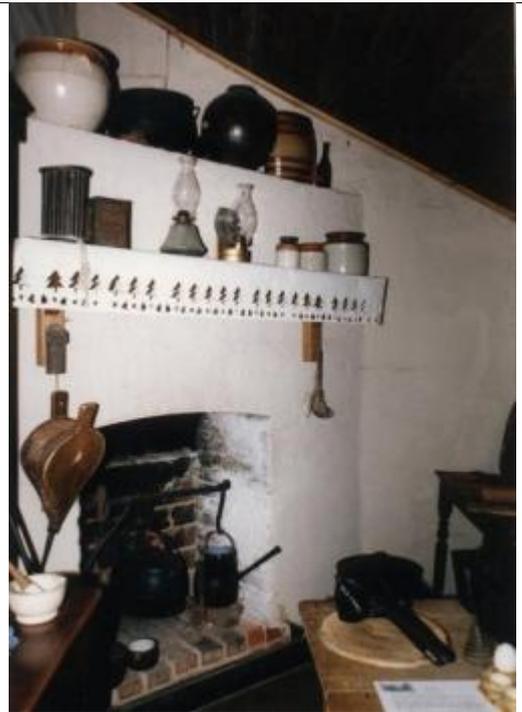
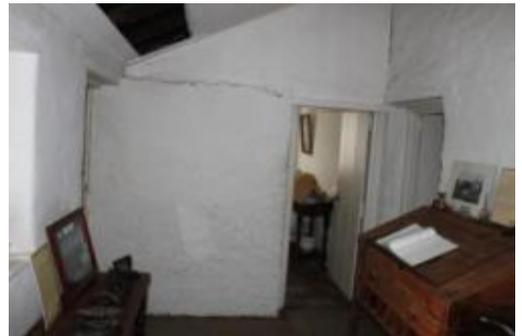
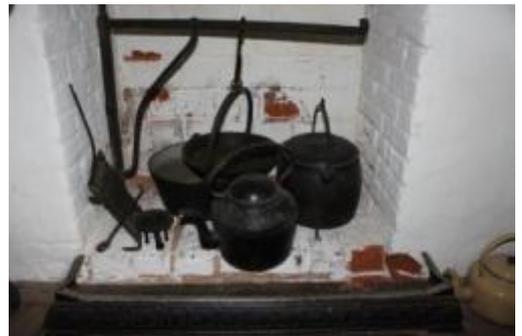
<p>2012</p>
<p><b>Room 5 Former kitchen</b></p>	<p>The major change in room 5 has been to the ceiling.</p> <p>1994—the ceiling was recycled lining boards.</p> <p>2012—the ceiling is now limewashed hessian, a strip of which has been removed to reveal the underside of the shingles above. It is not obvious if the former fibro and lining board ceiling was removed before the hessian was installed.</p> <p>Also in 2012, the fireplace has been fully limewashed.</p>

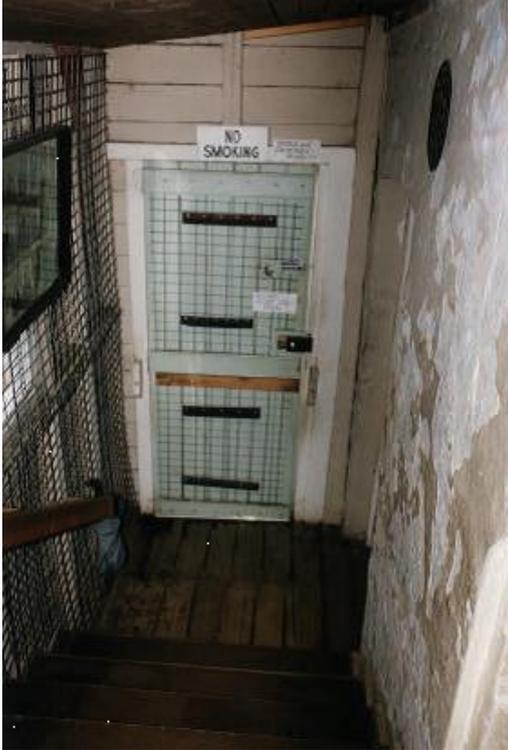
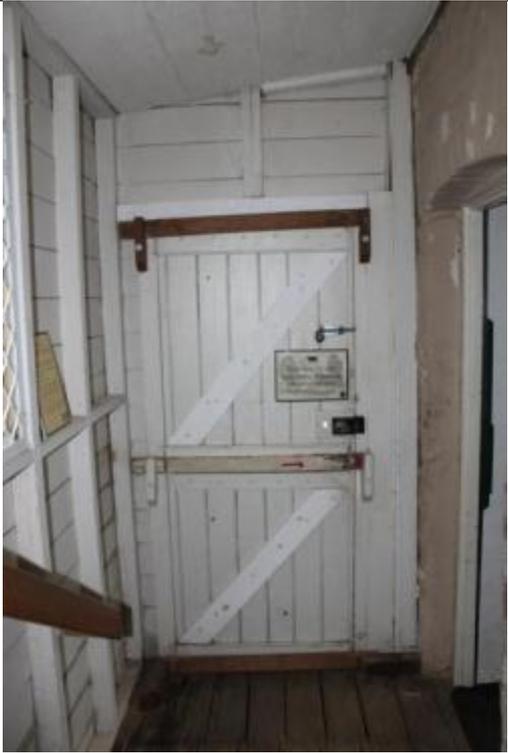
<p>1994</p>
<p><b>Porch</b></p>	<p>The most substantial change has been the removal of security mesh on the eastern wall, and repainting of the timber walls. The door has been painted from pale green to white and its security bars modified. The masonry wall, with its mottled collection of past paint finishes, has been left as evidence of former treatments. The ceiling has been covered with hessian that has been limewashed.</p>

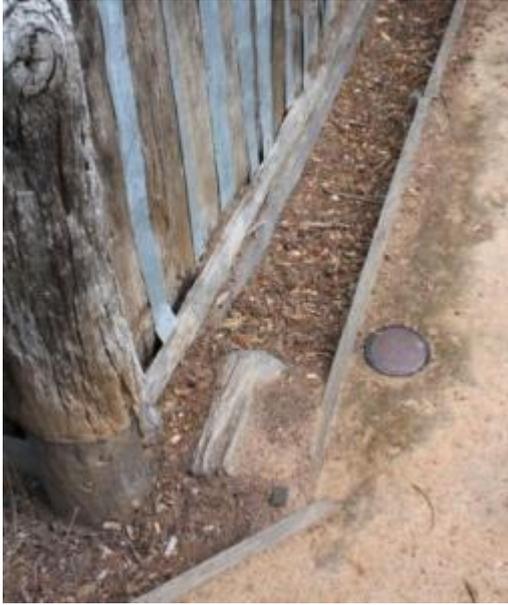
<p><b>Slab shed</b></p>	<p>The major modification since 1994 has been repair to base plates at the northern end and excavation of soil in the same area.</p> <p>The base of posts has been removed and a new base spliced on, and a soil retaining strip introduced about 450mm from the slab wall.</p> <p>Internally, the structure remains much as it had, although public access to the southern room is limited.</p>

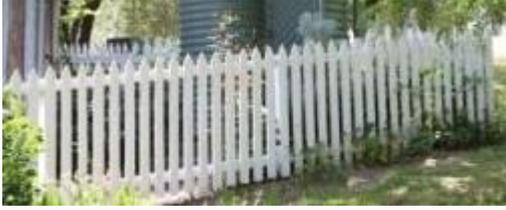
<p><b>Fence</b></p>	<p>The picket fence is understood to have been a reconstruction of the previous picket fence that was introduced after 1960 by the CDHS, ie it is a new version of an introduction which was based on conjecture not evidence.</p>

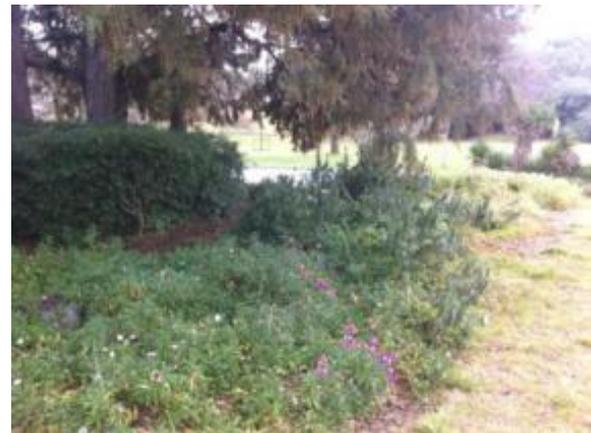
**Figure 4.6** Overgrown cottage garden under Himalayan cypress trees. (Source: GML 2013)

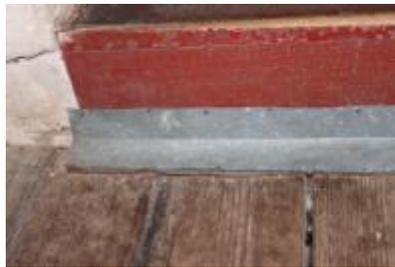
Element	Condition	Identified Issue/s	Recommended Works	Priority	Timing	Image
<b>COTTAGE INTERIOR</b>						
<b>Back porch Cover strip between steps and floor</b>	Fair	The cover strip is starting to come loose. This could become a trip hazard or worse if it catches on someone's shoe.	Carefully re-secure the metal strip to the floor following existing evidence.	High	2013

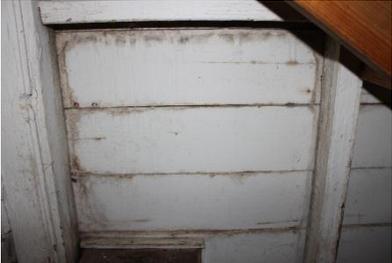
Roof leaks	Check if leaks have been repaired; monitor for leaks during rain.	High	2013	
		Ceiling stains	Research appropriate distemper/limewash products both in terms of content and colour, prepare and apply new.	It will identify if roof still leaking – High.	2013	
		Loose paint and plaster	Consolidate if possible, otherwise repair/replace damaged render as it is part of occupancy phase and therefore significant.	Medium	2015	
<b>Back porch East wall</b>	Stained	Evidence of former water entry. The stains mask whether there is on-going water entry. Gutters and valley on roof may be clogged.	Check gutters and valley on roof to prevent water penetration. Clean, and /or repaint.	Medium	2013 2015

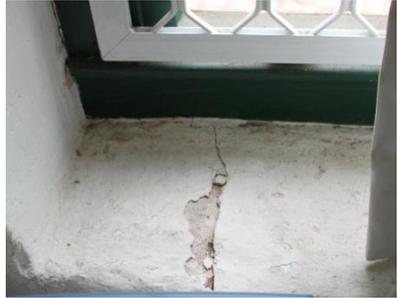
Decayed mortar by window sill	Prior to the room being lime washed the crack should be cleared to remove loose material to the substrate and then filled with lime mortar to patch.	High	2013

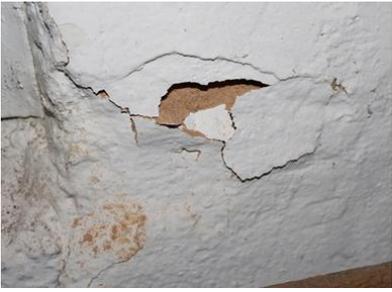
<b>Room 2 West wall</b>	Poor	Render is actively spalling in a localised area to the lower right of the stove. This may be on-going, or exacerbated by the water falling on the stove. Salt activity may be involved.	Ensure there is no cement under the present surface and remove if necessary. Removed decayed material, apply poultice, dry wall and apply new lime based render once possible salt action has been stabilised.  Monitor and check for other damp sources.	High	Mid 2013

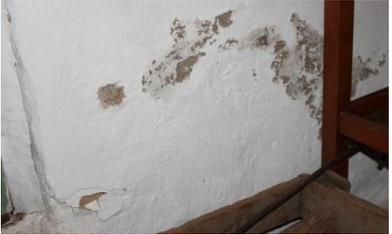
<b>Room 2 West wall Rising damp</b>	Poor	An arc of rising damp is evident up to about 700 mm to the left of the stove. The origin of the moisture needs to be located and resolved.	Check there is no cement under the current surface and remove if necessary. Remove built up soil and plants from the exterior to be consistent with local external ground level and well below the 50mm plinth. Review the recent flashing around the chimney and rectify. Ensure that roof and ground water is drained well clear of the wall. Make good interior render only after damp problems have been	Very high	Early 2013

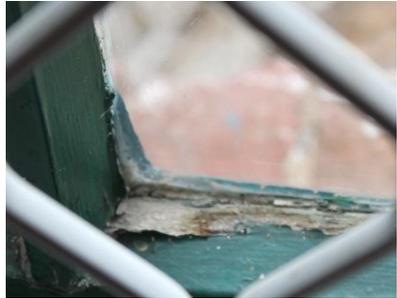
<b>Room 2 West window</b>	Poor	Paint on the interior of the windows is breaking down. Timbers in the sash will start to decay if this is not repaired. The problem is exacerbated by condensation on the inside of glass in winter.	<p>Sand back to sound wood, prime and paint.</p> <p>Use antifungal additive in paint or primer.</p> <p>De-humidify the room in winter to actively remove condensation.</p>	High	2013

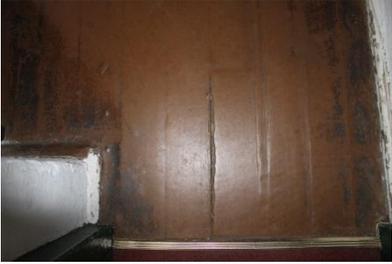
Element	Condition	Identified Issue/s	Recommended Works	Priority	Timing	Image
<b>Room 2 Linoleum floor</b>	Fair	The linoleum is distorting due to the uneven butt-jointed subfloor. This will exacerbate decay of the lino. The lino was added by the CDHS in 1963 and renewed in 1970. It is not individually significant but the use of recycled lino by the CDHS is typical of their conservation approach and should be noted and followed (if possible) if the lino is to be replaced.	Reinforce the underside of the lino. If the linoleum is lifted, investigate options for achieving a more level subfloor. Careful preparation will be needed to ensure linoleum is not damaged during lifting.	High	2013

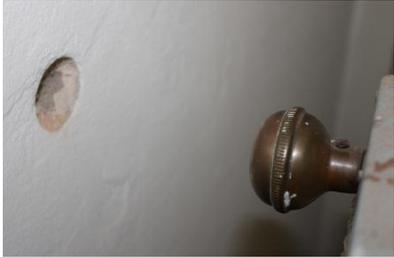
<b>Room 3 Door knob impact on wall</b>	Poor	The door knob has worn a large hole in the render from impact when the door is opened. The age of the wear is not established, but it is bad for both the knob and the wall.	Fill the hole with render and patch and paint. A small door stop at floor level is needed to prevent the problem re-occurring.	Medium	2014

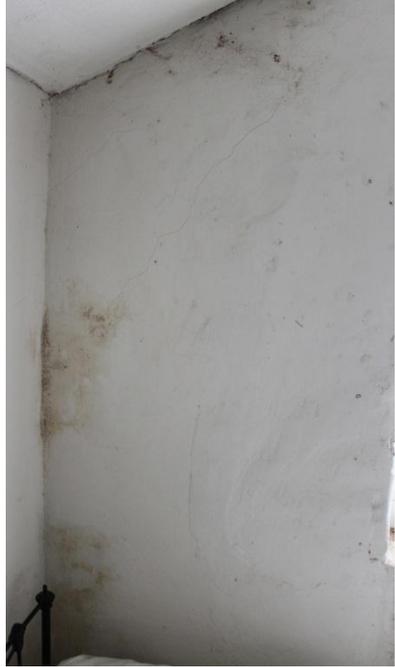
Element	Condition	Identified Issue/s	Recommended Works	Priority	Timing	Image
<b>Room 3 Southwest corner damp</b>	Poor	This is a continuation of the damp that is causing problems on the NW corner of Room 2. The problem is due to clogged gutters and downpipes externally, plus some deterioration of external mortar.	<p>Check and clear/repair the roof and down pipe as necessary.</p> <p>Roof water needs to be discharged well clear of the building and a comprehensive review of roof drainage should be undertaken. In the short term the down pipe needs to be flushed clear or replaced. Gutters also need to be cleaned on a monthly basis. The internal surface can be repaired only after the external damp has been controlled.</p> <p>Check ground drainage is directed away from building.</p> <p>Renew mortar with lime based mortar after clearing out all loose material.</p> <p>Allow to dry, scrape off stained material. Apply algaecide if moulds or algae present.</p> <p>Apply new limewash/distemper after researching suitable products.</p>	Very high	2013

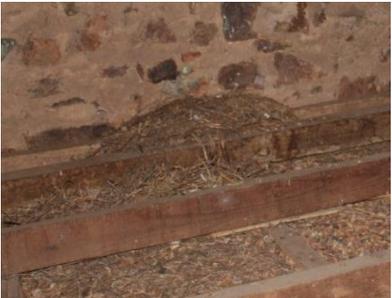
<b>Room 4 Ceiling space</b>	Dangerous	A large amount of debris has built up on the west wall in the ceiling, most probably due to former starlings or rats. The matter is highly flammable. It may also include asbestos.	Investigation of asbestos presence and remediation. Engage a specialist to investigate for asbestos presence and recommend appropriate clearing.	Urgent	Immediate

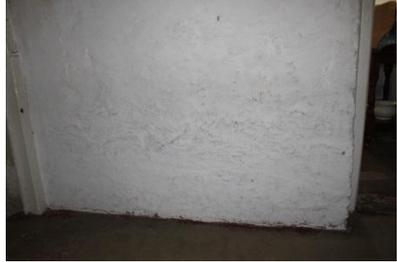
<b>Room 5</b>	Scuff marks	Heavy visitor use has resulted in a fair amount of scuffing along this wall.	At an appropriate time the wall could be cleaned and possibly re-limewashed/distempered in accordance with the interpretative presentation of the cottage.	Low	When other walls are being limewashed/distempered

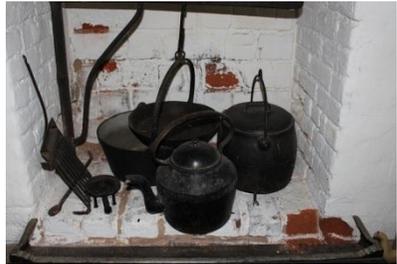
<b>Room 5</b>	Fair	Fretting bricks	Investigate to determine the cause—damp or drying?  Apply a poultice to extract salts and then apply a sacrificial lime mortar, after salts have been removed/stabilised limewash can be applied. Monitor.	Medium	At the same time as similar repairs elsewhere in the building

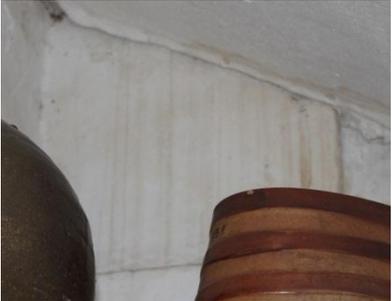
Element	Condition	Identified Issue/s	Recommended Works	Priority	Timing	Image
<b>Room 5 Stains above chimney</b>	Fair	Stains above the chimney suggest that there has been leaking at the chimney roof junction. It is not obvious if this is old or recent.	<p>Check the roof flashing above the chimney and rectify if necessary to prevent further water entry.</p> <p>Clean stains in the short term, and apply limewash/distemper when the rest of the room is being limewashed, in accordance with 'Blundells Cottage Paint Analysis 2012' and consistent with the interpretative presentation of the cottage.</p>	Very high	Check for leaking in the flashing in 2013. Remaining works when convenient.

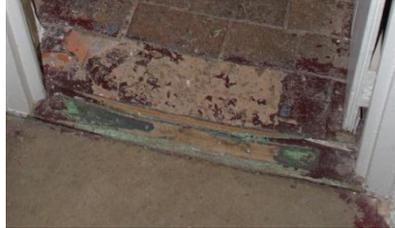
Element	Condition	Identified Issue/s	Recommended Works	Priority	Timing	Image
<b>Room 5 Threshold to room 3</b>	Historic fabric	The surviving finishes of timber, paint and linoleum are at risk of being eroded from foot traffic.	If possible, compare with colour images from Freeman CMP 1994 to determine rate of erosion. Investigate options for consolidation or application of protective film. If warranted, cover with small carpet. Consult specialist materials conservator.	Medium	2015

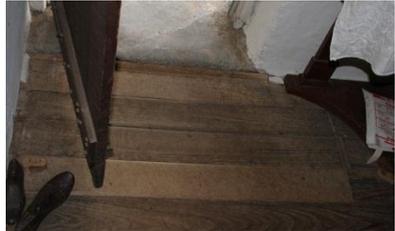
<b>Room 6 Loose boards by front door</b>	Fair	Some of the flooring boards by the front door are loose. These boards may provide access to the subfloor.	Screw the boards to the floor using slot head screws. Ensure boards can be easily removed for subfloor inspection.	Low	2015

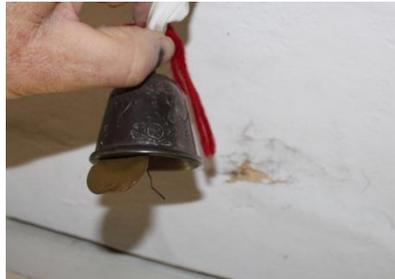
<b>Room 6 Door bell</b>	Eroding	Every time the door is opened or closed, the doorbell swings up and hits the underside of the head beam. This is damaging the paint and substrate.	Replace the doorbell with a fixed bell that does not swing.	High	2013

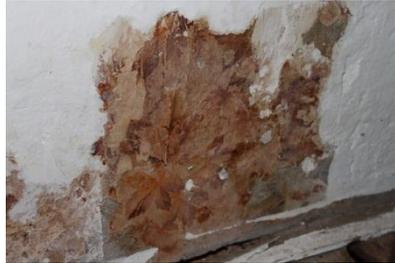
<b>Room 6 Original wall paper</b>	Good	A small sample of original wall paper has been left exposed.  This is significant fabric that provides an opportunity for reinterpreting the room's décor.	Ensure the sample is not inadvertently damaged. Investigate protection with something like a Perspex cover. Consult specialist materials conservator for conservation options which allow interpretation.	Low	2015

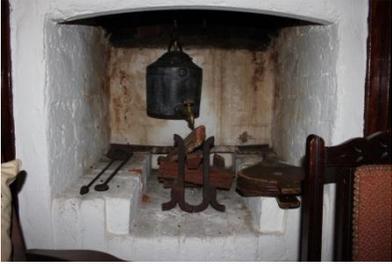
Element	Condition	Identified Issue/s	Recommended Works	Priority	Timing	Image
<b>Room 6 Fireplace</b>	Fair	There are stains in the back of the fireplace which themselves are not a problem, however they may indicate occasional leaking down the chimney. Evidence suggests the fireplace was previously limewashed.	Monitor the fireplace during rain to observe if water is entering the chimney. Check chimney flashing and repair/replace as needed. Re-apply limewash.	High	2013

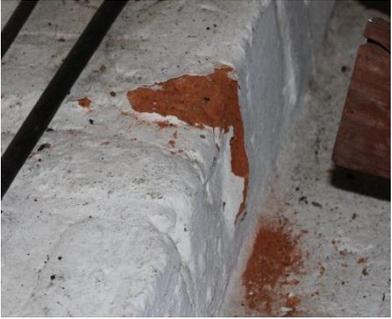
<b>Room 6 Fretting brick in fireplace</b>	Poor	The brick is decaying, probably due to salts, low brick firing and water penetration.	Investigate and remove the source of the water. Apply poultice to remove salts and when stable re-limewash.	High	2013

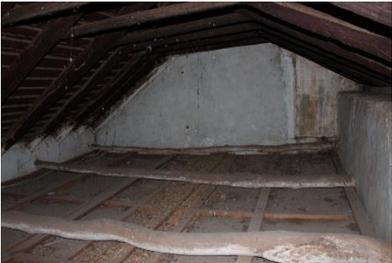
<b>Room 6 Ceiling space</b>	Stable	There is clear evidence of a former ceiling and shingle roof.	Consider additional interpretation of this space to visitors. Consider lighting to assist viewing.	Low	2015

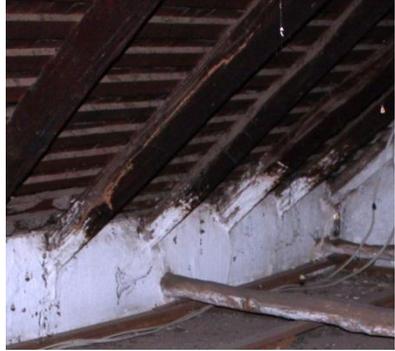
Element	Condition	Identified Issue/s	Recommended Works	Priority	Timing	Image
<b>Room 6 Ceiling space</b>	Unclear	There appears to be mud tunnel on the edge of a ceiling joist that is consistent with termite activity.	Confirm if this is a termite tunnel and treat it. Install termite bait and monitor. Assess and repair any timberwork damage.	Urgent	Immediate

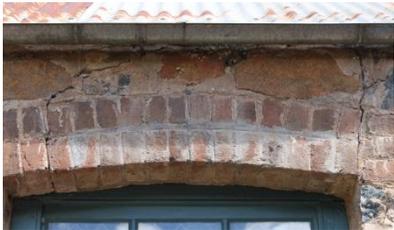
<b>East wall Window arch</b>	Cracked	Subsidence cracks in stone and mortar. Similar cracks are evident elsewhere in the wall and could also be treated.	Check lintel is safe. Engage a heritage engineer or experienced heritage bricklayer to provide detailed assessment and long-term strategy for this problem. It may be appropriate to lift the arch and retrofit an arch bar to support the brickwork prior to repointing.	Medium	2014

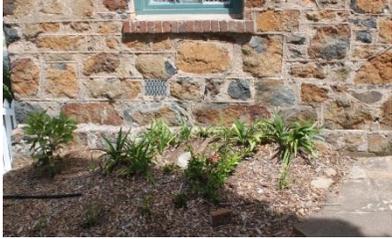
Element	Condition	Identified Issue/s	Recommended Works	Priority	Timing	Image
<b>East wall Soil build up</b>	Fair	Soil is building up in the garden bed.	All soil levels next to the building should be kept low and below internal floor level to prevent water entering the stonework.  Ensure all surface ground water flows away from the building.	Low	2015

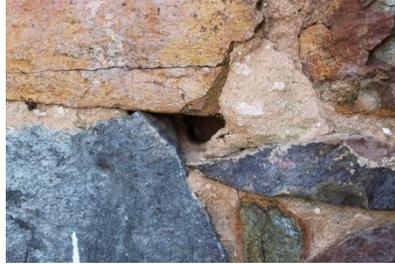
<b>Wall behind tank</b>	Fair	<p>Mortar has eroded in places to leave deep holes. This occurs in multiple locations around the building and will be allowing water penetration.</p>	<p>Remove any hard cement.</p> <p>Implement lime based mortar repairs to all locations where mortar has eroded. Allow up to 10% of joints for repointing.</p> <p>Carefully maintain existing masonry character. Match colour and style. Prepare samples first and match when dry. An appropriate mix is 1 lime putty: 3 selected sharp sand. A mix of 1 cement: 2 lime: 9 sharp sand may also be used, especially if it enables a more sympathetic colour match to be achieved.</p>	High	2013

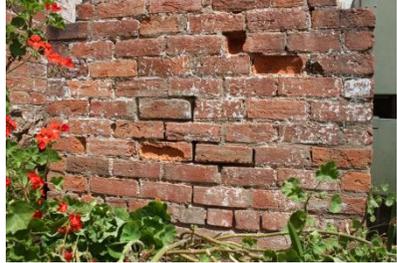
Element	Condition	Identified Issue/s	Recommended Works	Priority	Timing	Image
<b>East wall Chimney</b>	Poor	Spalling bricks and eroding mortar.	<p>Resolve the damp which is eroding the pointing—remove built up soil from garden bed and do not water plants next to walls.</p> <p>Apply poultice to withdraw salts.</p> <p>Replace eroded bricks with closely matching replacements.</p> <p>Remove loose material and repoint joints, holes with lime mortar.</p>	Very High	2013

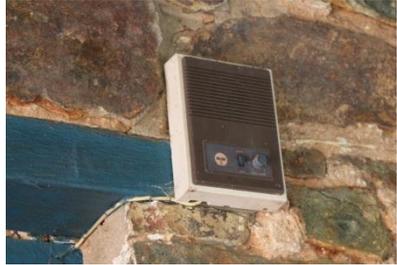
<b>Intercom by front door</b>	Poor	The intercom is not consistent with Blundells heritage values.	Remove the intercom if it is redundant or arrange alternative.	Low	2015

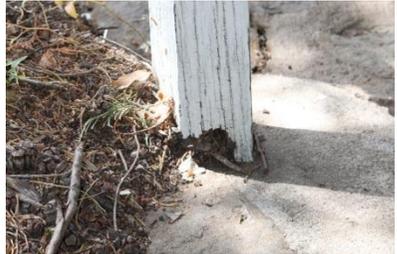
<b>Front Verandah post</b>	Poor	The base of the post has decayed.	<p>Scarf in the timber at the base, or replace the whole post.</p> <p>The post dates from 1963 and is not significant fabric. Any replacement should be like for like; that is, 100 x 100 rough sawn hardwood, sanded and then painted in accordance with 'Blundells Cottage Paint Analysis 2012' and consistent with the interpretative presentation of the cottage.</p> <p>Seal the base of the post and secure to pavement with a concealed pin.</p>	High	2013

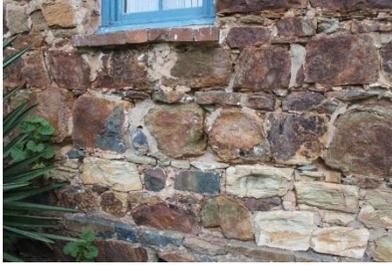
Element	Condition	Identified Issue/s	Recommended Works	Priority	Timing	Image
<b>West wall Mortar loss</b>	Poor	Mortar loss on the west wall is generally more pronounced than on the other walls, probably due to greater weather exposure and cyclical wetting and drying.	Repoint the worst affected areas with lime based mortar to ensure full joints and reduce water penetration to the building. Allow 50% of pointing to be redone with 1 lime putty: 3 sharp selected sand. Match dry samples for colour and style before repointing affected areas.	High	2014–2024

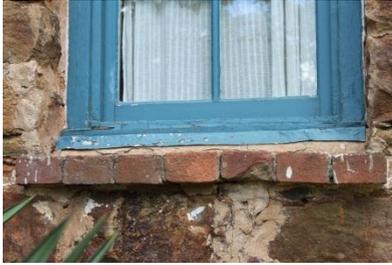
<b>West wall Windows x 2</b>	Poor	The existing paint is breaking down.	Carefully prepare and repaint both windows in accordance with 'Blundells Cottage Paint Analysis 2012' and consistent with the interpretative presentation of the cottage.	High	2013

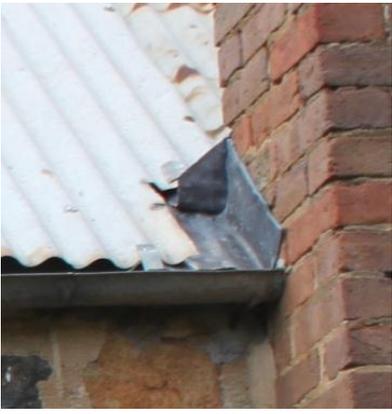
<b>West wall Chimney flashing</b>	New	<p>This has been done poorly and not consistently with traditional methods. The flashing has been cut into the brickwork instead of stepped into the mortar course. The cross flashing appears to direct water under the roof iron.</p> <p>It is not known if this work has led to the leaking onto the stove below.</p>	Flashing should be removed and replaced by a tradesman who is appropriately trained. In future, such work should be only undertaken by people with appropriate expertise.	Urgent	2013

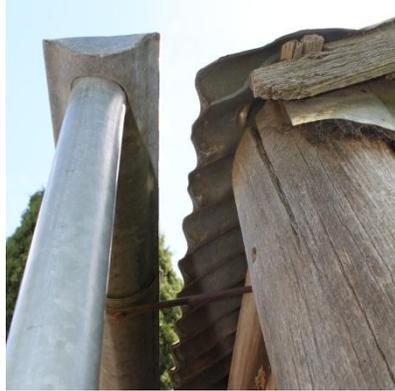
Element	Condition	Identified Issue/s	Recommended Works	Priority	Timing	Image
<b>SLAB SHED</b>						
<b>Slab shed Gutter</b>	Loose	The gutter has drifted away from the roof and is not functional.	Reinstate and monitor effective operation.	High	2013

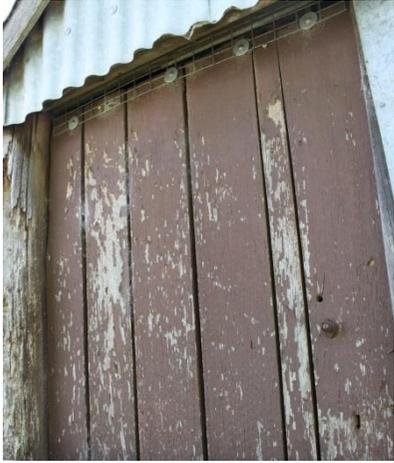
Element	Condition	Identified Issue/s	Recommended Works	Priority	Timing	Image
<b>Slab shed South door</b>	Poor	Peeling paint	Prepare carefully and apply new paint or umber stain to the door in accordance with 'Blundells Cottage Paint Analysis 2012' and consistent with the interpretative presentation of the cottage.	Medium	2014

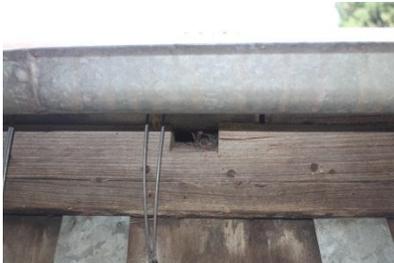
<b>Slab shed East wall Top plate</b>	Good	The top plate provides evidence that this shed is the one that has been on the site from early days.	Retain all evidence embedded in the shed's fabric such as this rebate that supported the buggy lean-to roof.	High	Ongoing

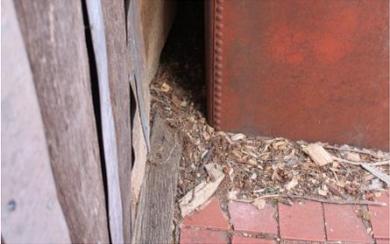
<b>Slab shed West wall</b>	Poor	There is leaf litter between the tank and the slab wall that is likely to lead to decay of timbers.	Clean the leaf litter out. Move the tank away from wall a sufficient distance to allow regular access for cleaning.	High	2013

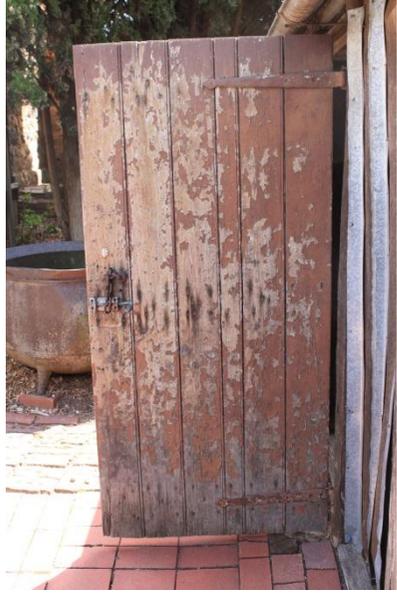
Element	Condition	Identified Issue/s	Recommended Works	Priority	Timing	Image
<b>Slab shed Shed door</b>	Poor	There is peeling paint and timbers are starting to decay.	Check the security of hinges and their hanging. Fix as necessary. Carefully prepare and repaint to match existing colour scheme in accordance with 'Blundells Cottage Paint Analysis 2012' and consistent with the interpretative presentation of the cottage.	High	2013

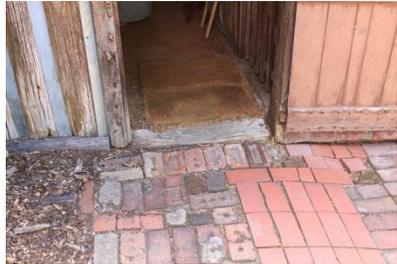
<b>Slab shed Doorway</b>	Mixed	Ensure that rain water doesn't enter the building.	Monitor and re-grade the bricks if required. The bricks are modern introductions to the landscaping and can be altered.	Low	Ongoing

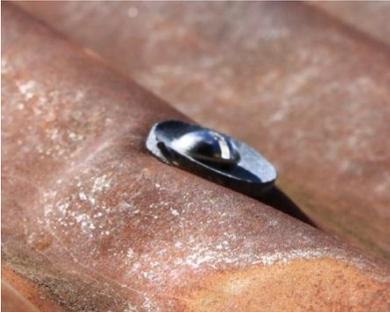
<b>Slab shed New roofing screws throughout</b>	Bright zinc finish	These bright steel screws won't patinate over time. Ideally galvanised screws will be used.	Obtain a supply of galvanised screws and lead washers for future repairs.	Low	2015

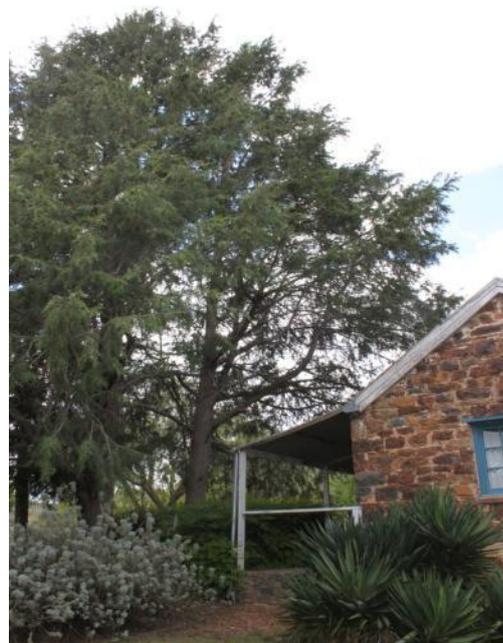
**Figure D.8** Manage the Himalayan cypress closest to the building. (Source: GML 2012)

Of the three Himalayan cypresses located at the front of the building it is recommended that the one closest to the verandah be investigated for active management to eliminate most of the foliage overhanging the building. Periodic follow-up pruning may be necessary.

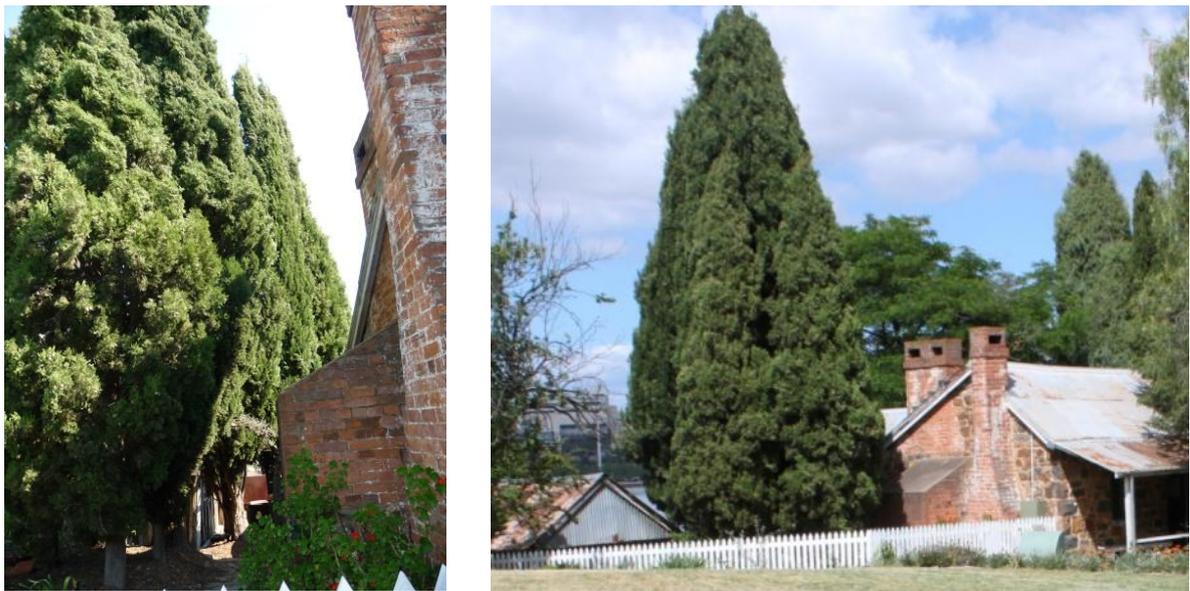
The Roman cypress trees between the cottage and slab shed are also problematic as they drop an enormous quantity of plant material on both buildings and the ground. This has resulted in past rotting of base plates and slabs in the shed that has necessitated expensive remedial work. These mature trees have become hazards to both significant buildings.

**Figure D.9-D.10** Roman cypress trees between the stone cottage and the slab shed.

For the Roman cypress trees between the cottage and slab shed an assessment should evaluate the effects of planting a replacement specimen (propagated vegetatively from the existing specimens to retain the current variety and form) further from the buildings to reduce crowding and fire danger. This will enable the remaining pines to be managed by removal at a future time when the replacement tree has grown to gain some presence in the landscape.

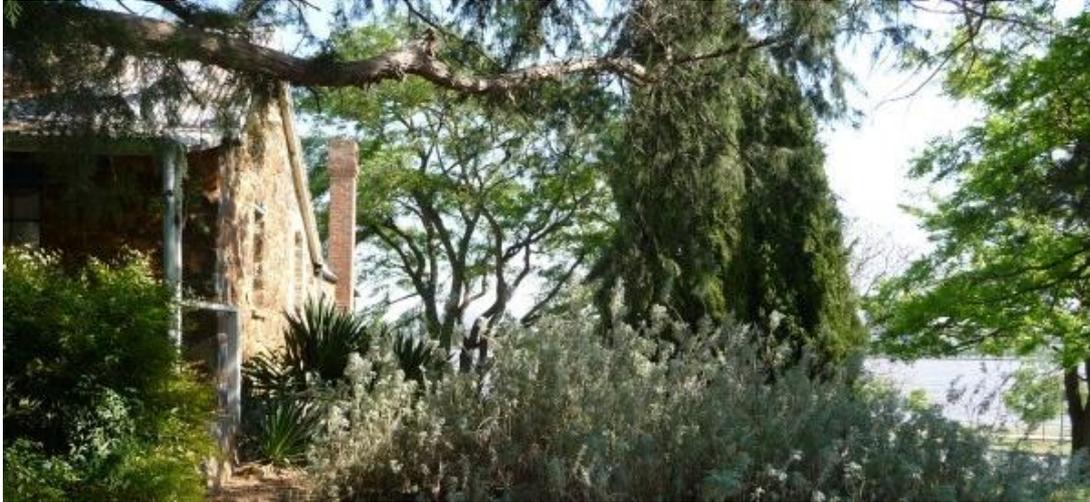
There are also Roman cypress to the southeast of the cottage which do not appear to be Oldfield era plantings and which obscure the view of the cottage from the lake edge approach path around from Commonwealth Park (Figure D.11 and D.12).

**Figure D.11** Roman cypress trees at southwest of cottage obscure the view of the cottage from the Menzies Walkway along the side of the lake. (Source: GML 2012)

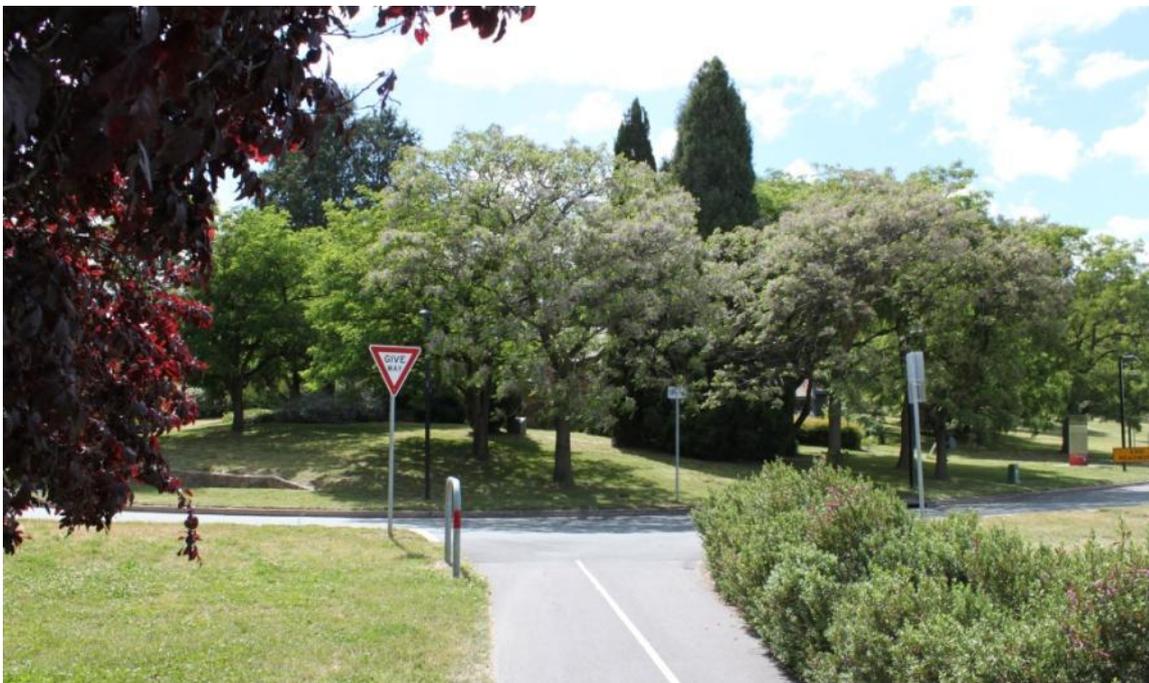
**Figure D.12** View of Blundells from west approach pedestrian/cycle path arriving from Commonwealth Park. (Source: GML 2012)

The approaches to the cottage require both opening up and definition. The Roman cypress on the southwest side of the cottage (which does not appear to be part of the pre-1960 planting), could be removed and some of the park's deciduous trees could be treated with under-pruning to open up the view of the cottage from the southwest. The approach path to the front of the cottage should be redesigned to be more historically accurate in concept; archaeological evidence may assist in confirming the formal cottage approach unless major changes in land level have removed all indications. The picket fence is historically inaccurate and its removal and replacement should be part of the proposed landscape plan for the cottage. The same plan could examine the expressed desire of installing a simple post and wire boundary fence to the edge of the lawn area between the cottage and Wendouree Drive road to contain school groups on the lawn in front of the cottage—for its relative merits in terms of being a safety feature, for lack of true historical accuracy which may confuse visitors about historical fencing patterns and the potential as an interpretative device to define the heritage curtilage at this point.

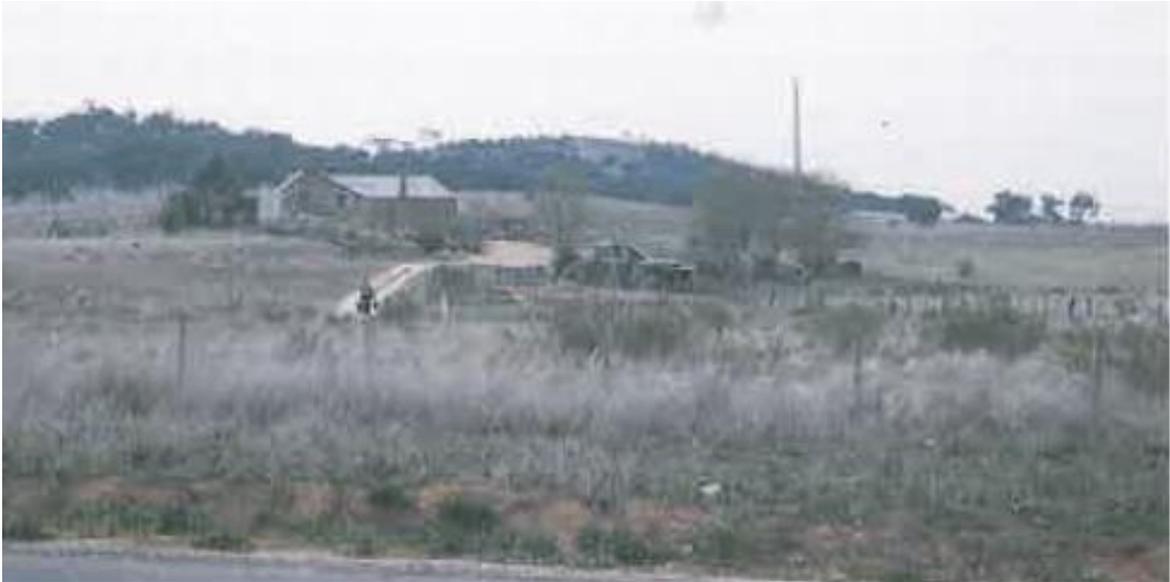
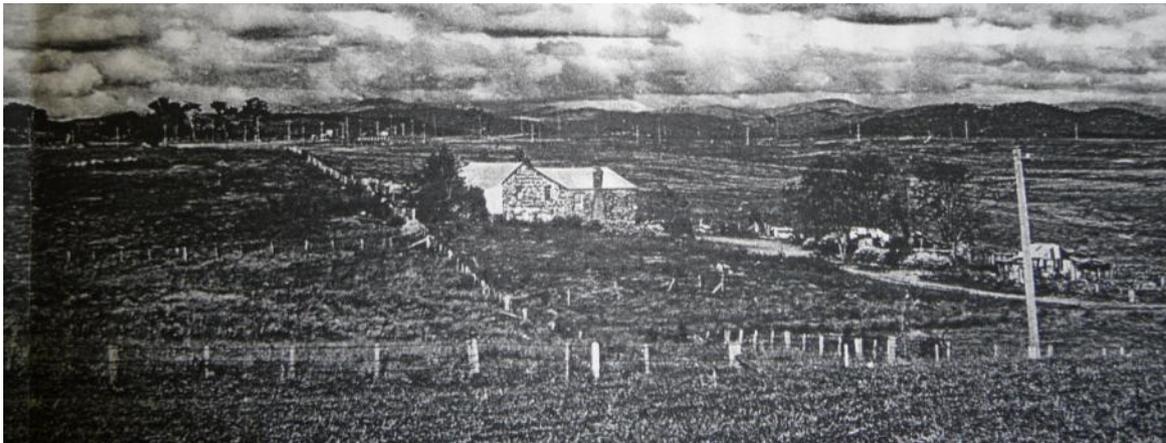
**Figures D13-D.14** Historic view of Blundells from west approach 1957 showing the open landscape with few trees. Post and wire fences in existence. (Source: Photos from Beth Knowles, Canberra)

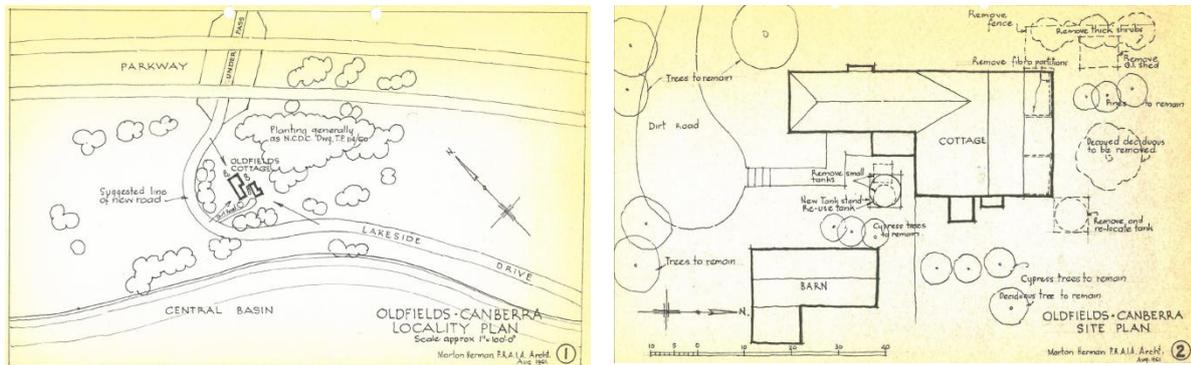
**Figure D.15-D.16** Morton Herman site plans of Oldfield's Cottage 1961.

Generally a path to a simple cottage like Blundells would have been practical and straight, leading directly to the front door, addressing and reinforcing the central axis. This is the case at Mugga Mugga. Herman identifies this axis on his locality plan with an arrow directly off Wendouree Drive. However when approaching from Constitutional Avenue today the pathway is awkward (Figure D.15)

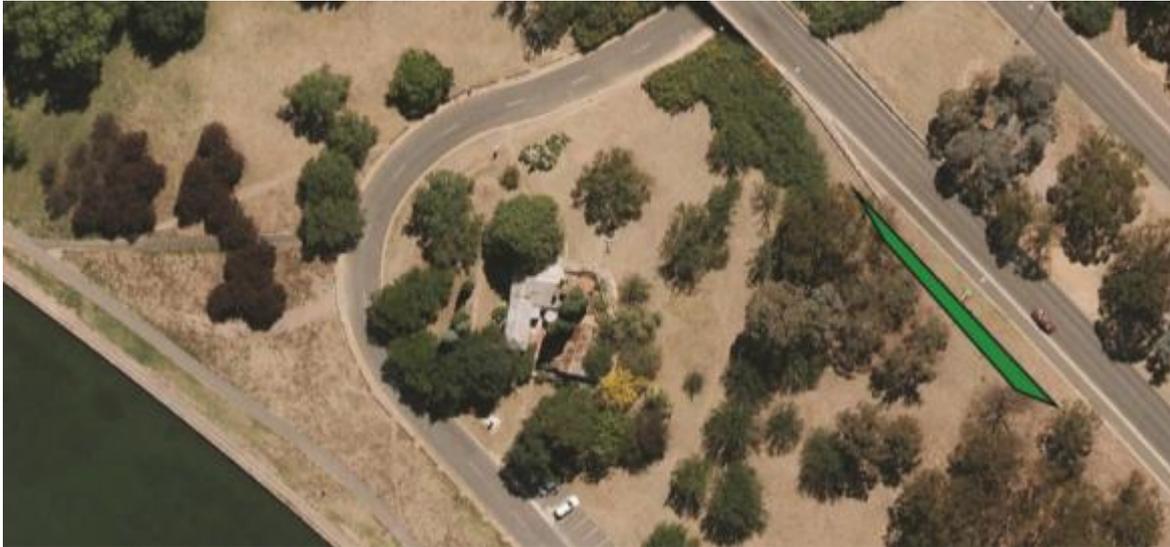
One way to achieve this is to add an earthen berm (mound) in King's Park adjacent the highway and to plant dense vegetation in its proximity (Figure D.18). A heritage impact assessment would have to be undertaken to determine effects on both the heritage values of Blundells Cottage and on the heritage values of the King's Park landscape design.

**Figure D.18** Suggested position of earth berm to Parks Way shown.
