Prepared by Duncan Marshall, Phil Creaser & Douglas Partners for the National Capital Authority

EXECUTIVE SUMMARY

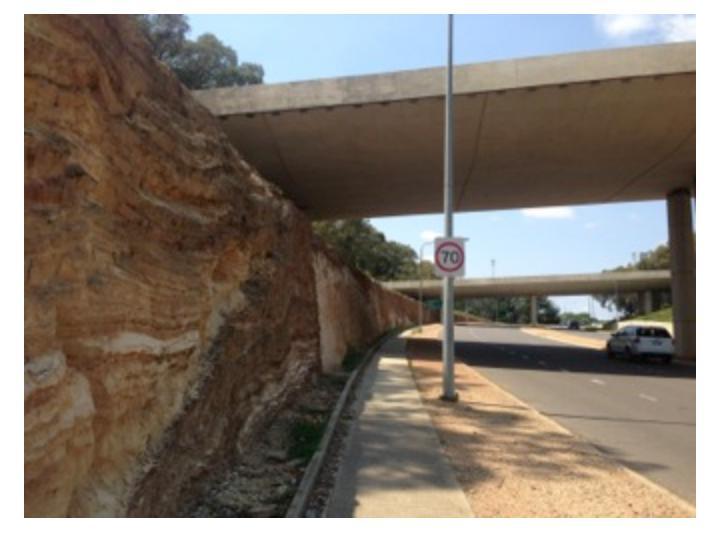
Figure 9. View towards Kings Avenue

- There is a 100 mm high concrete kerb extending along the northern side of the footpath at the toe of the lower batter face from CH 204 metres to a grated drain at CH 57 metres (CH = a chain measurement along the length of the cutting). Much of the 'channel' behind the concrete kerb is filled with fallen rock fragments. (see Figure 9)

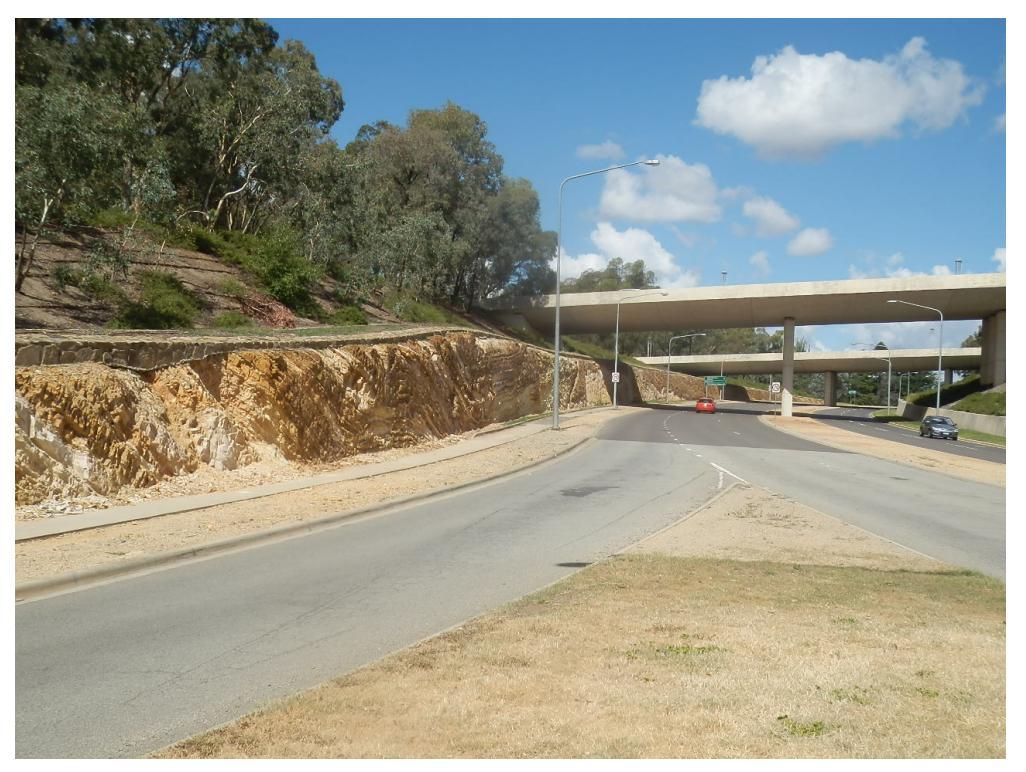
Plate 1 - General view of the excavated batter face looking eastbound along the entry ramp from Commonwealth Avenue and State Circle

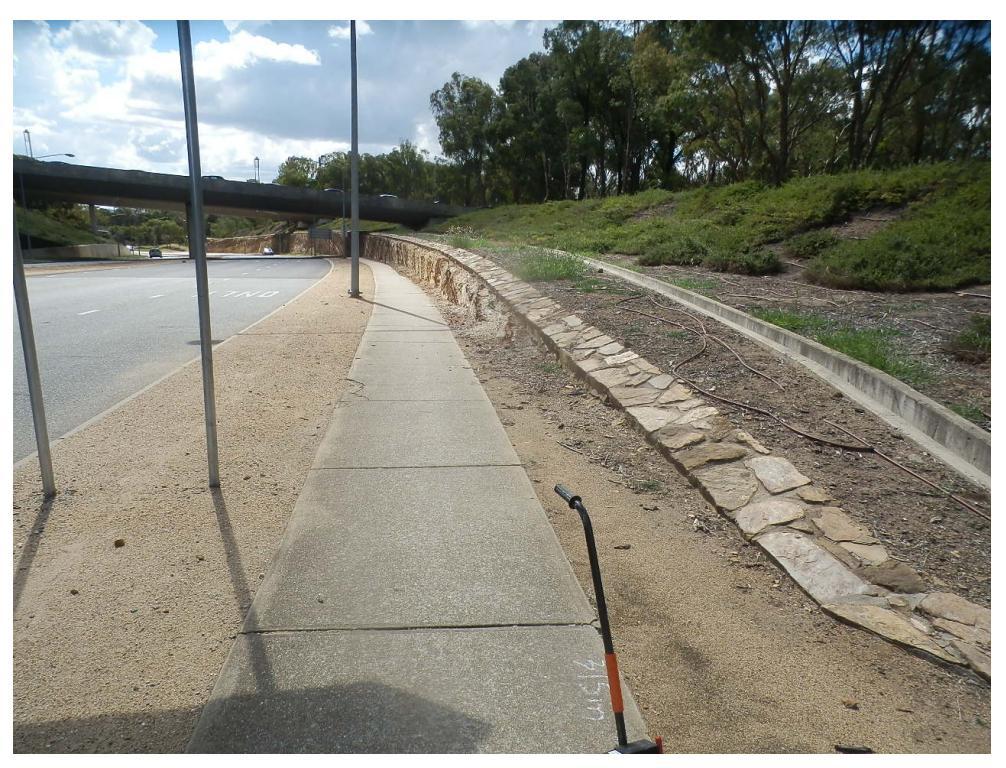
A 100 mm wide concrete gutter has been constructed between the toe of the cutting and the footpath for approximately half the length of the slope, evidently to direct stormwater or seepage from the face towards a grated drain and sub-surface drainage lines. A 300 mm wide by 500 mm deep, concrete box drain runs along the mid-level bench for the full length of the slope. A cemented stone capping layer has been constructed along outer edge of the mid-level bench at the crest of the lower batter face (refer to Plate 2).

Plate 2 - View from the eastern end of the slope showing the concrete box drain on the midlevel bench and the cemented stone capping layer along the creast of the lower batter face
