# **Tree Management Report 11 Talbot Street, Forrest**

#### Date of report: 31 October, 2023

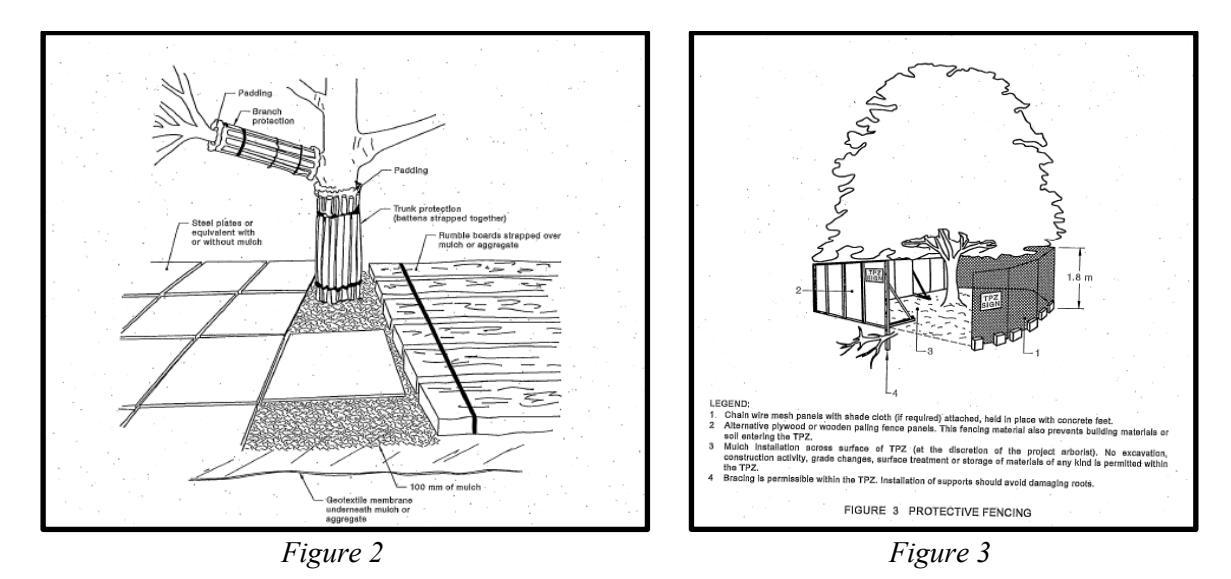
*Figure 2. Shows trunk and low branching protection, as per the Australian Standard for Tree Protection on Development Sites AS 4978 – 2009*

While it is understood that the works area will have its own fencing, consideration should be given to additional tree protection measures, such as lower trunk and branch protection, as shown in *Figure 2*, and temporary fencing as tree protection fencing, shown in *Figure 3*.
