RECONSTRUCTION
CHANGI CHAPEL

NATIONAL
POW MEMORIAL
RMC DUNTROON

Reconstruction of Changi Chapel
As A National POW Memorial
RMC Duntroon, Canberra

Report March 1990

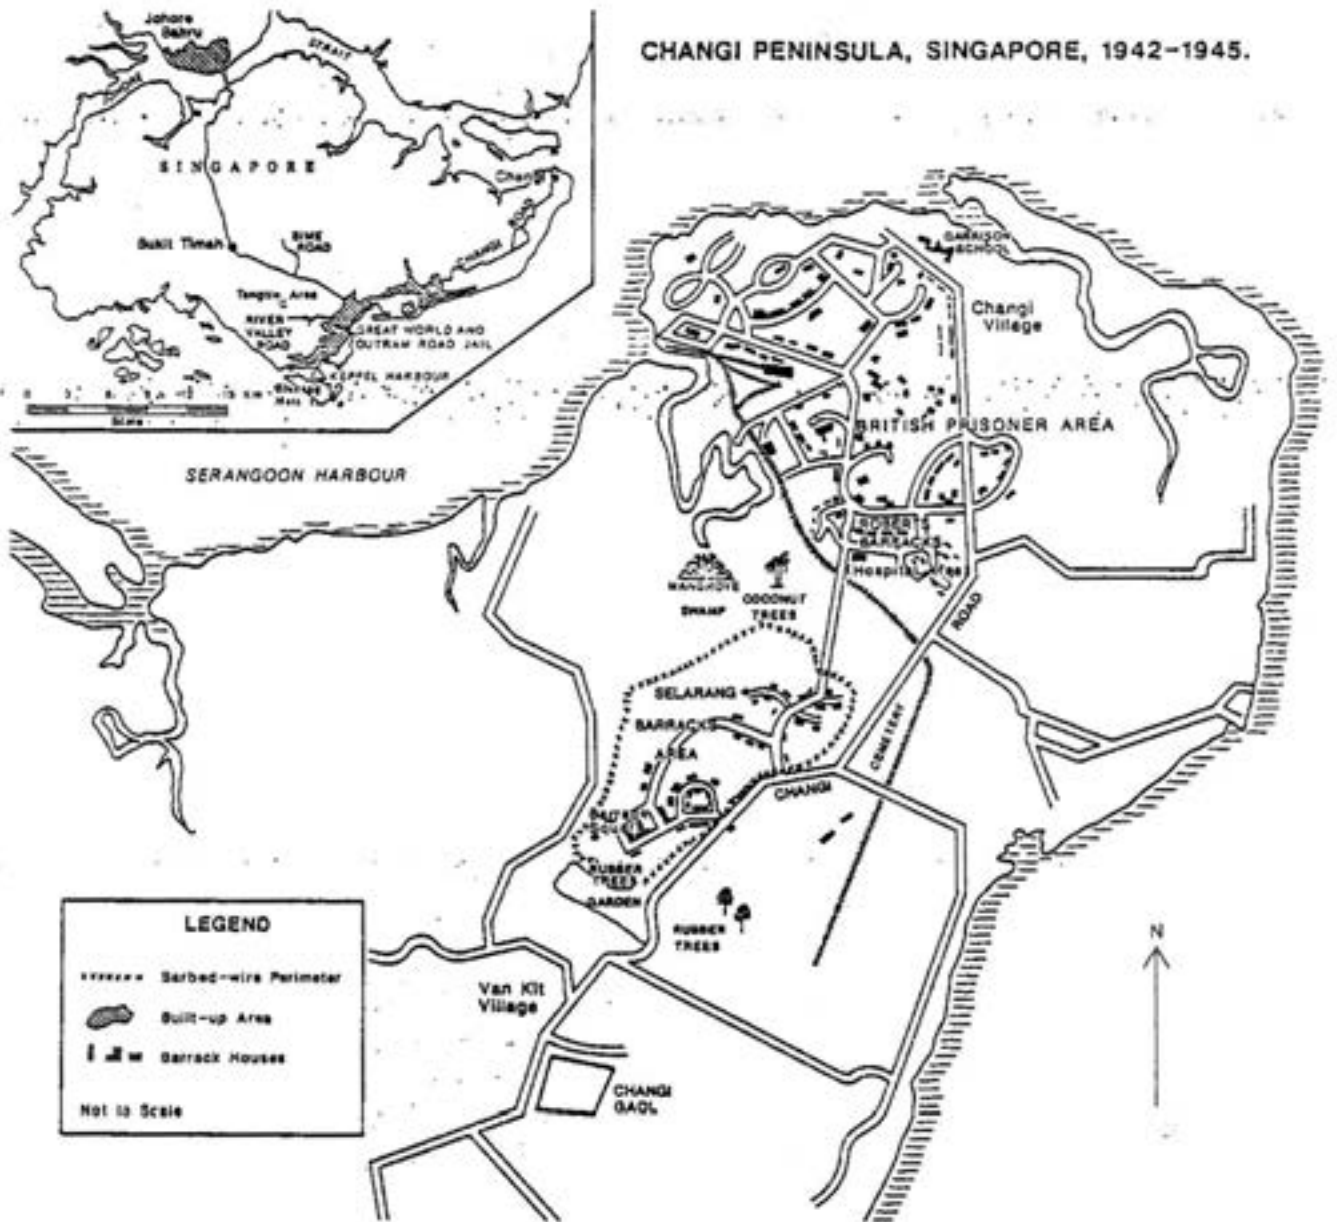
FIGURE 1

After the surrender of British Forces on Singapore on February 15, 1942, the captured Australians were housed in the Selarang Barracks area, one of the separately wired off camps which made up the whole Changi prison compound. (Figure 1)

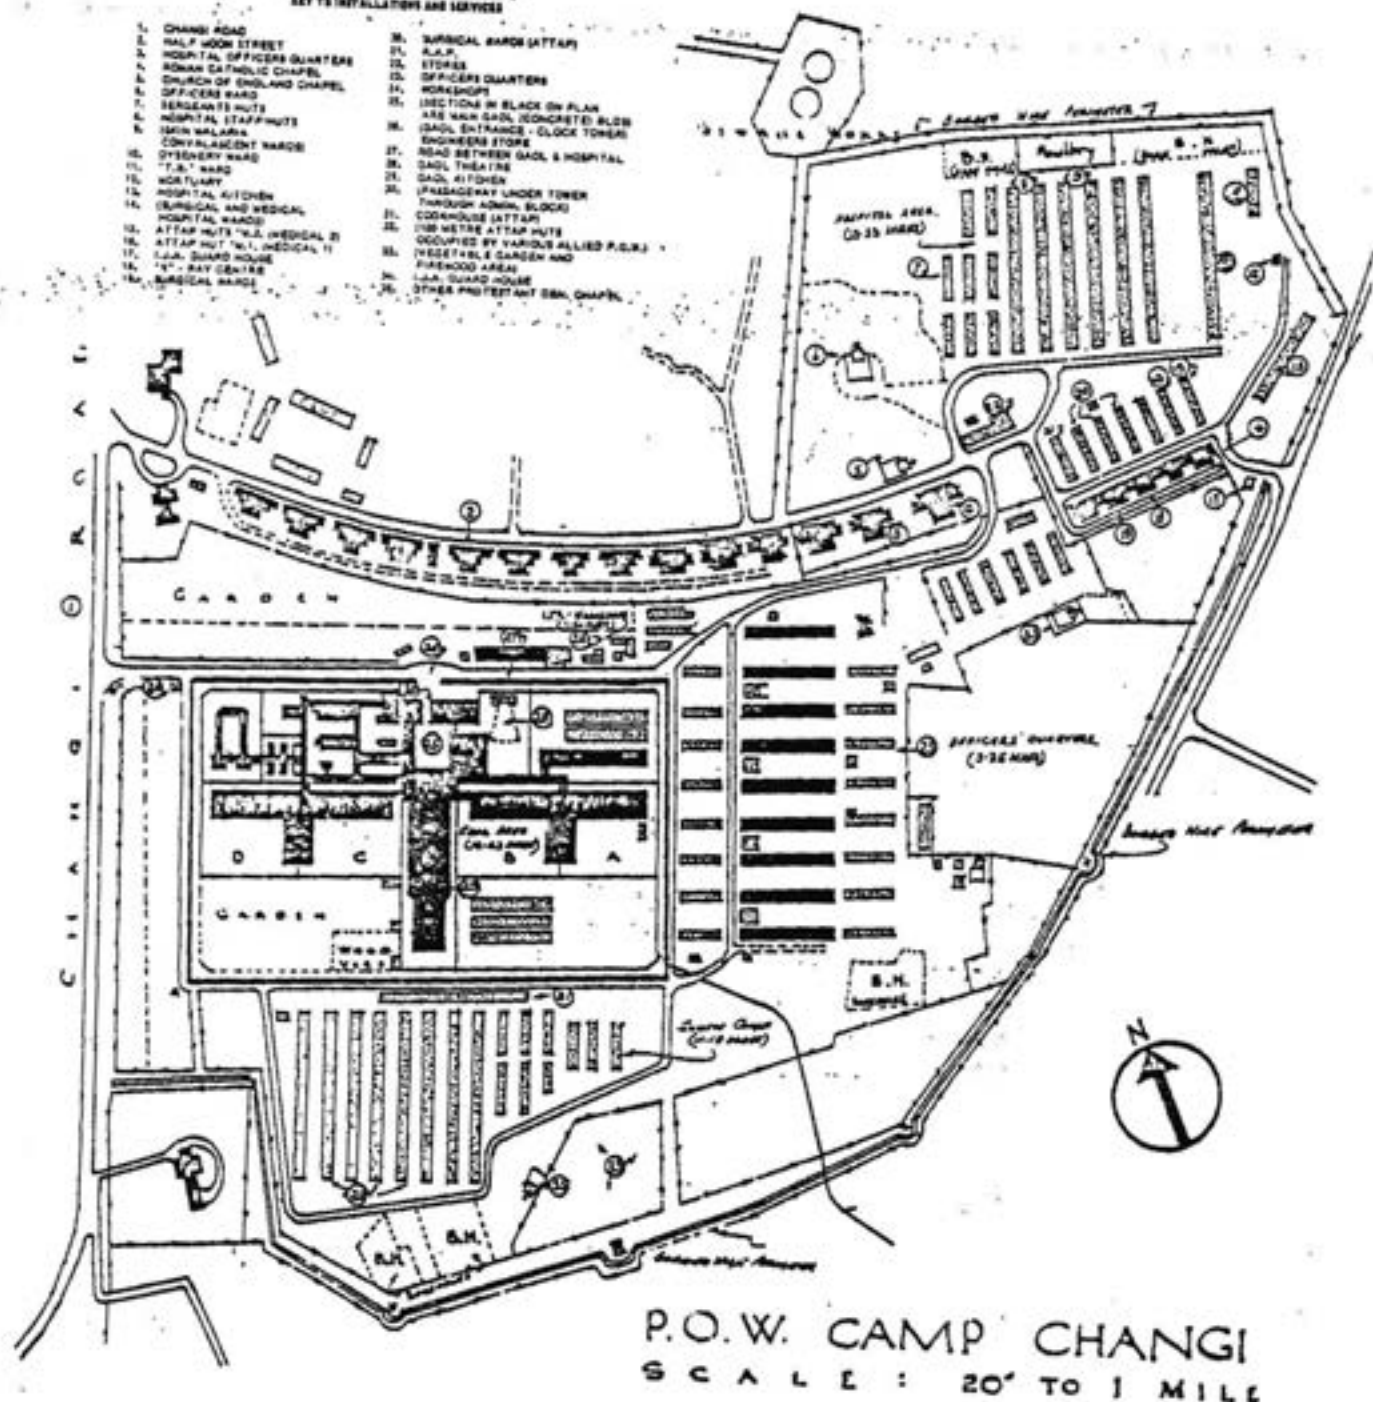
FIGURE 2

The new Changi gaol camp (Figure 2) was laid out into four accommodation areas:
