King George V Memorial

Heritage Management Plan

Volume 2: Conservation Works and Maintenance Program

May 2014

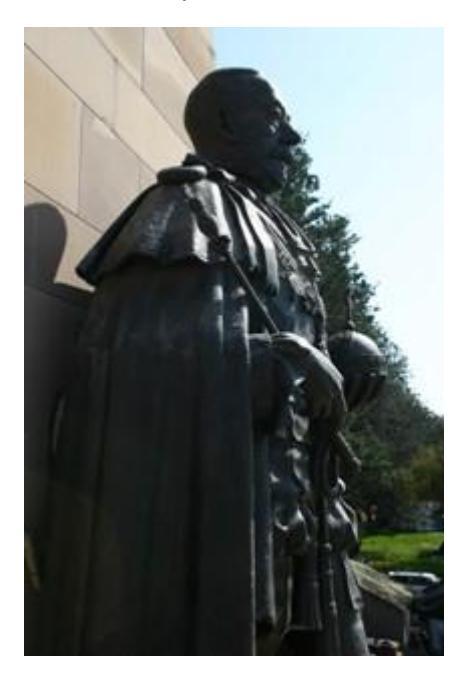
The figurative sculpture, plaques and lance are cast from bronze. They have a maintainable wax finish on the surface, last applied about six years ago. Other than some minor surface dirt and corrosion these elements are in good condition. Note that it is not possible to assess the interior of the main sculpture.
