20 December 2019

Ref: 5701

Preliminary Arboriculture Report¹ and Tree Management Plan 12 Somers Cres Forrest ACT 2603

Canopy Tree Experts have been engaged to carry out a Preliminary Arboricultural Report (**PAR**) and prepare a Tree Management Plan (**TMP**) for the trees on the above-mentioned site. We have combinded the two parts into one report.

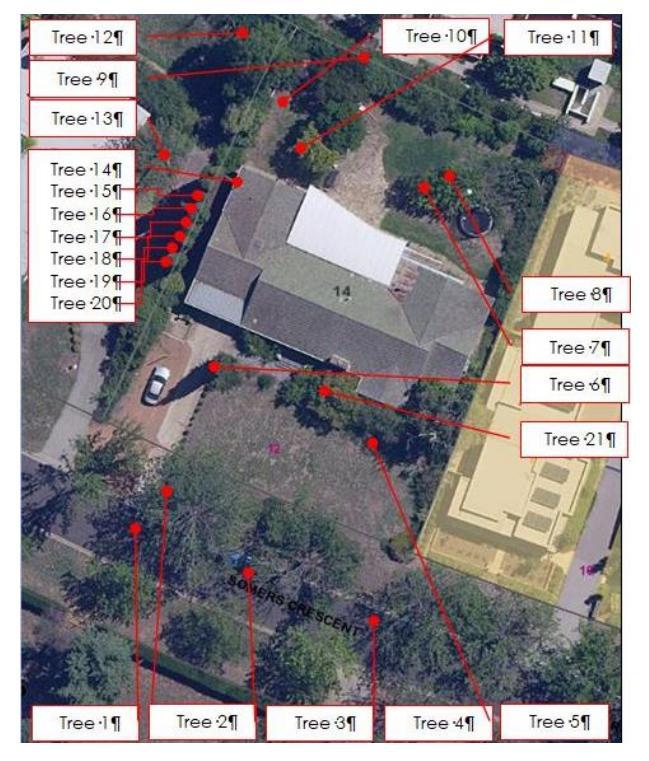
1. Tree Location Plan -

Please refer to the Tree Location Plan (Image 1) Tree Schedule and Tree photos and Appendix 1 & 2 for explanation terms and method.

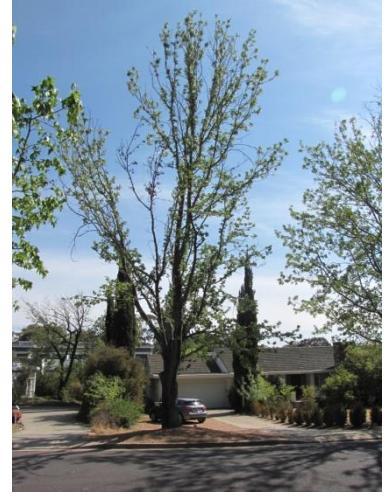
Tree 1- Street Tree

- 4 Street Trees, Tree 1 is a very poor quality tree.
- 1 Regulated Tree on the site Tree 9 Arbutus unedo a poor quality tree.
- 7 Regulated trees on the neighbouring property.
- The remaining trees were assessed as either weeds species or under 12m in height.

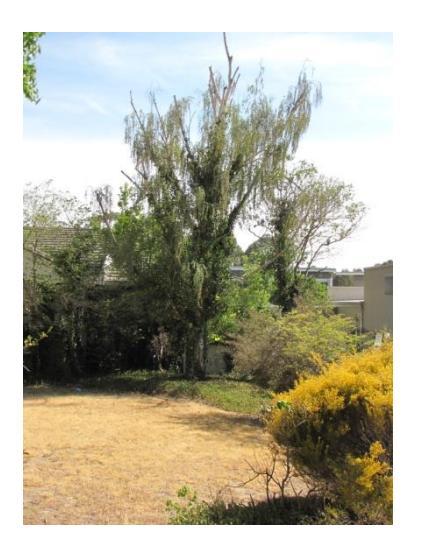
Tree 5- Not Regulated Silver Birch

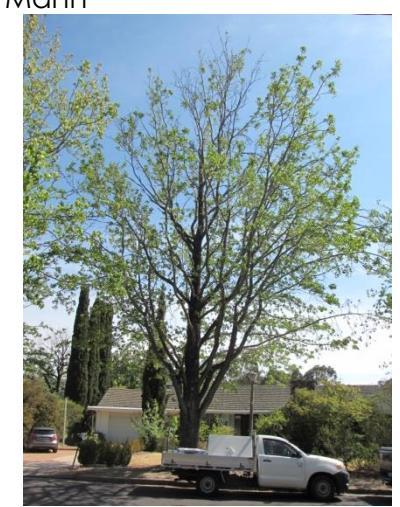
Tree 2- Street Tree

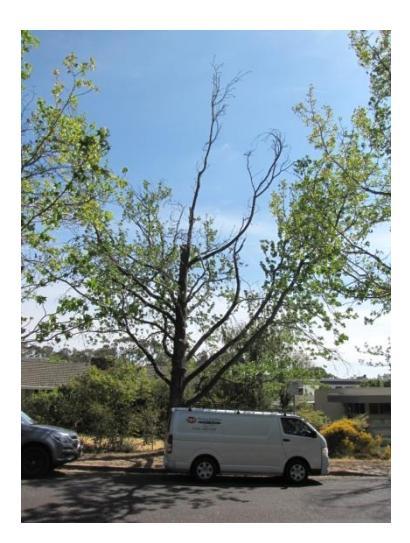
Tree 3- Street Tree very poor quality

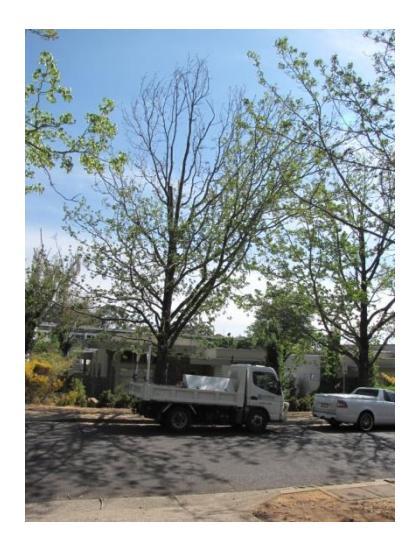
Tree 4- Street Tree

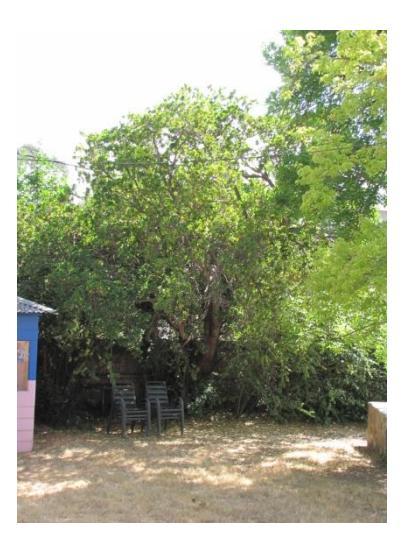
Tree 9 Poor quality Regulated tree on boundary under powerlines is a Arbutus unedo - Strawberry Tree

The only regulated tree on the subject site is a poor-quality **Arbutus unedo** located under the powerlines. It is regulated because of multiple leaders IT is proposed that this tree will be removed subject to approval from the NCA.

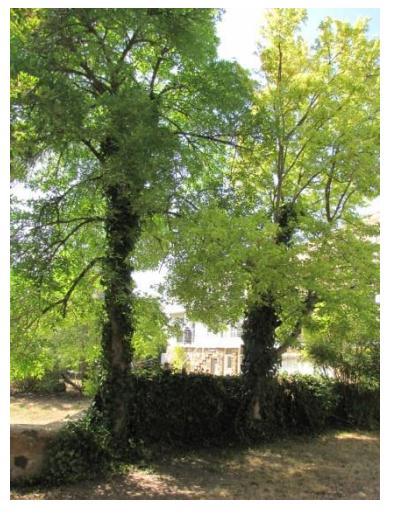
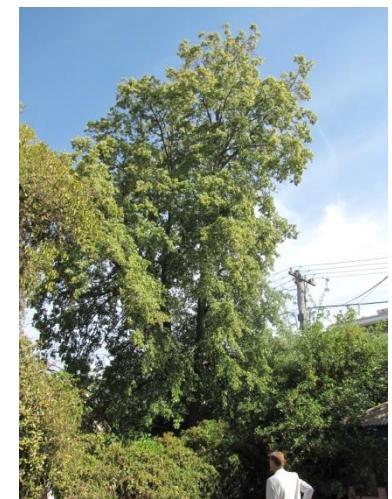
oxycarpa and Acer buergerianum to be property tree protection measures are removed for the development,

Tree 10 & 11 Non regulated Fraxinus Tree 12 Regualted tree on neighoursing outlined in TPM

Tree 12 is a regulated tree on the neighbouring property. Some protection measures are required as outlined in the the Tree Management Plan to follow.

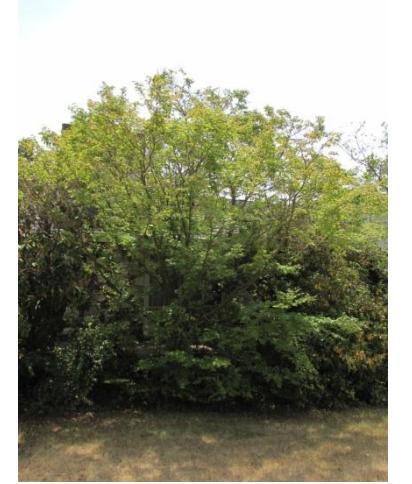
Tree 21 - Not Regulated Acer palmatum -Japanese Maple

All other trees are under 12m in height (non-regulated) or are weed species and will be removed as part of the redevelopment.

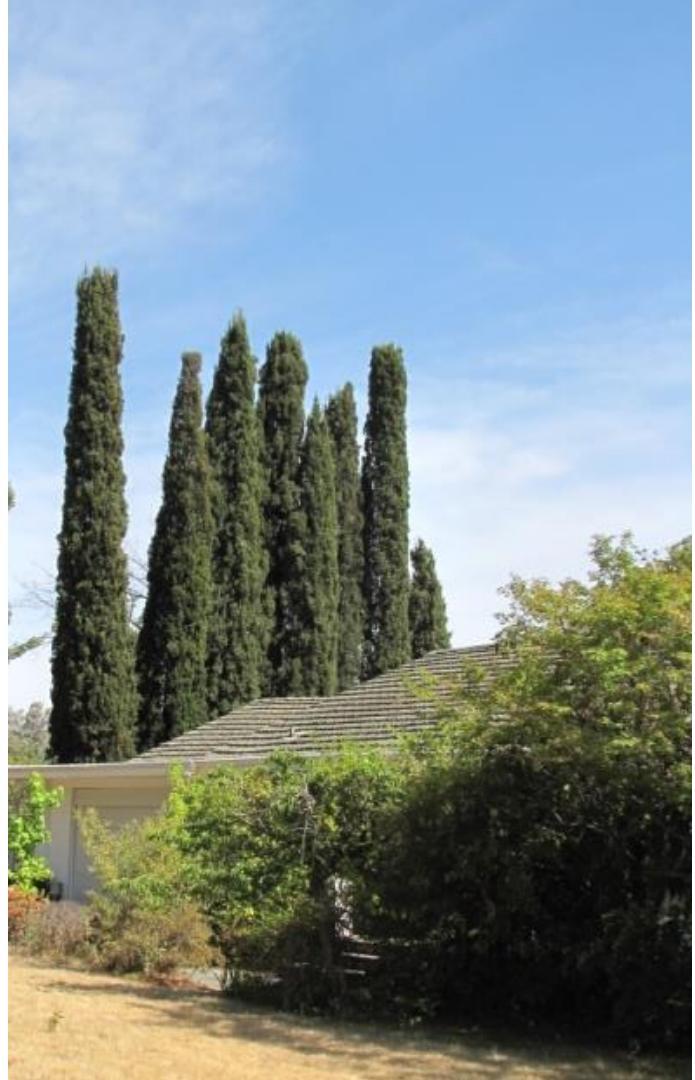
Tree 20-14 -L to R Regulated trees on neighbours property Retain as a group. Refer to TMP for protection measures.

There are 7 Cupressus sempervirens "Stricta" on the neighbouring property that will be maintained and protected during construction. The **TMP** to follow will outline tree protection measures for these trees..

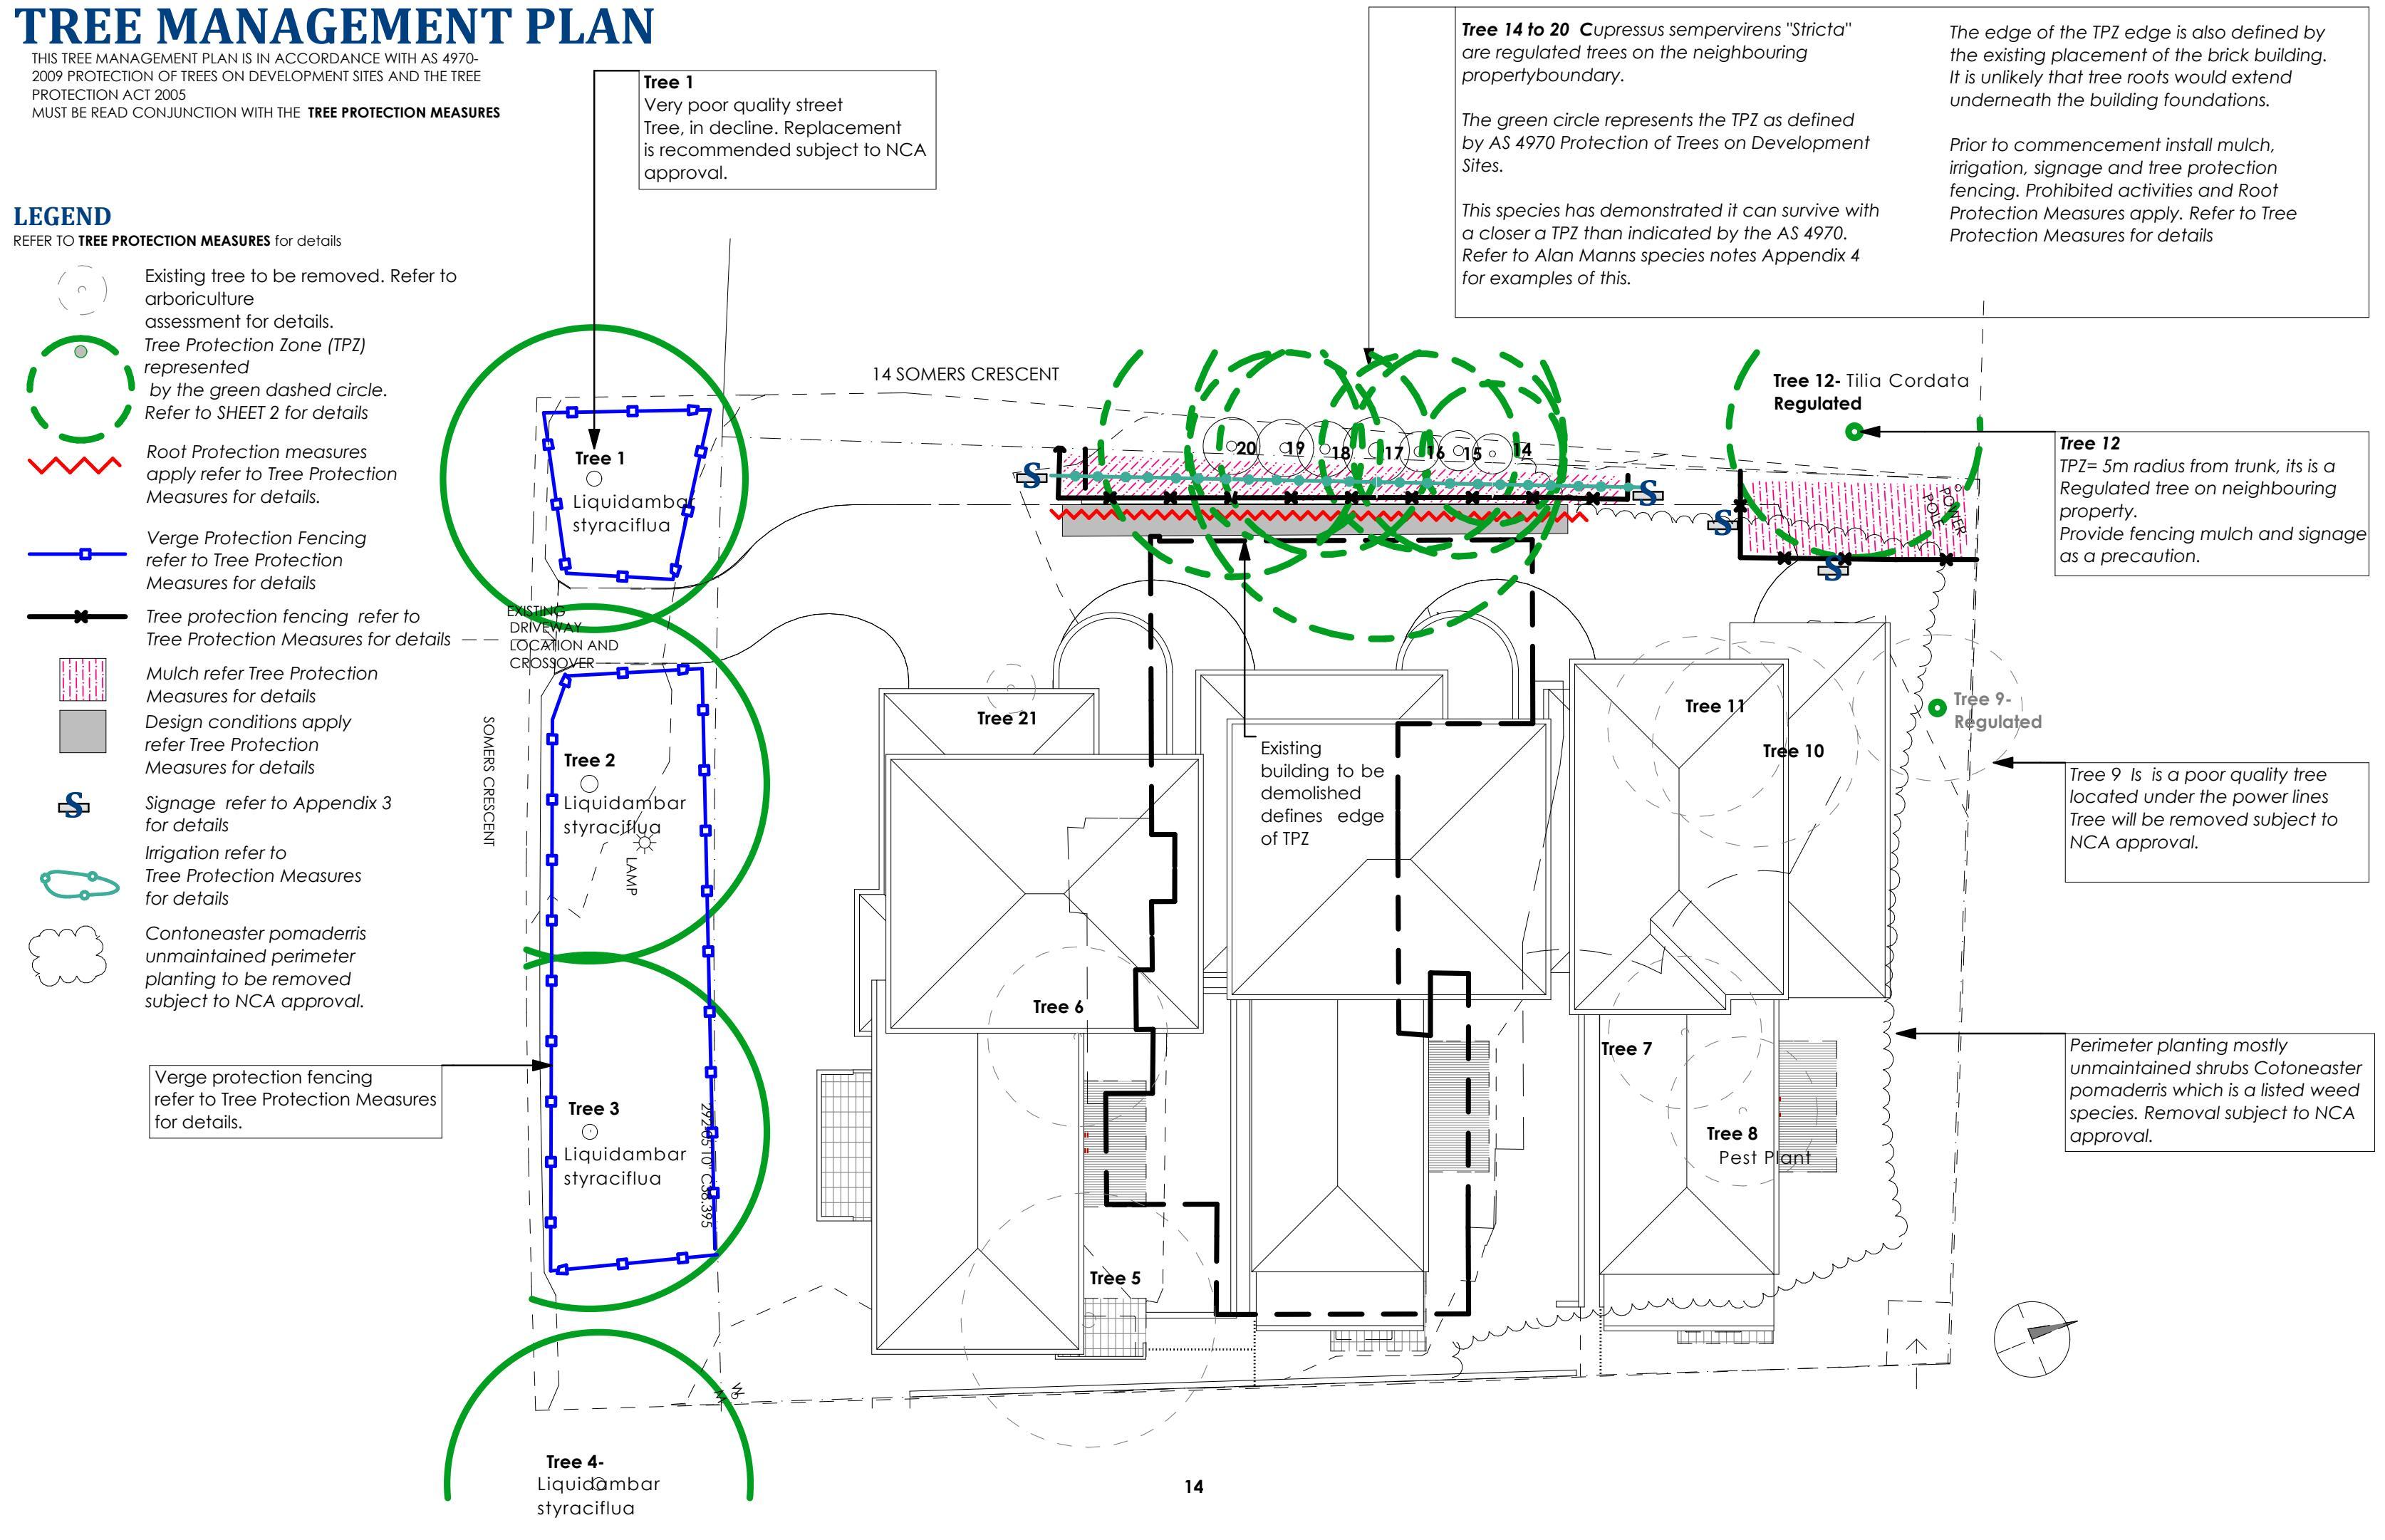
Tree Protection Measures- To be read in conjunction with Tree Management Plan (TMP) Approval

4. The Tree Protection Zone (TPZ), for the Trees is a circle centred on its trunk and of radius listed in the schedule. This is the root protection portion as designated by the Australian Standard AS4970-2009 'Protection of trees on development sites'. It is shown outlined by green circle on the drawing.

- 5. Tree Protection Fences of 1.2m high parawebbing on steel posts are to be installed around the fenced section of TPZ, as indicated on the drawing.
- 6. The Verge Protection Fences for the Street Trees are to be a 1.8m high chain mesh on steel posts that are driven into the soil and installed as indicated on the Tree Management Plan with by a blue line type as indicated to the left
- The fences are to be installed prior to commencement of demolition, excavation and construction for this project and maintained in good order until construction is complete.
- The boundary fences will suffice where they correspond with the TPZ fences
- The fences may be removed at the end of the construction work for the installation of the landscape, however, the 9. Prohibited Activities (b-h) and Root Protection clauses still apply.

10. Signs, as depicted on Appendix 3, are to be installed as indicated on the drawing, prior to work commencing on site. Mulch

- 12. Prior to work commencing on site, an irrigation line with drippers is to be installed as shown on the drawing;
 - a. At least 8 weeks prior to any excavation within the RPZ of Tree 1, the irritation is to be used to supply 600 of water to the tree by slow drippers.
 - b. Every 4 weeks during the construction period the irrigation line is to be used to supply 600l of water to the tree by slow drippers.
 - c. This irrigation program may be changed on the advice of an AQF level 5 arborist. If there is a period of unusually wet or unusually dry weather an AQF level arborist is to inspect the tree and site and advise on changes to the irrigation program

- 16. New Driveway. Where the driveway is located beyond the existing building envelope(to be demolished) of Trees 14-20 the:
 - a. Construction is to be carried out without machinery entry into the fenced section of the TPZ,
 - Excavation is not to extend further than the driveway edge or into the fenced section of the TPZ. b.
 - Driveway is to be built to float over the existing ground level; And. C.
 - Root Protection Measures and Prohibited Activities still apply. d.

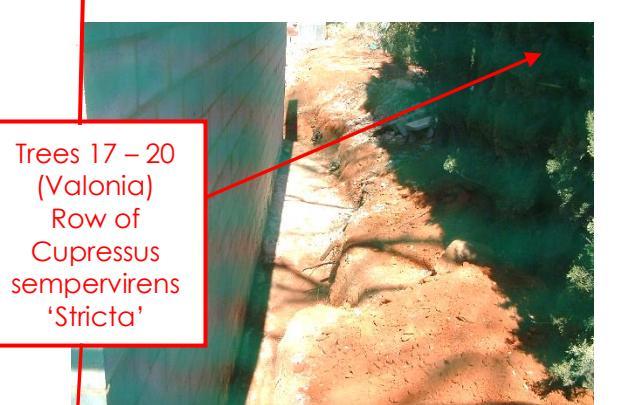
Figure 3 August 2006 Excavation beside the trees that are indicated in Figure 1

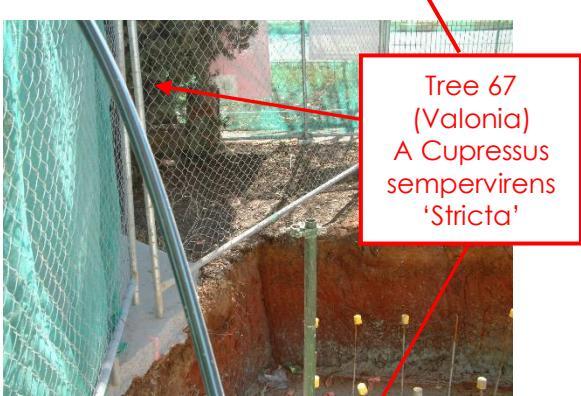
Figure 4 August 2006 Excavation beside the tree that is indicated in Figure 2

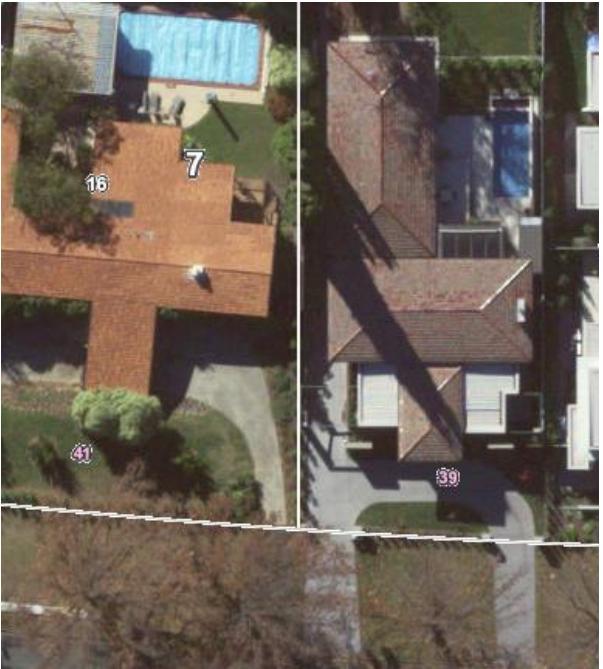
Figure 10. Aerial image from2012 <u>www.actmapi.act.gov.au</u> A knockdown re-build was carried out with deep excavation for driveway adjacent to 6 C. sempervirens

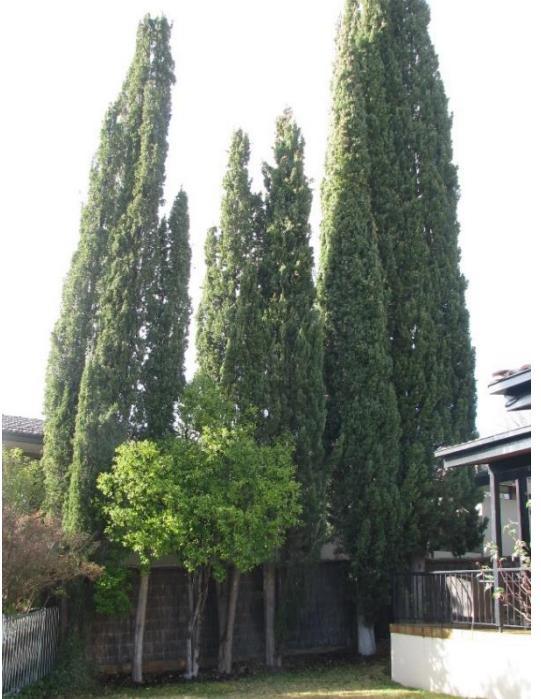
Figure 11 20180918 at least 7 years after excavation approximately 1m from trunks. Trunk diameters from 190mm – 650mm (By AS4970-2009 their TPZ would be 2.3 – 7.8m radius)

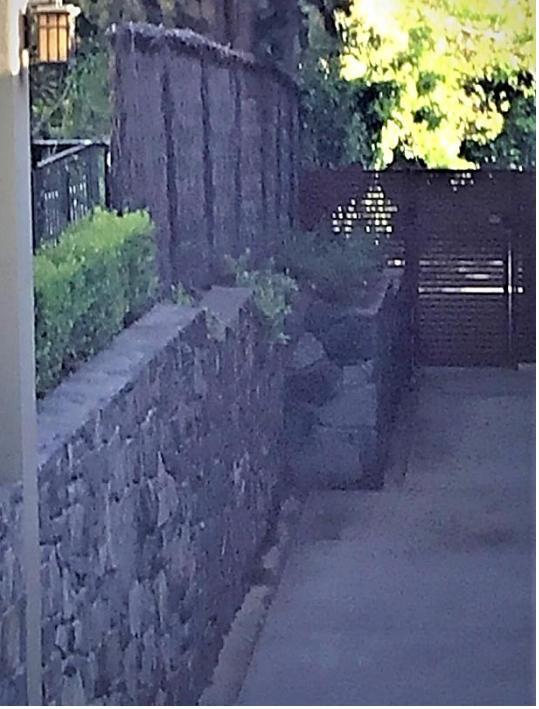
Figure 12 20191029 the driveway to the basement at 39 National Cct. Deep excavation and retaining wall installation approx. 1m from the row of C. sempevirens
