2. LOCATION, DESCRIPTION AND ASSOCIATED PLACES

Parkes Place is a parkland area located in the central part of Canberra, adjacent to Old Parliament House.

2.2 DESCRIPTION AND CONDITION

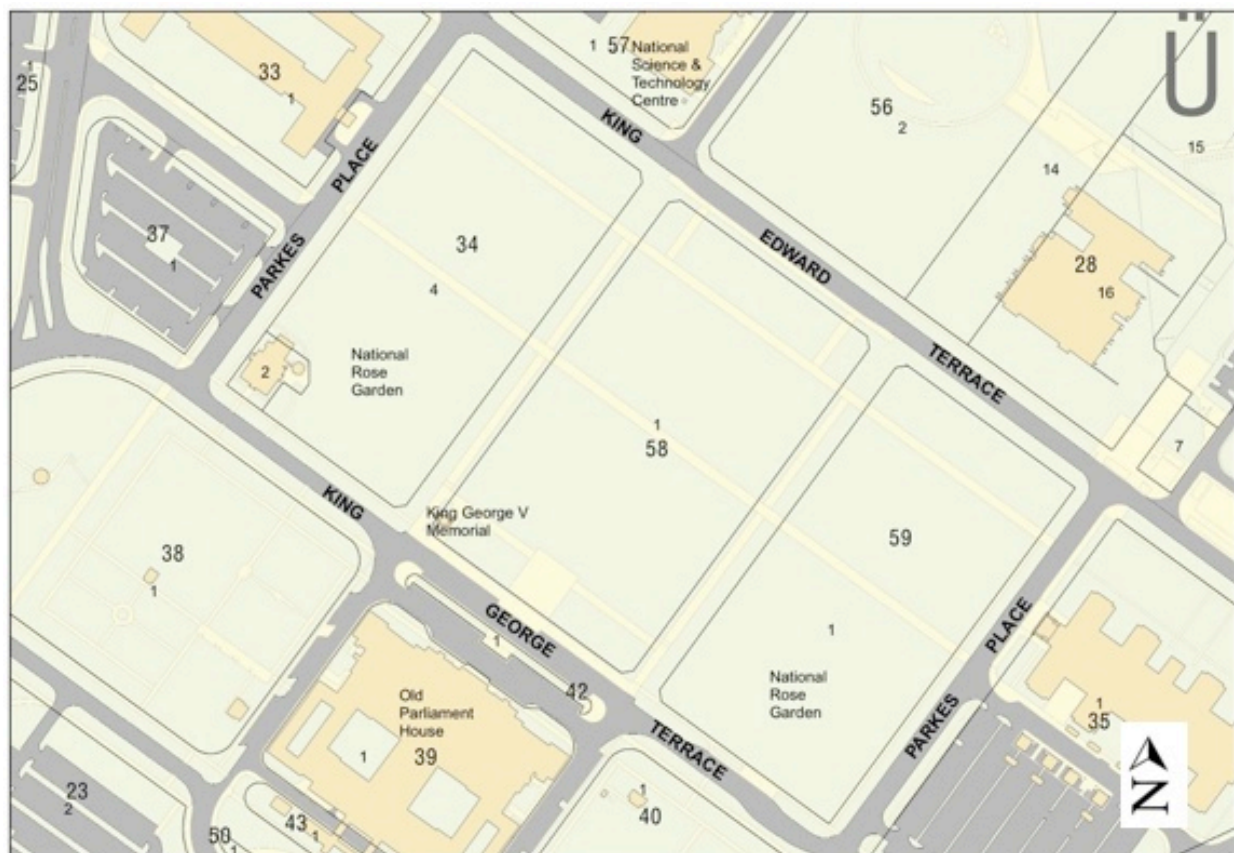
Figure 2. Block and Section Plan of Parkes Place

The blocks and sections included are Block 4, Section 34, Block 1, Section 58 and Block 1, Section 59, Parkes. The two road reserves within Parkes Place are also included.

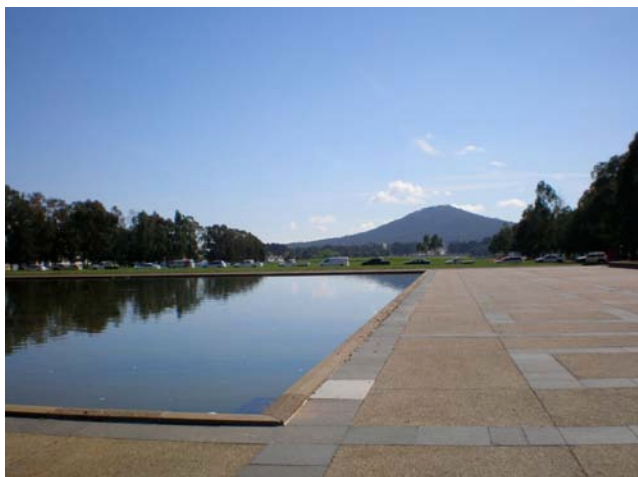
Figure 9. Land Axis vista from adjacent to the central reflecting pond, looking north

The vista is bordered by two rows of eucalypts (*Eucalyptus elata*) in front of the row of original plantings (*Cupressus sempervirens*, *Cupressus arizonica* and *Populus nigra* 'Italica'). A few additional eucalypts have been randomly planted in the area of the Aboriginal Tent Embassy.

The vista is enhanced by the broad sweep of the grassed surface, only some of which is irrigated. Adjacent to the roadway of King George Terrace is a terrace paved with concrete in the central area with grass at the sides. The concrete retaining wall of this terrace accommodates a planting bed with low shrubs.

Access to the lower unirrigated grassed terrace is by broad concrete steps at the centre with additional steps at each side accessing the north-south walkways. Further north the Land Axis bisects the cross axis vista with a paved terrace and ornamental ponds. Towards the King Edward Terrace roadway the vista is bordered with eucalypts and Casuarinas (*Casuarina cunninghamiana*), and the grass is irrigated.

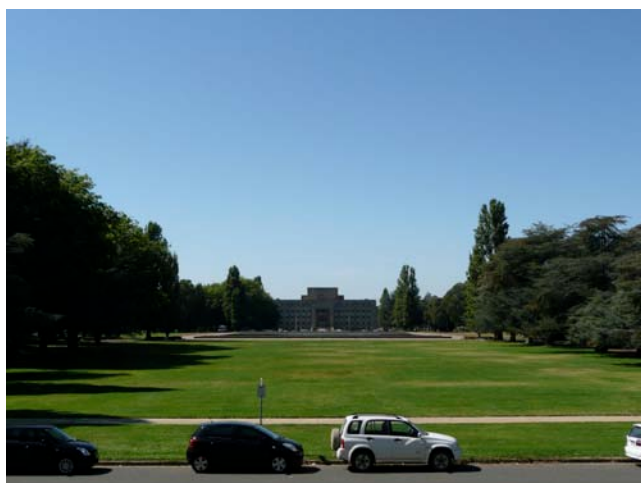
Figure 10. Cross Axis vista looking towards the John Gorton Building

The vista between the Treasury Building and John Gorton Building is maintained by a broad sweep of irrigated grass, the low profile of the central terrace and ornamental ponds, and the strength and visual integrity of the deciduous and evergreen bordering trees (*Quercus palustris*, *Platanus acerifolia* and *Cedrus atlantica*).

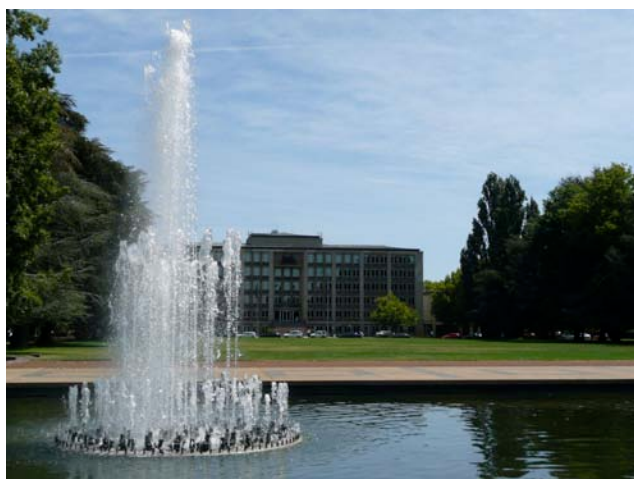
Figure 11. Side reflecting pond with 'wedding cake' fountain. Treasury Building in background.

The intersection of the two vistas is marked by a formal terrace containing a large square reflecting pond with rectangular ponds each side, each containing 2 gushing (wedding cake) fountains. The terrace surrounding the ponds is patterned with a large square motif formed by bluestone slabs inset to exposed aggregate paving.

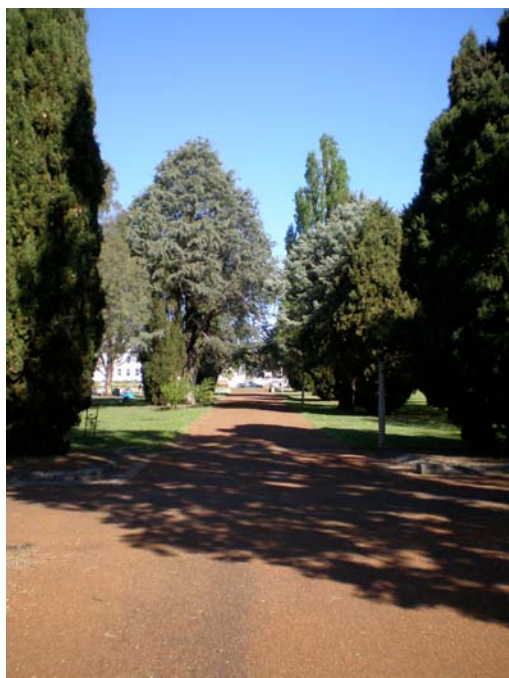
Figure 12. North-south walkway, eastern side of Land Axis, looking south

The two north-south stabilised red gravel walkways edging the Land Axis vista and the Rose Gardens present an unfolding sequence of views under and between mature dark-green evergreen conifers (*Cupressus sempervirens* and *Cupressus arizonica*), light-green deciduous trees (*Quercus palustris*), and fine-leaved, grey-green eucalypts. Fastigate deciduous trees (*Populus nigra* 'Italica') planted in square at-ground planting boxes mark the intersection with other walkways and access points. Many of the trees are mature and reflect the various periods of plantings that have occurred. The plantings discontinue across the vista space and then continue again.

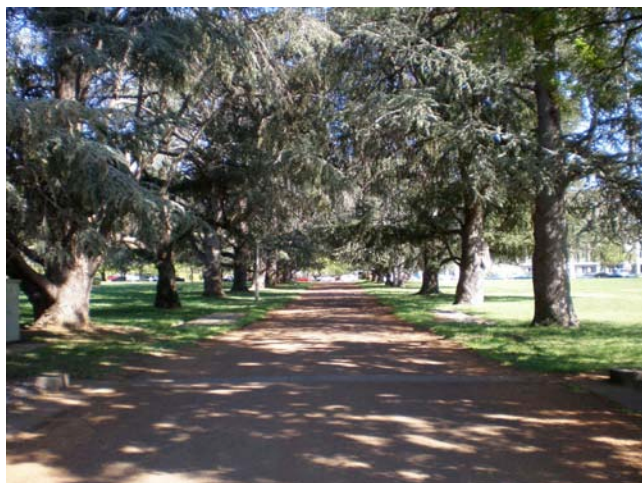
Figure 13. Cross Axis walkway, southern walkway looking west

Two east-west walkways edge the Cross Axis. The southern walkway is edged by a single row of large mature grey-green conifers (*Cedrus atlantica*) on both sides of the stabilised red gravel walkway. The plantings discontinue across the vista space and then continue again. The northern walkway is edged with one line of conifers to the south (*Cedrus atlantica*) and two lines of deciduous species to the north (*Quercus palustris* and *Platanus acerifolia*). Fastigate deciduous *Populus nigra* 'Italica' mark the intersection of pathways.

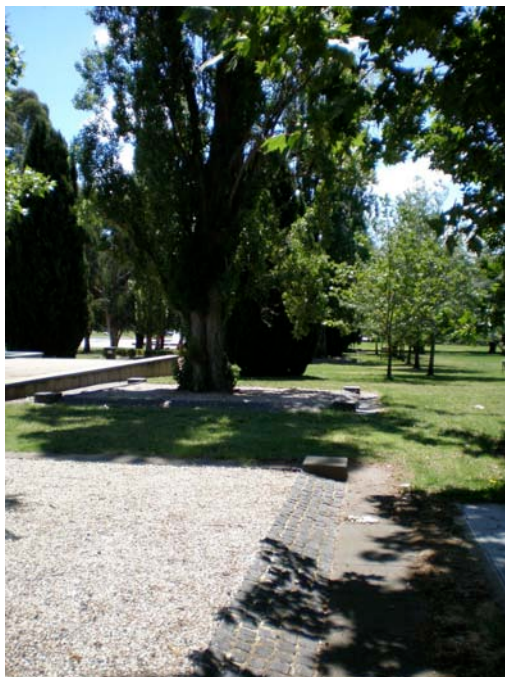
Figure 15. Poplar node plantings without shrubs

Fastigate deciduous trees (*Populus nigra* ‘Italica’) are planted in square at-ground planting boxes edged with granite sets. Some are formally planted with trimmed low shrubs (*Buxus sempervirens*), others are unplanted. They mark intersections with other walkways and access points, and occur in groupings of two and four.

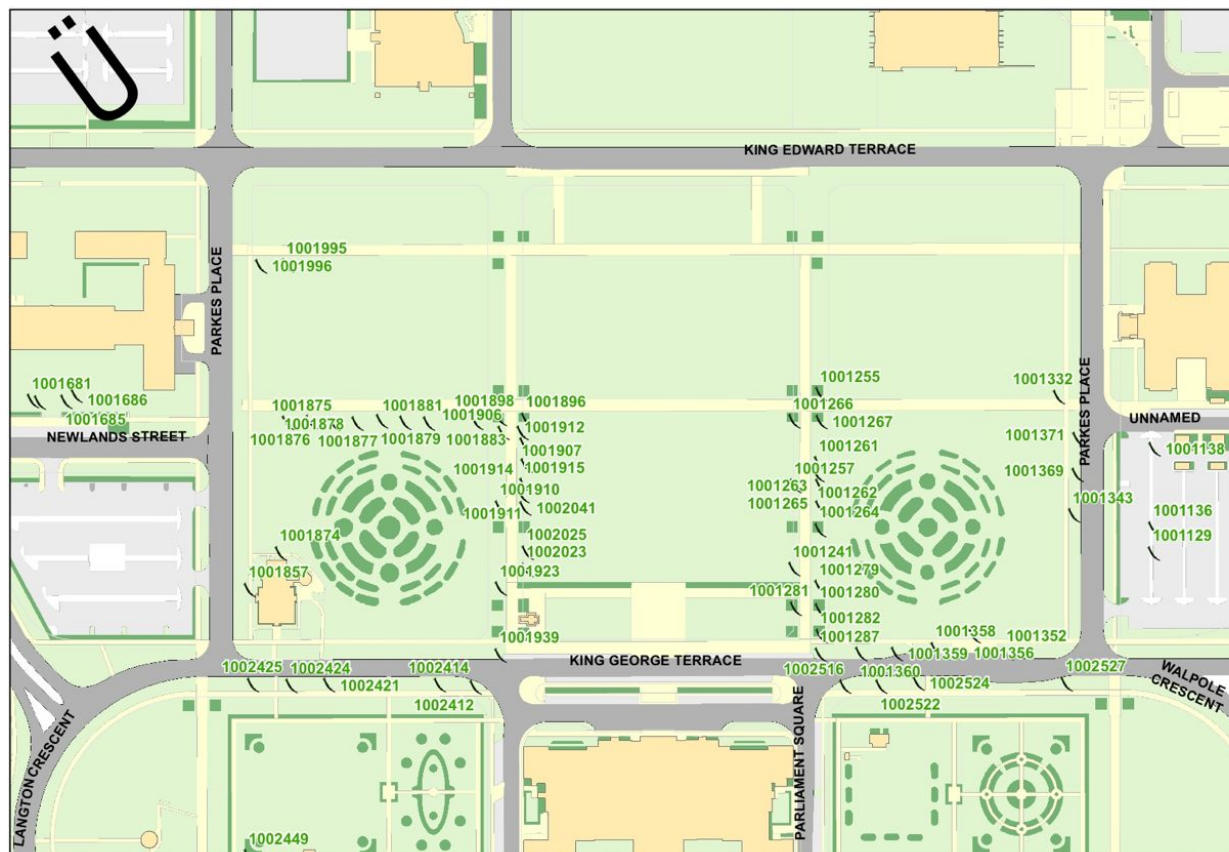
Figure 19. Location of Significant Trees identified in the 1998 Survey

In addition to/overlapping with the above, a 1998 survey of the Parliamentary Zone identified 33 individually significant trees. Relevant data from this survey is presented in the following table and figure. To some extent, the 1998 survey data overlaps with the list above. However, in one case a tree has died, and in another case, the tree is partly dead, as noted.

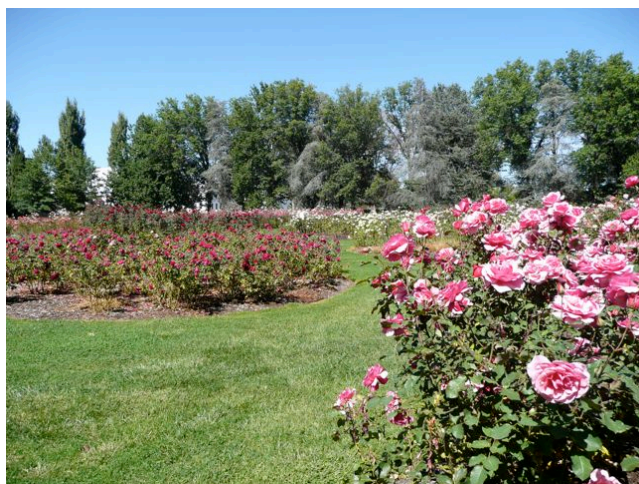
Figure 21. National Rose Gardens

The gardens are in two parts, set symmetrically either side of the grassed and paved terrace in front of Old Parliament House. The design of the two gardens is similar in plan, but each displays an individual character. The site slopes gently to the north (approximately 1.5% slope) and covers an area of approximately 4.5 hectares. The general character of the gardens is of a spacious formal parterre enclosed by mature trees. The gardens have three basic components: the rose beds themselves, perimeter plantings of trees and the lawn.

The rose beds in each garden are laid out in plan to symbolise the petals of a fully-opened rose. This consists of a central circular bed enclosed by punctuated annulus beds in a formal quartered configuration. The original colour pattern has not been maintained. The replacement of ageing roses with new varieties occurs regularly.

The eastern garden is showing a well worn track between the beds indicating high pedestrian use between the John Gorton Building and Old Parliament House.

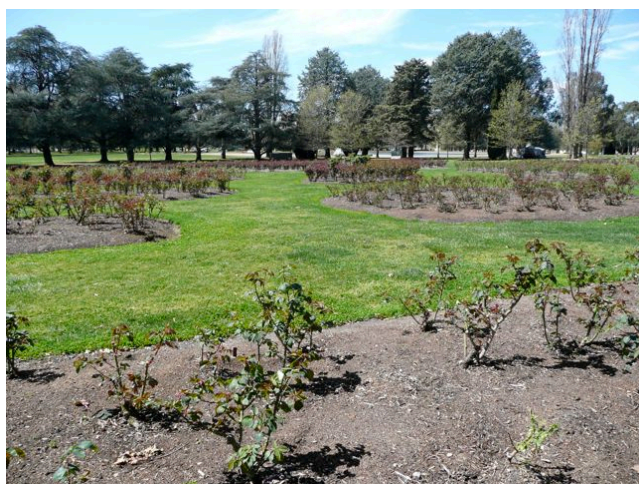
Figure 22. National Rose Gardens

A number of the rose beds have a commemorative association.

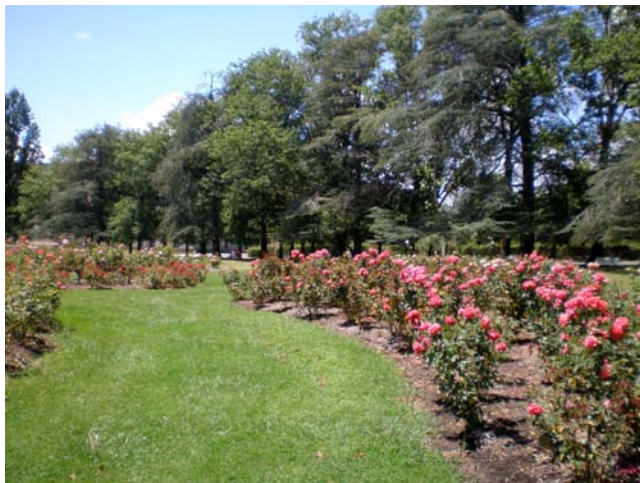
Figure 25. Mixed border tree planting to the eastern rose garden

Each garden is enclosed by a perimeter of large mature trees of a variety of non-native species, evergreen and deciduous, and arranged in a regular order. The species used (basically cedar, oak, pine, plane and poplar) provide for a range of seasonal visual effects as well as wind protection and space definition. Pruning of low limbs has provided unimpeded pedestrian access. The avenue of cypress trees (*Cupressus sempervirens*) which separates the rose gardens and the central grassed terrace is a memorial planting. Planted by visiting dignitaries on the occasion of the meeting of the delegates of the Empire Parliamentary Association in 1926, some of the trees still have a memorial plaque at their base. Also along this avenue are mature poplar

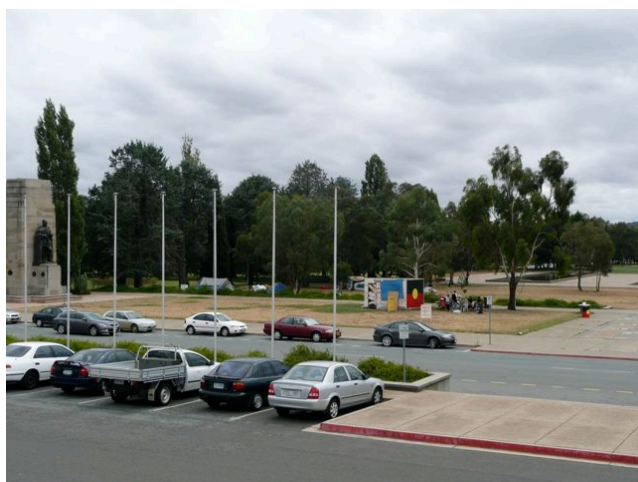
Table 2. Built Elements	
Category	Examples
Minor Buildings	<ul style="list-style-type: none"> Aboriginal Tent Embassy, including: <ul style="list-style-type: none"> a Sacred Fire for Peace and Justice; a lightweight portable building housing a small display and information about the Aboriginal Tent Embassy; flag, a number of metal barrels along the northern edge of the site; an art mural on the ground at the southern end of the site closest to Old Parliament House; and an array of tents, campsites and camp infrastructure and vehicles. (Note: These features differ from those noted in the Australian Heritage Database citation because of changes over time.) Lobby Restaurant and public toilets: <ul style="list-style-type: none"> is a design based on a square plan with steel support columns. A set of four steel internal columns support the clerestory. The glazed walls on the front and two side faces are full height and regularly patterned. The remaining wall and toilet section are face brick. The building style has clearly expressed horizontal planes of the external building platform, eaves, and a clerestory window. A small central spire provides a feature similar to the Late Twentieth-Century Ecclesiastical style. The building has good quality finishes with its roofing, fascia and spire clad in copper. The timber lined eaves extend into the building. the public toilet section is contiguous with the restaurant building. the café section has an original timber framed and clad structure which has been enclosed by a large temporary glass, metal, panelled and plastic sail structure. Bus shelters – round painted concrete structures

Figure 26. Aboriginal Tent Embassy adjacent to the King George V Memorial

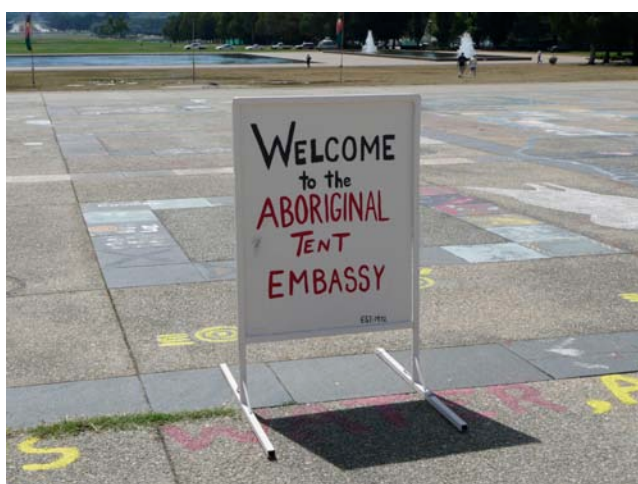
Figure 27. Aboriginal Tent Embassy mural on paving

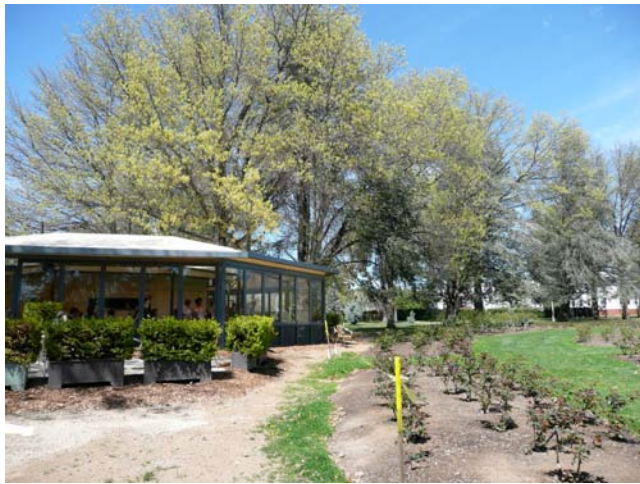
Figure 29. Lobby Restaurant – temporary extension to café section

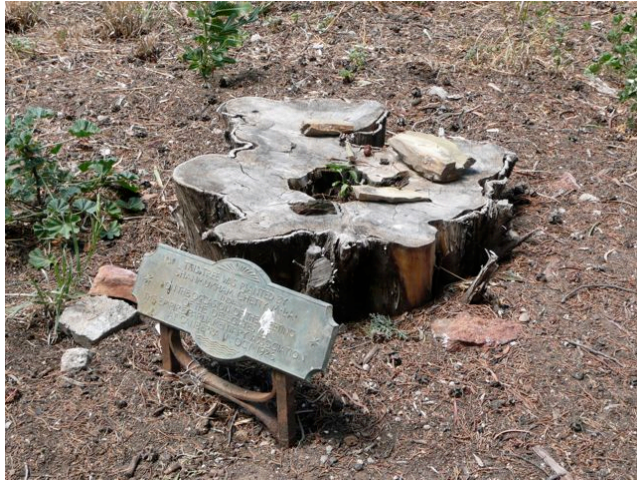
Figure 32. Empire Parliamentary Association Cypress Tree stump of 1926, with plaque
Source: Duncan Marshall

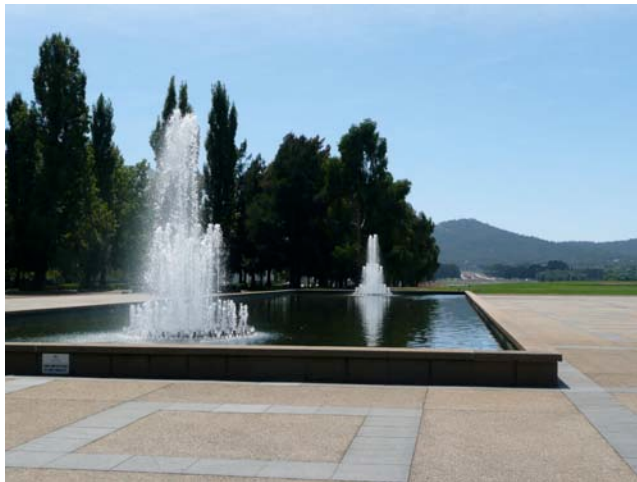
Figure 33. Land Axis reflection ponds and fountains, and decorative paving
Source: Duncan Marshall
