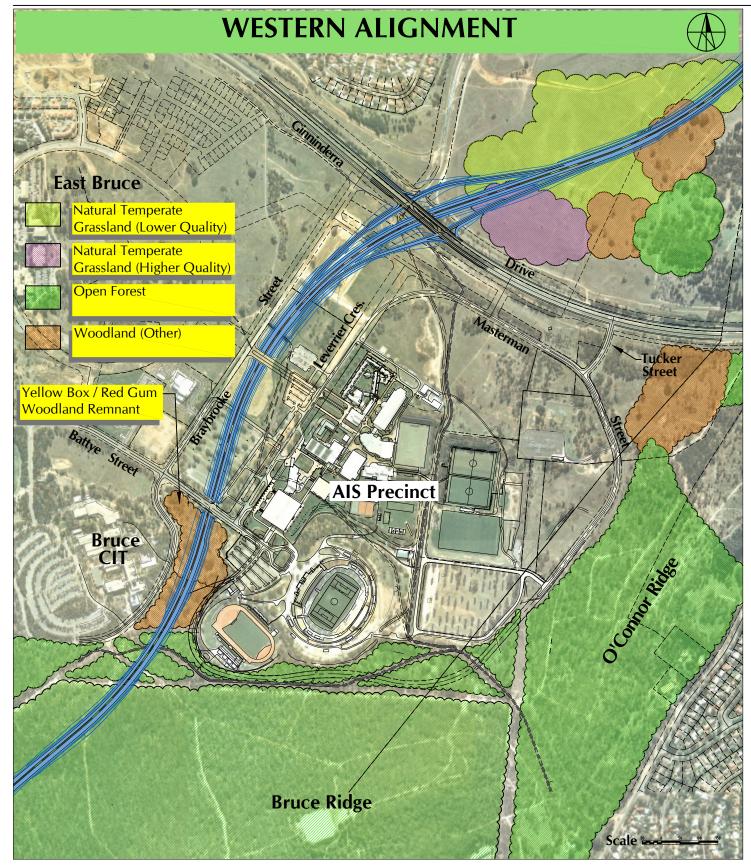
- 1. Both higher and lower quality natural grasslands north of Ginninderra Drive impacted.
- 2. No endangered fauna species identified.
- 3. Open forest (Yellow Box / Red Gum remnant) impacted south of Battye Street.

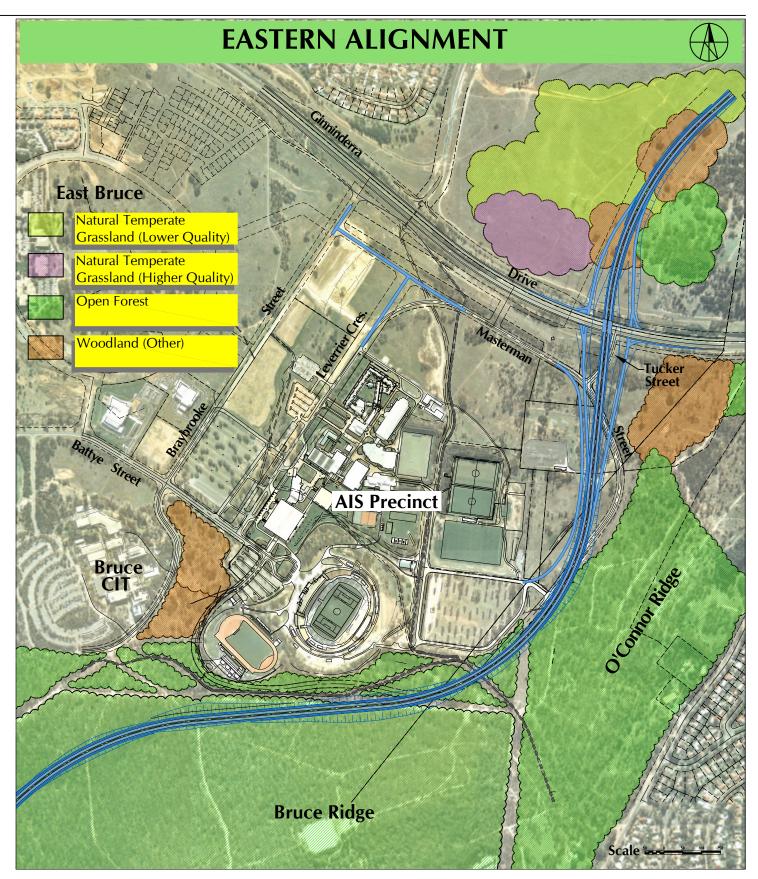
- 1. Largest impact on Bruce Ridge section of Canberra Nature Park, approx 15 Ha impacted.
- 2. No endangered fauna species identified.
- 3. Moderate quality woodland and small section of lower quality grassland impacted north of Ginninderra Drive.
