CLIENT  
**Australian War Memorial**

**Australian War Memorial**  
Detail Survey  
Block 1 and 2 Section 39  
Campbell

Proj No. 99027 Rev S  
Sheet No. 1 of 1 99027\_001R  
© Veris Australia Pty Limited ABN 53 615 735 727 B1

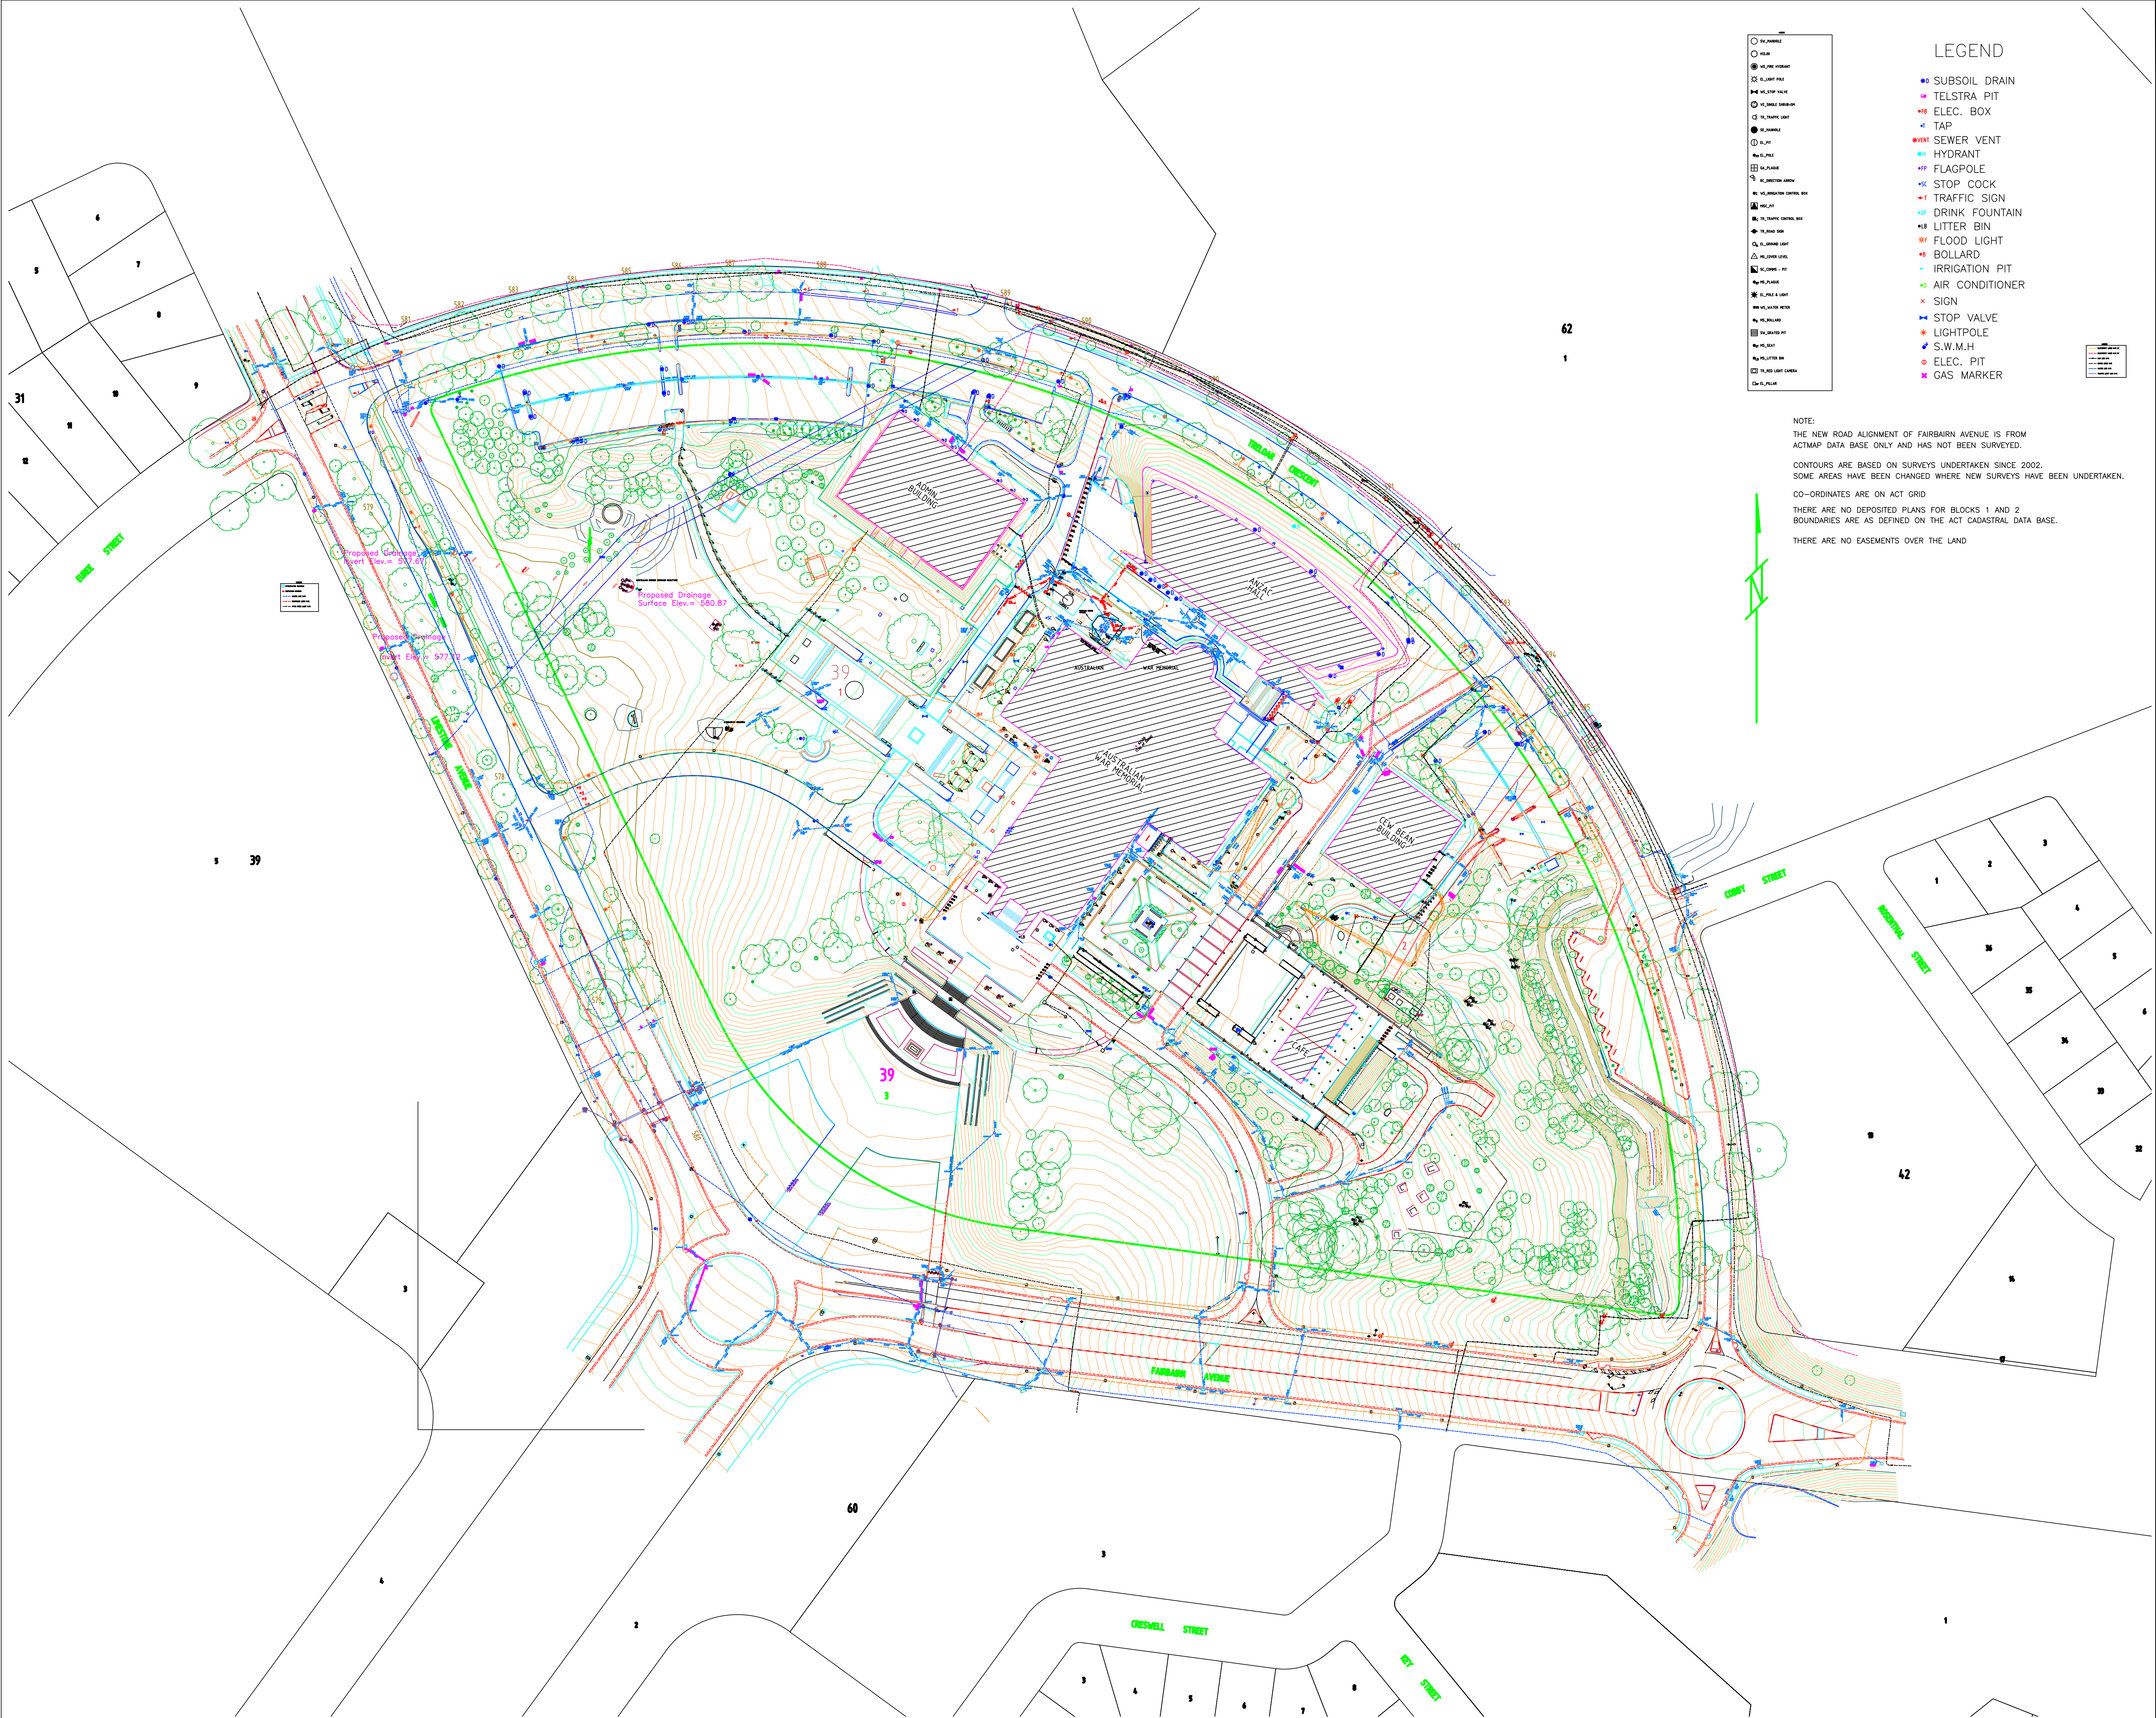
Services shown hereon have been determined from a combination of visual evidence and tracing by Veris Sub-Surface Sydney. Prior to any demolition, excavation or construction on the site the relevant authority should be contacted to establish detailed location and depth.

Contour Interval 0.25 Datum A.H.D.  
BM SR979 RL 588.080  
Scale 1:1000 0 10 20 40
